Reservoir Regulation and Vegetation in the Draw-down and Delta Zones of the Duncan Lake Reservoir, British Columbia

Regulated Rivers II: Science, Restoration, and Management of Altered Riverine Environments

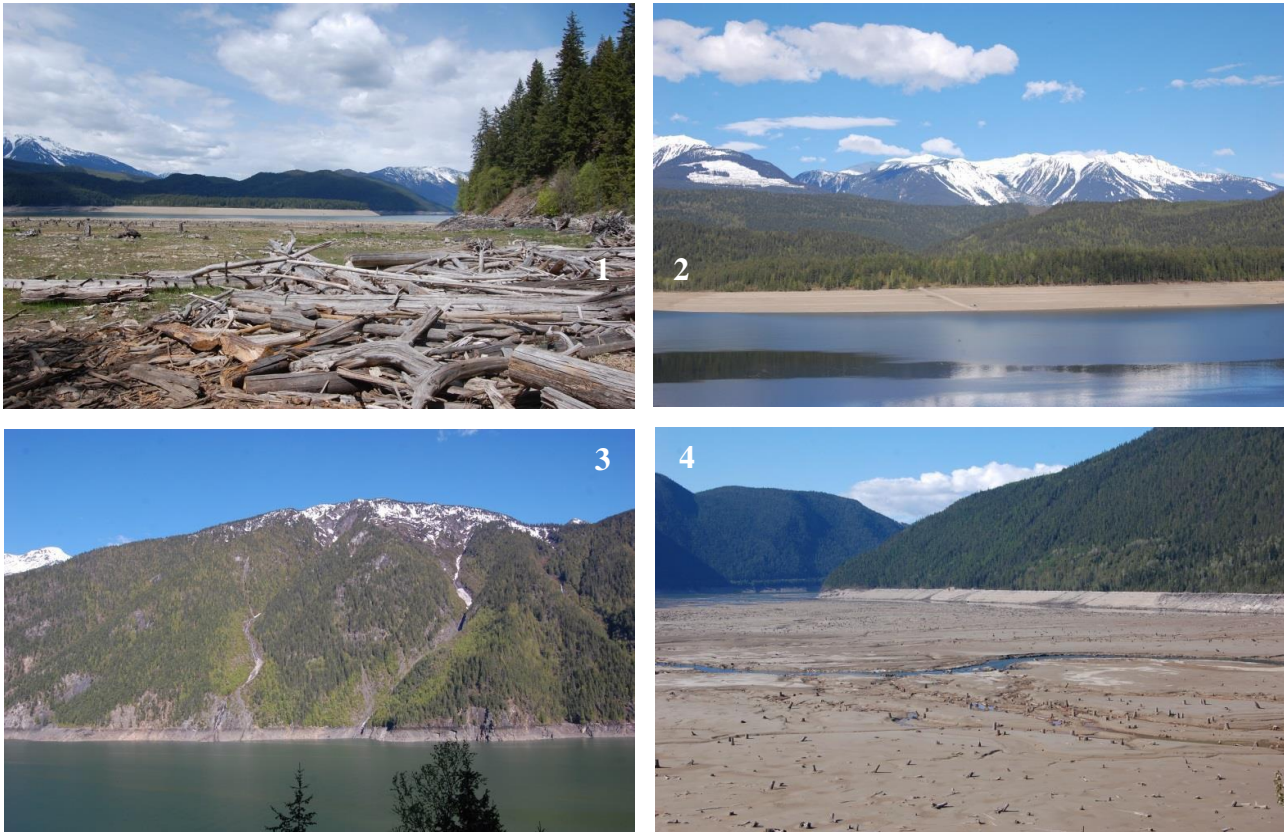
Figure 4. Photographs of the Duncan Reservoir at full draw down (May 7, 2019). (1) The alluvial fan at Glacier Creek, with an extensive area this is only slightly below the full pool elevation. (2) Sloping bank and boat launch near the town of Howser. (3) A steep slope drops directly into the former Duncan Lake and the draw down zone provides a near-vertical bedrock band. (4) Perhaps the greatest ecological loss was the wetland zone upstream of the prior lake. Here, Howser Creek inflows from the left and will join the Duncan River along the right bank. The wetland zone was quite flat along the transverse (valley wall to valley wall) and longitudinal (along river corridor) axes, and surface sediments were finer, with fewer large trees (stumps following clearing).

The most promising locations would continue to be on the alluvial fans from inflowing creeks, such as in Figure 4, photo 1; and towards the upstream end of the reservoir as in Figure 5, photos 5, 6 and 7. These locations provide more gradual slopes that would expand the exposed surfaces, and are at relatively higher elevations with reduced inundation depth and duration. Additionally, the inflowing creeks or river provide alternative alluvial groundwater sources when the reservoir is deeply drawn down.

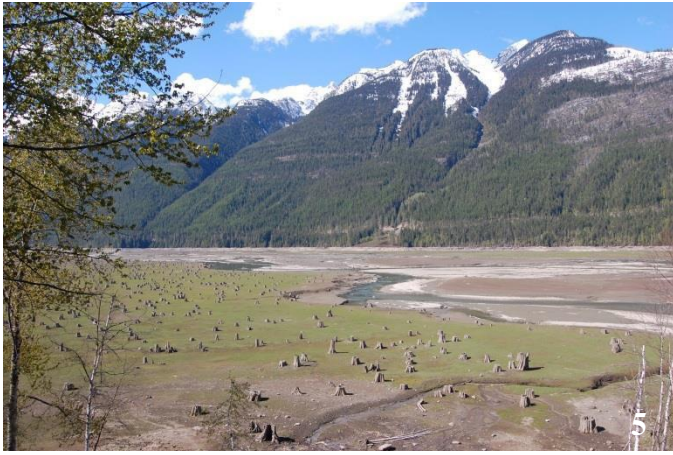
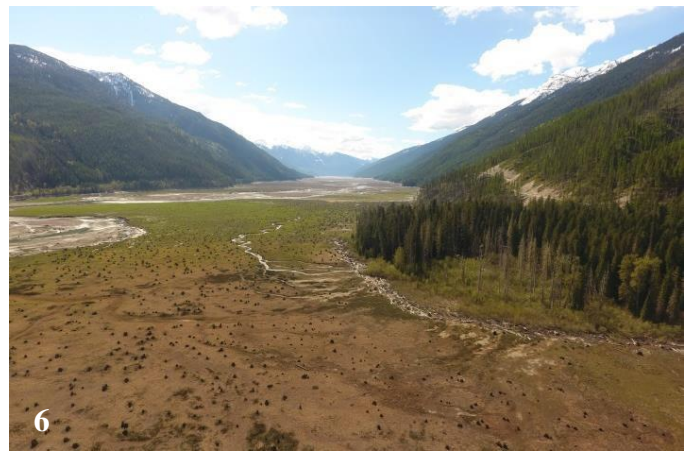
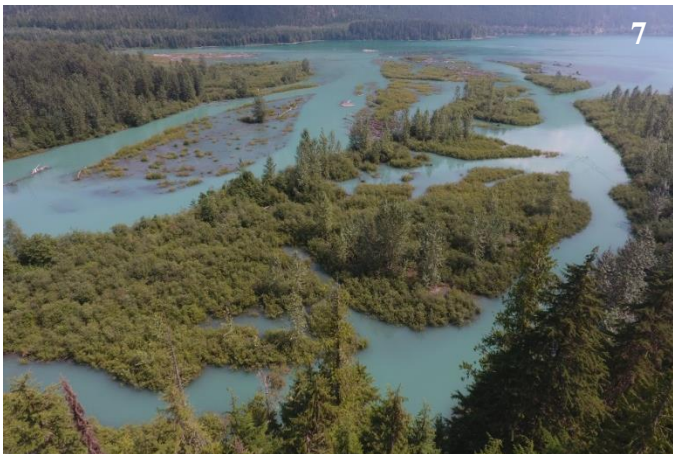
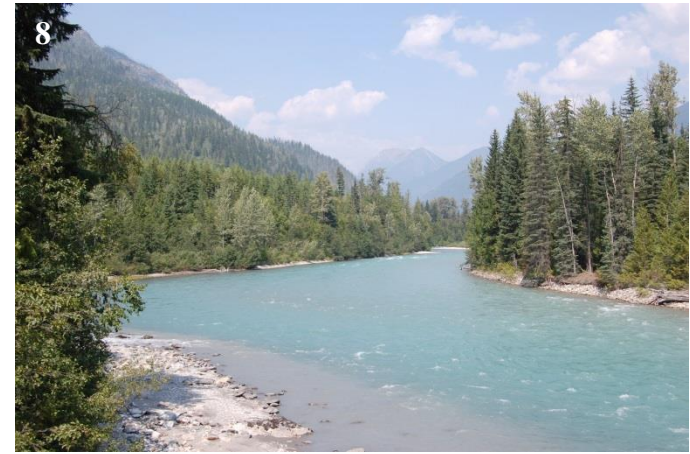
Figure 5. More photographs of the Duncan Reservoir, extending upstream (northward, 5 & 6 May 2019). (5) The elevation of the reservoir bottom progressively increases to the upstream end and consequently the depth and interval of inundation decline. Associated with this, vegetation increase as with this fairly complete ground cover of grass. (6) Puddingbowl Creek (study Site 13, aerial view) provides the most upstream inflow and its alluvial fan supports abundant shrubs and trees. Extending into the inundated zone, horsetail (*Equisetum arvense*) was prolific. (7) The most abundant woody vegetation was situated at the upstream end of the reservoir with the inflow delta from the upper Duncan River (aerial view with the reservoir near full pool, July 2018). This delta zone included braided distributaries from the river, which created a mosaic of wetland and riparian patches with abundant cottonwoods, willows (*Salix* species) and alder (*Alnus incana*) and could be deserving of conservation such as through ecological reserve designation. (8) Upstream from the delta, the upper Duncan River is free-flowing and relatively pristine (July, 2018).
