# Analyzing and Projecting Post-Flood Vegetation Colonization along the Bow River through Calgary, Alberta

Stewart B. Rood, Soba Kaluthota, Laurens J. Philipsen and Karen P. Zanewich  
Chinook Environmental Resources, RR9 Site 1 Box 1, Lethbridge, AB T1J 4R9, and  
Environmental Science Program, University of Lethbridge, AB

This report was undertaken as part of the *Calgary Rivers Morphology and Fish Habitat Study*, sponsored by the City of Calgary and led by Klohn Crippen Berger; and the Alberta Environment and Parks Watershed Resiliency and Restoration Program project, *Post-Flood River Regulation for Riparian Enhancement*.

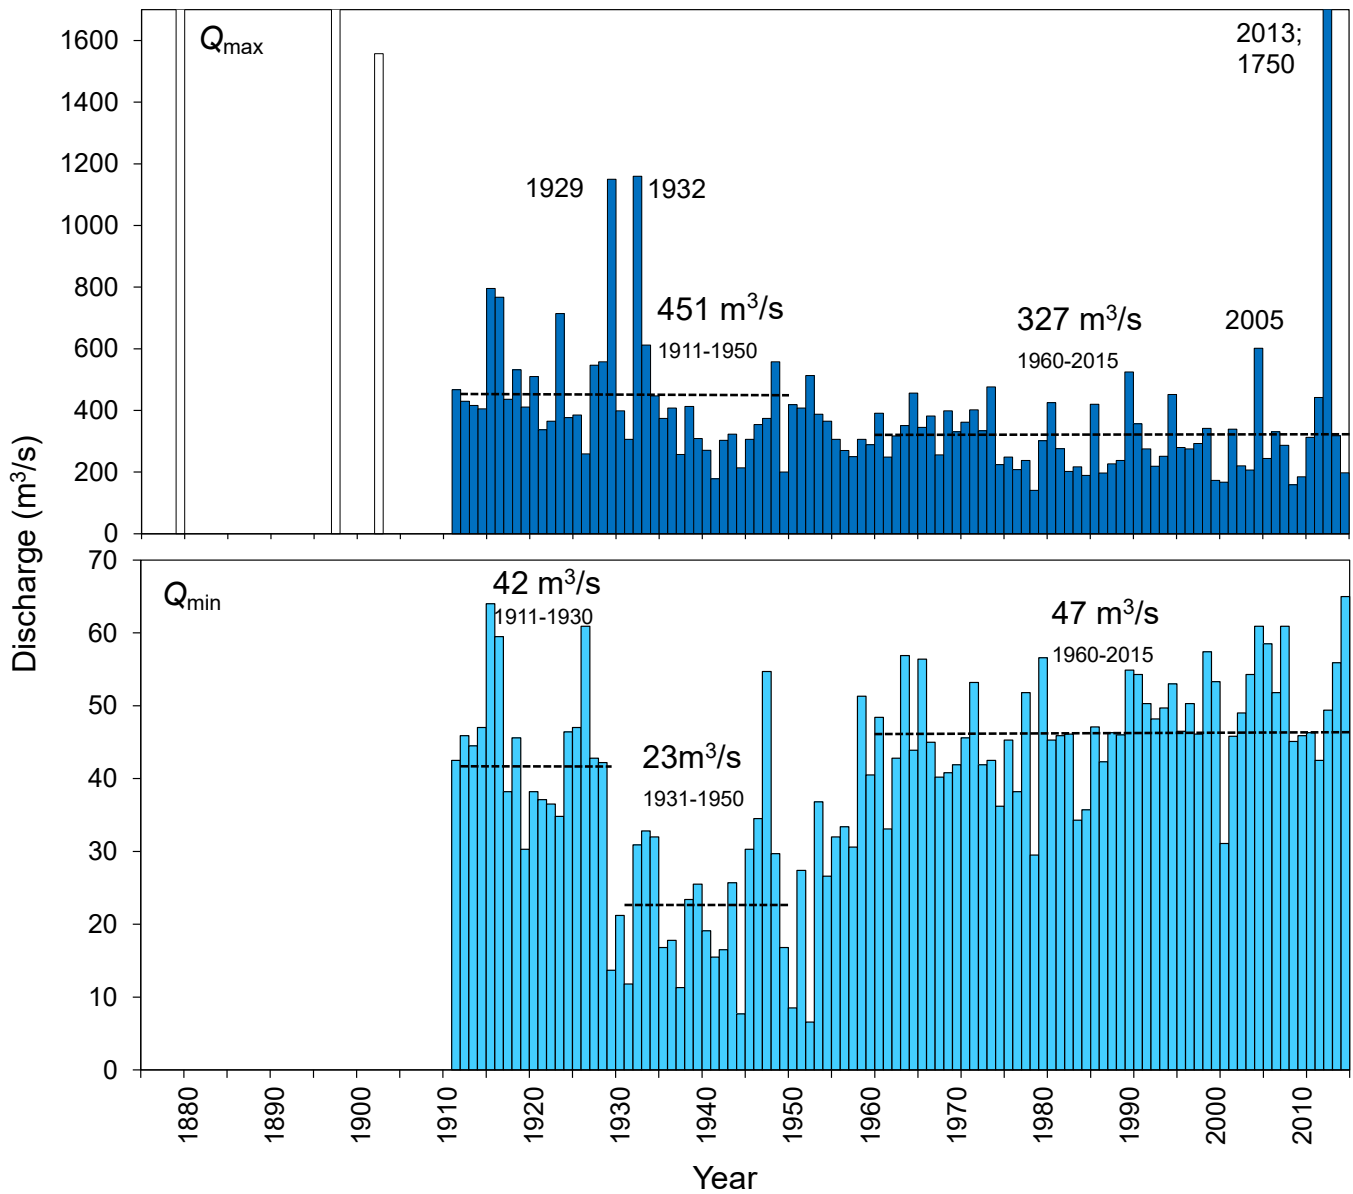
Figure 1. Maximum ( $Q_{max}$ ) and minimum ( $Q_{min}$ ) mean daily discharges along the Bow River through Calgary for the period of record. Note the differences in y-axis scales. Mean values for management intervals are provided. Early floods are indicated but were not gauged and should be considered as coarse estimates.

Floodplains are relatively flat, low-lying riparian zones that are, as the name indicates, occasionally flooded. Major floods inundated the original settlement of Calgary in 1879 (Figure 1), when Fort Calgary provided the only substantial permanent structure; and again in 1897, flooding the Inglewood area and other areas of settlement and prompting some early settlers to relocate to higher positions within Calgary (Sanders 2013). Only five years later, another major flood in 1902 caused further damage, including the bridge over the Bow River where the 10<sup>th</sup> St. or Hillhurst Louise Bridge is now situated.

Other floods in the early twentieth-century followed and with the hydrometric gauge installed around 1911, the magnitudes of these floods were determined (Figure 1). The next flood occurred in 1915 and destroyed the original Centre St. Bridge, and subsequently the 1929 flood damaged the newly opened Calgary Zoo (Sanders 2013). The final historic flood of the twentieth century was in 1932. That occurred right after completion of the Glenmore Dam and that empty reservoir trapped the Elbow River peak, attenuating flooding of the Bow River downstream of that outflow.

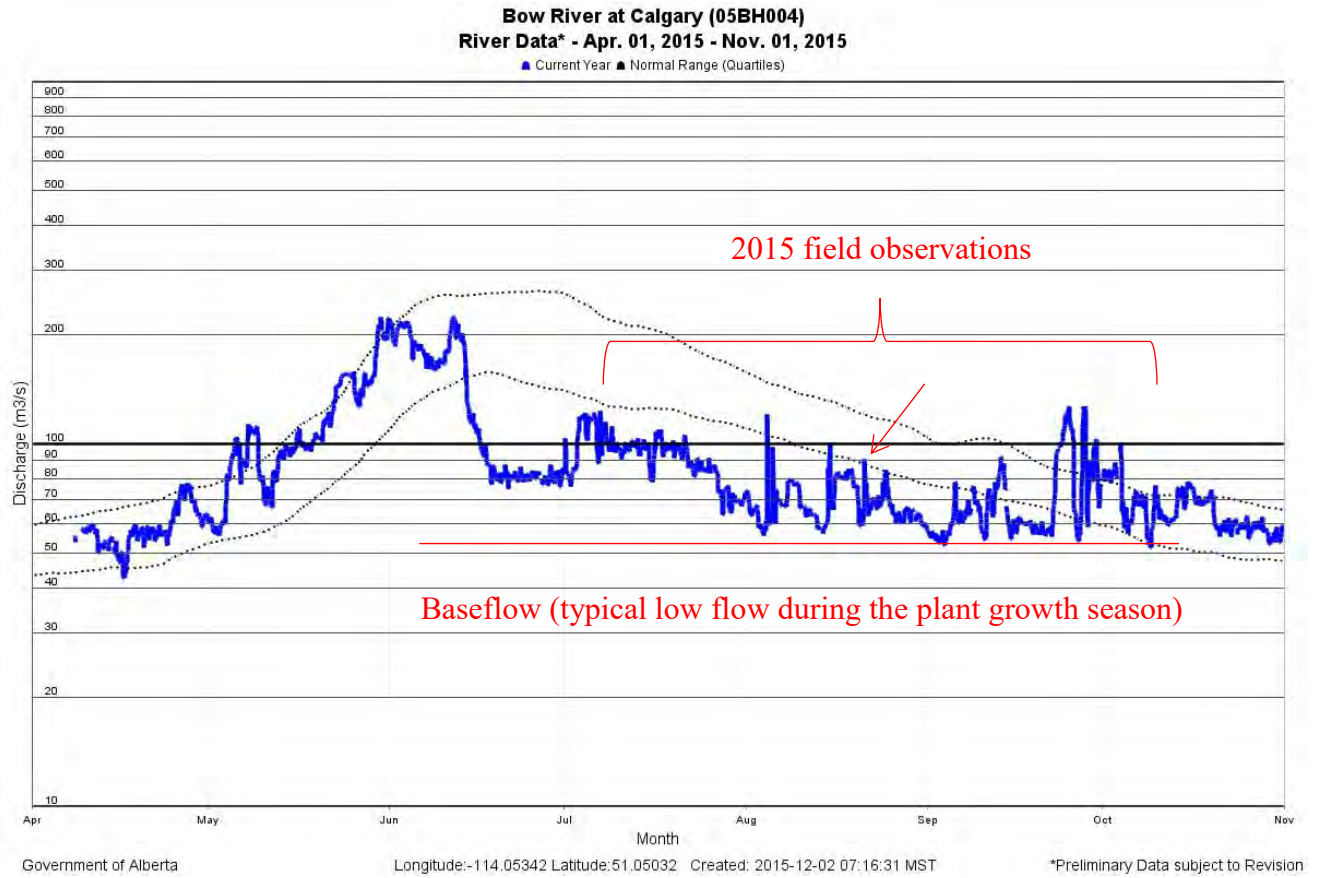
Figure 2. The seasonal hydrograph with provisional discharges for the Bow River at Calgary through 2015. The interval of field observations is indicated. An arrow indicates the field survey interval and the confounding influence from a flow spike. Note that the baseflow has been augmented following river damming and flow regulation.

However, there was a further complexity that could have introduced variation exceeding our 5 cm objective. There was substantial short-term variation in  $Q$  that occurred through much of the summer of 2015 (Figure 2). The arrow indicates a spike in flow ranging from 60 to 90  $\text{m}^3/\text{s}$ . We considered the reported  $Q$  during our field work and this was generally between 70 and 80  $\text{m}^3/\text{s}$ . We did not observe substantial river stage change during any site visit and are optimistic that the flow and stage pulses would not substantially impact our analyses of river-coordinated elevations. Supporting this, the correspondence between our observed elevational distributions of the vegetation and the shoreline inundation patterns suggests that the flow irregularity did not impede the project success. This short-term flow variation thus provided another complexity, but we anticipate that the field measurements at multiple sites and over multiple days would have dampened this confounding influence.

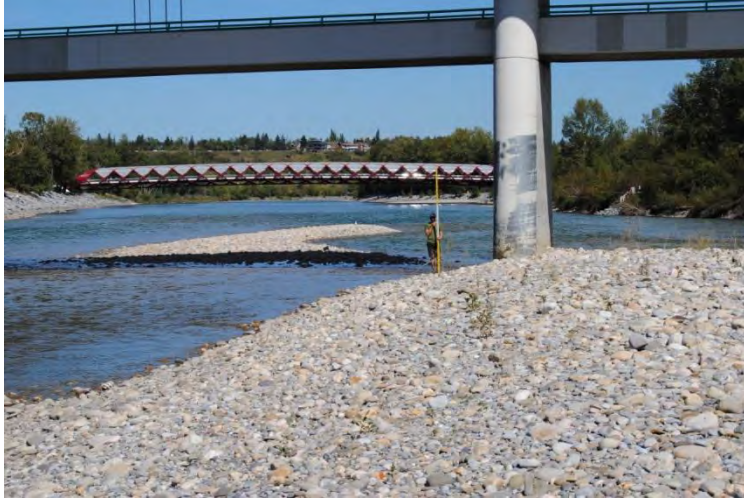
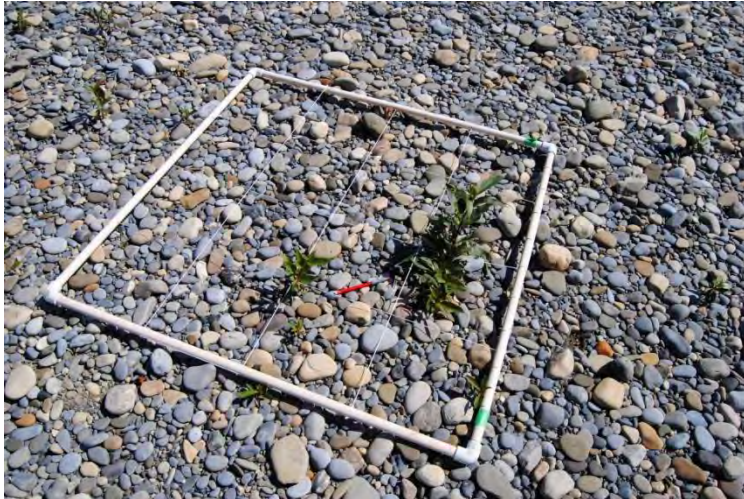
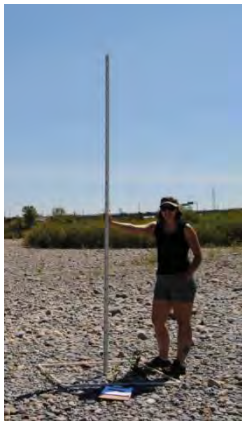
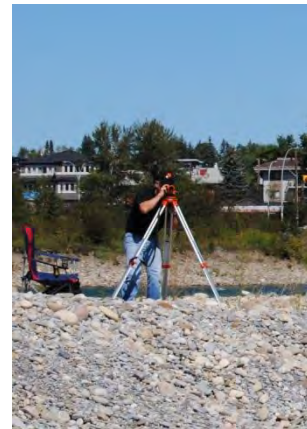
‘Rovers’ with staff gauges stopped at intervals along transects and also at other positions on the bars and islands, and elevations were determined relative to adjacent river surfaces. Positions were determined with bearings from the transit, and distances with tape measure or a laser range finder.

Vegetation was inventoried in 1 x 1 m quadrats, with strings at 0.25 m intervals. Sediment sizes were assessed at each string intersection (3 x 3 per quadrat). All plants within the quadrat were counted by species. For balsam poplars, apparent seedling ages were assessed based on sizes.

The elevation of each quadrat was surveyed.

Figure 3. Photographs of field inventory methods.

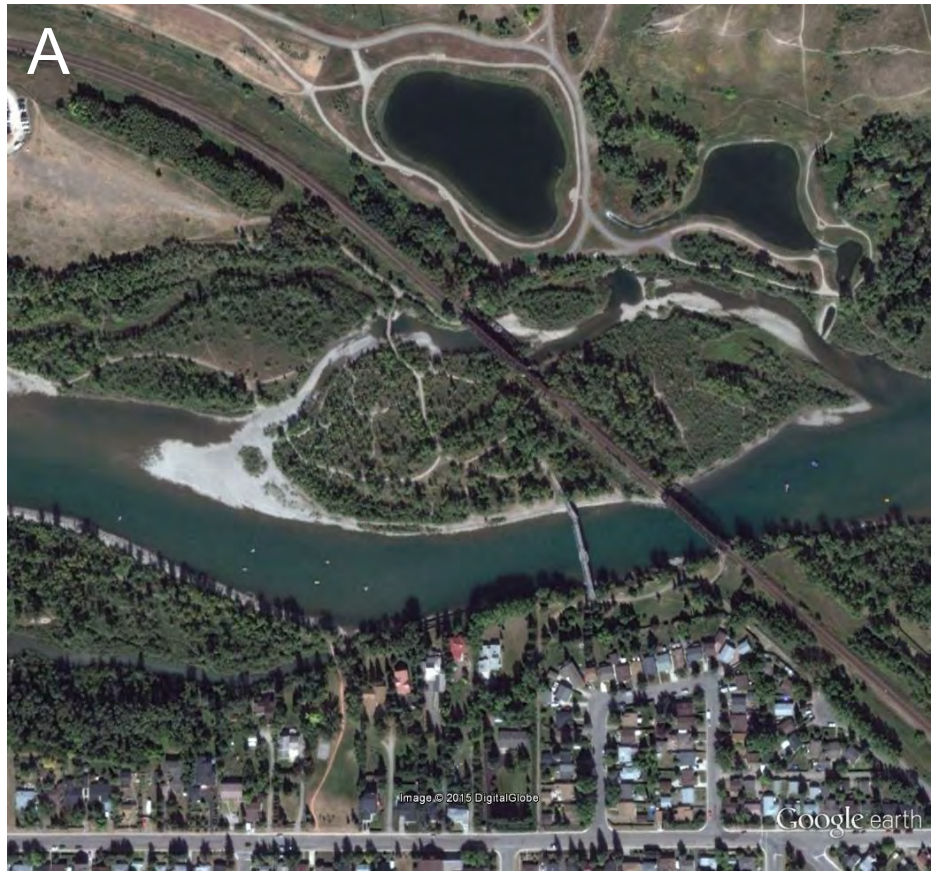
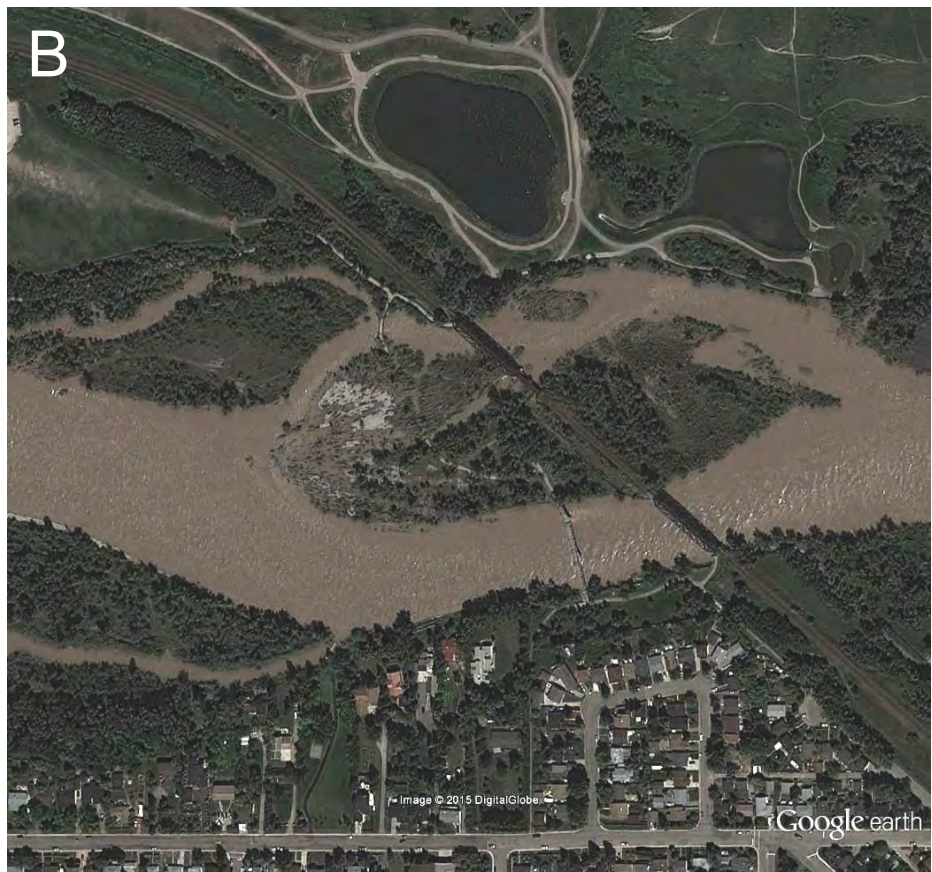
Figure 6. Aerial photographs showing the Bowmont Park study site prior to the 2013 flood (A) and during the flood, but after crest (B).

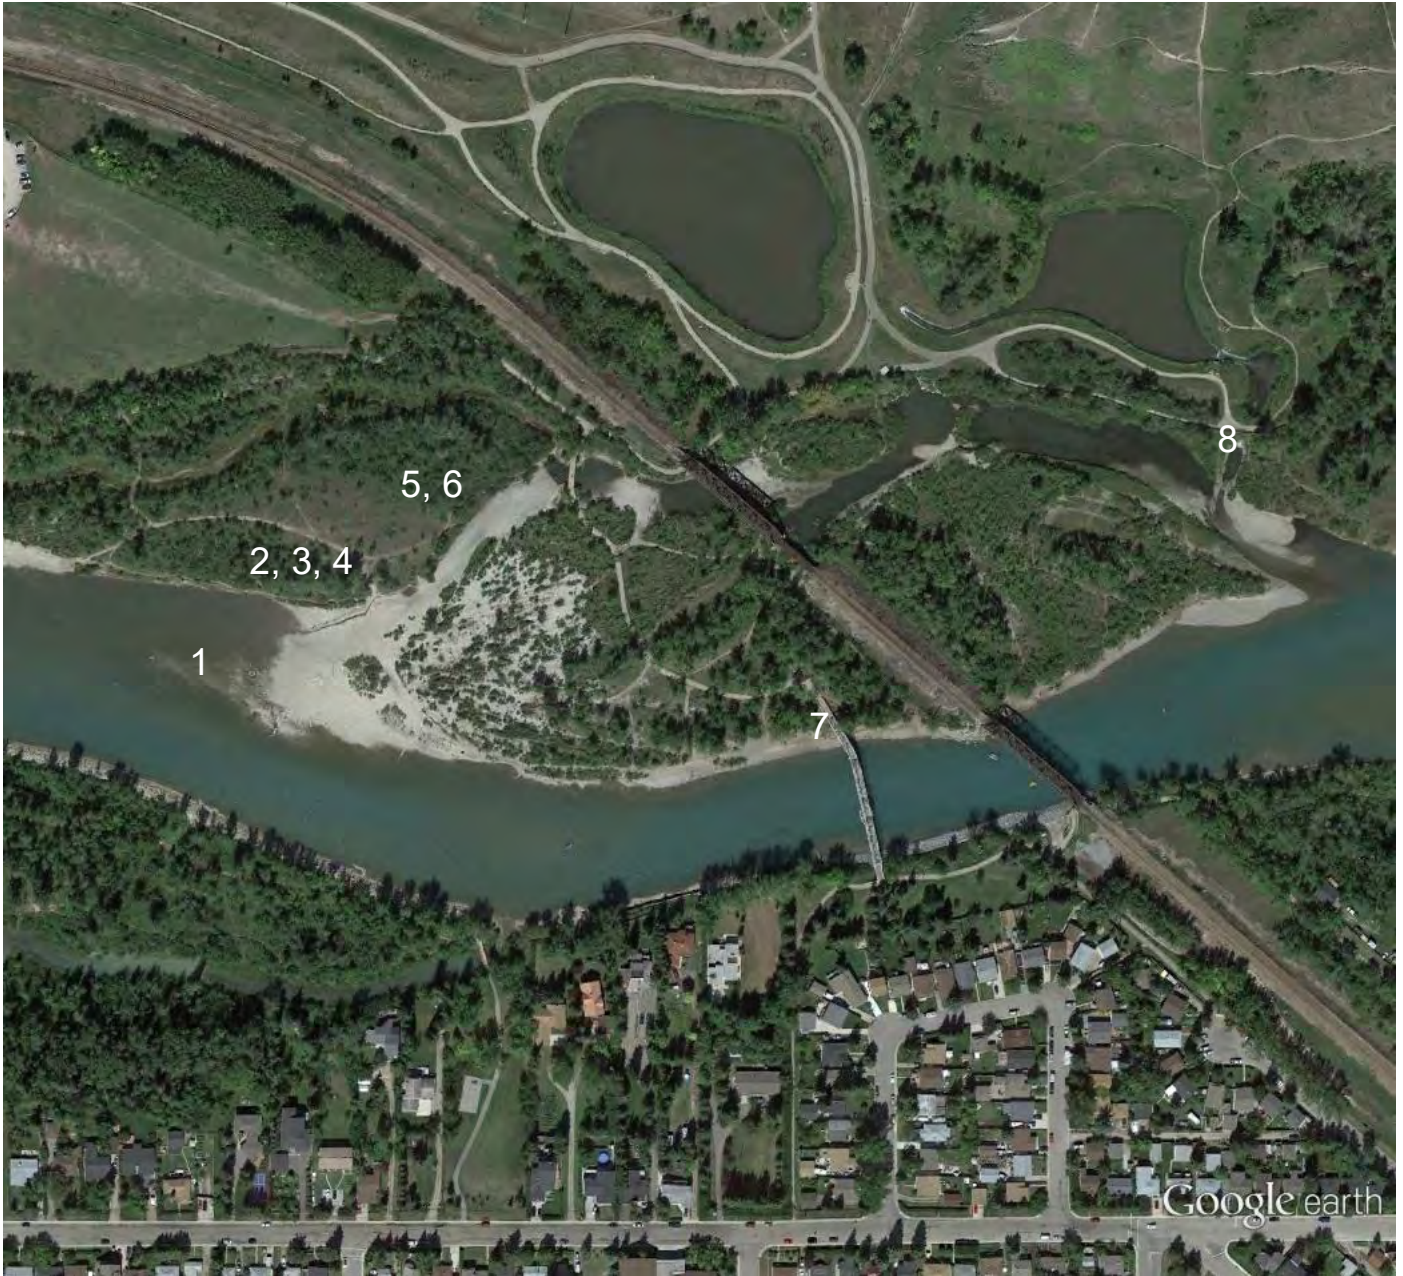
Figure 7. Aerial photograph showing the Bowmont Park study, Aug. 22, 2015, after the 2013 flood. The numbers indicate positions from which the ground level photographs were taken.

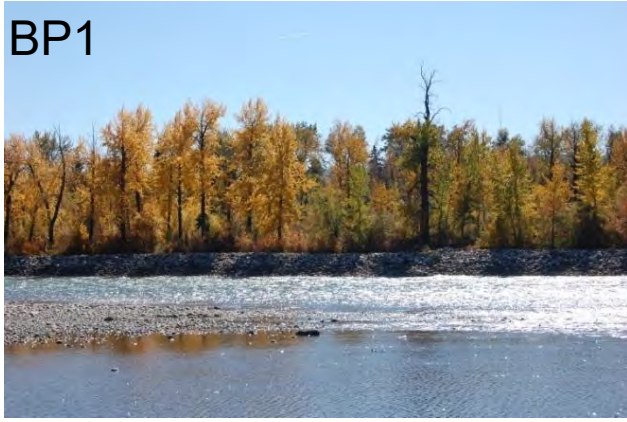
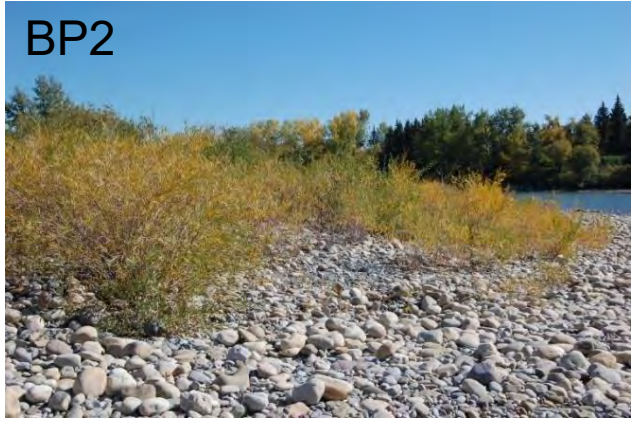
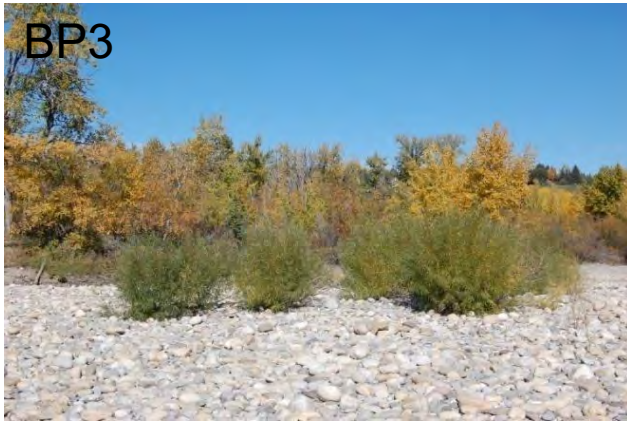
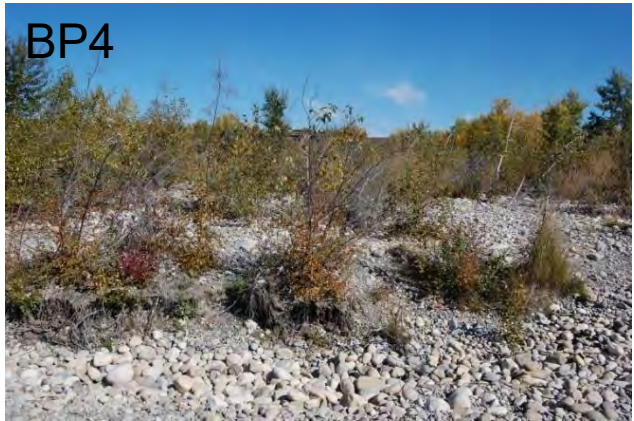
Figure 8. Ground level photographs at the Bowmont Park study site. The photograph numbers correspond to the positions indicated in Figure 7.

Passing below Stoney Trail, the river passes Bowness Park, where the channel widens and the south bank has a sequence of eight large rock groynes angled upstream into the current. From these, there is extensive and continuous rock armour along the south bank (Figure 8 BP1) to the 85<sup>th</sup> St. Bridge, which provides the western limit of Bowmont Park. That armored bank resisted the river and the 2013 flood flow provided extensive erosion and deposition on the upstream end of the Bowmont Park island, which supports the railway line. At that upstream zone, the surface material is very coarse, and predominantly cobbles (Figure 8 BP2, BP3). As indicated in the pre-flood, flood, post-flood aerial photograph sequence (Figures 6 and 7), there was substantial thinning of the woodland at the upstream end of the island. Slightly surprisingly, the shrub patch at the extreme upstream end was more resistant to erosion and persisted through the flood. This patch consists of willows (*Salix* species) and especially sandbar willow (*Salix exigua*), and confirms the flood-resistant nature of this shrub. This woody plant is characterized by extensive fine branching, with these thin branches being pliable, and narrow leaves that would minimize drag. This shoot architecture is ideally suited to survive the shear stress of swift water flow with a major flood. We had somewhat anticipated this adaptive benefit (Rood et al. 2011) and the shrub's persistence through the 2013 Bow River flood provides reasonably conclusive direct demonstration.

In contrast to the flood resilience of the willows and especially sandbar willow, other shrubs on the Bowmont Park Island were toppled, stripped of leaves and uprooted by the flood. As displayed in BP4 (Figure 8), shrub-sized river birch trees and other shrubs, as well as juvenile and even mature balsam poplar trees were more impacted and the substantial gaps in the woodland indicate complete excavation of many of these. The remaining clumps of shrubs have protected some soils, with sands and silts held by the plant root systems and some protection of the surface materials (Figure 8 BP4).

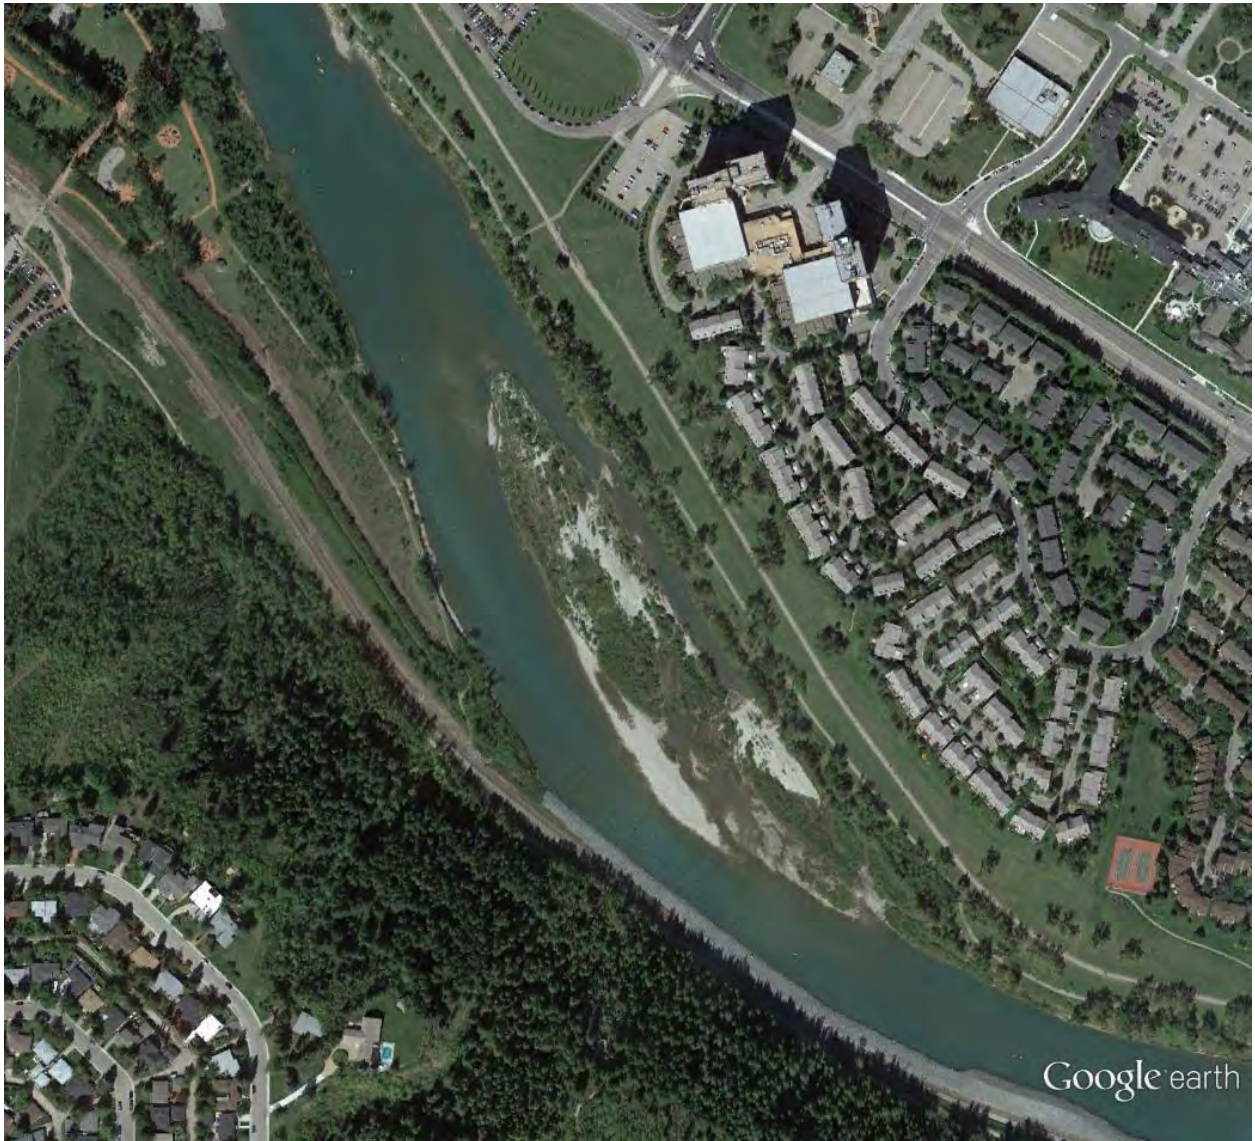
Figure 9. A post-flood composite aerial photograph of the Point McKay bar (Aug. 22, 2015), which has provided a longer-term study site for riparian shrubs and particularly willows along the Bow River.

Moving downstream there is an island bar adjacent to the Point McKay townhouse complex along the north bank of the Bow River, downstream of Edworthy Park (Figure 9). This shallow bar is predominantly occupied by willows and has been the site of our longer-term riparian willow study (Amlin and Rood 2001). As was observed at the Bowmont Island, the Point McKay willows survived through the 2013 flood, even though this bar is quite low and would have experienced extended inundation and swift flows. This provides a second demonstration of the flood resiliency of willows and especially sandbar willow.

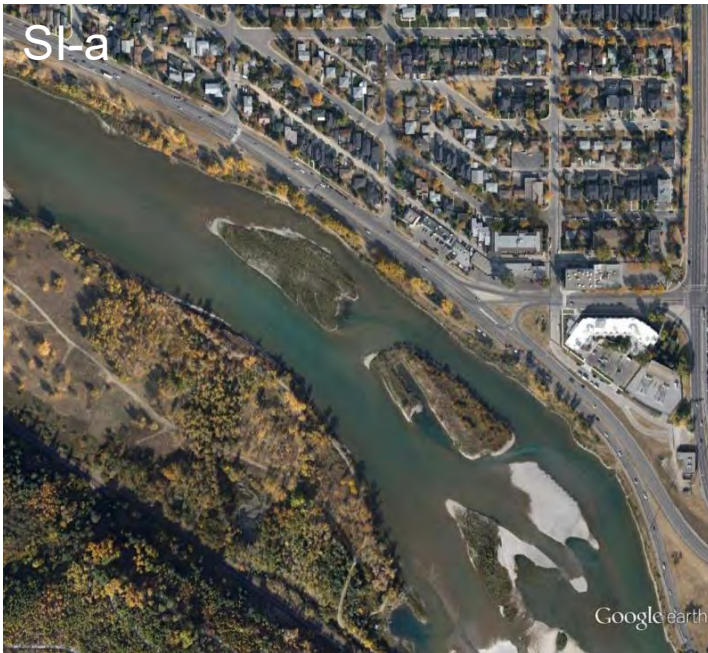
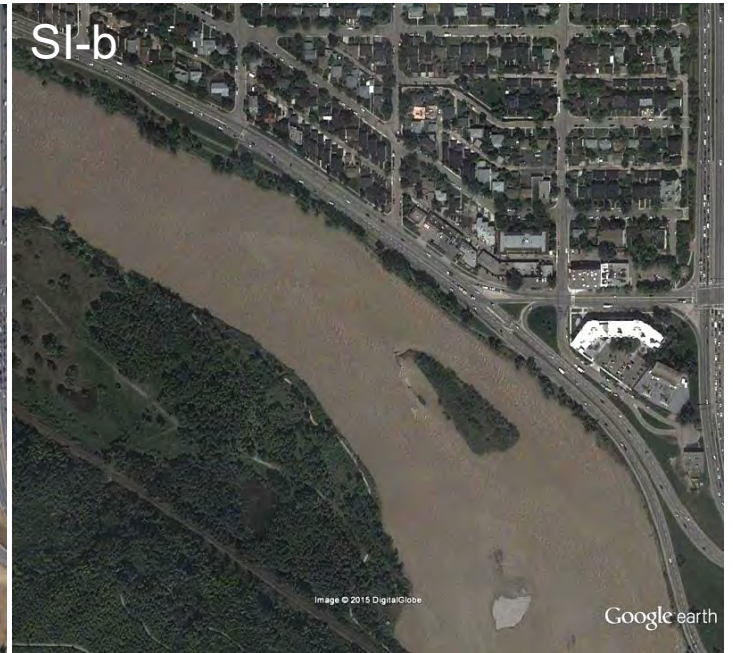
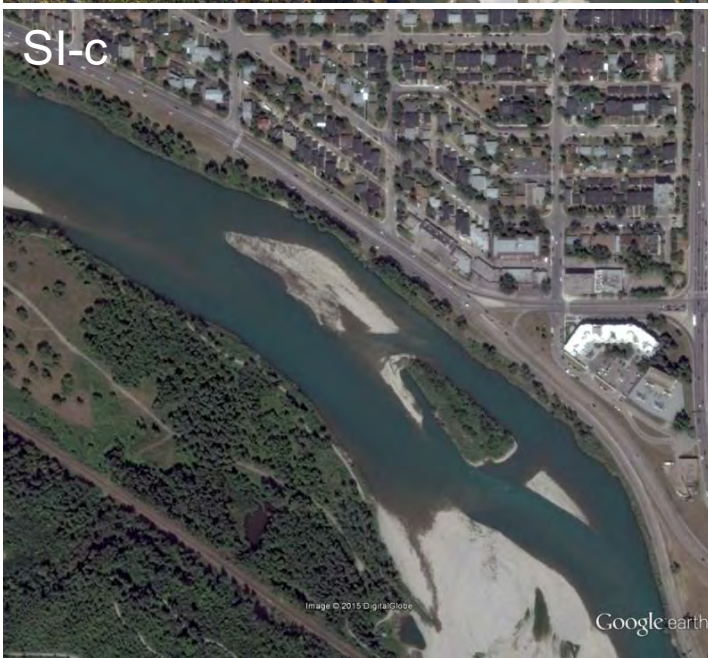
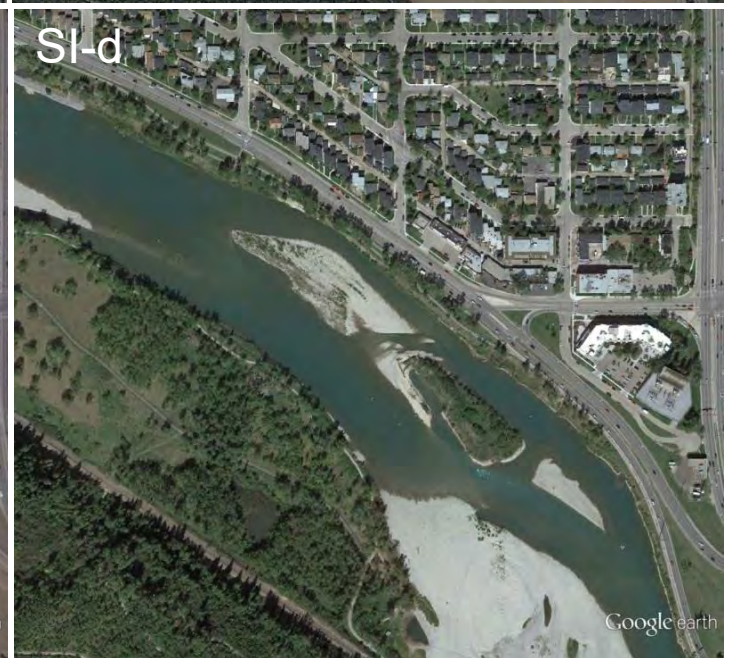
Figure 10. Aerial photographs of the Shrub Island and Wooded Island study sites in the Bow River displaying conditions prior to the 2013 flood (SI-a), during the flood, and after the flood in 2014 and in 2015 at about the time of the field sampling.

In marked contrast to Shrub Island, Wooded Island was very unusual as an island in the Bow River that was apparently not inundated with the extreme 2013 flood (Figure 10). Although no aerial photograph exists from the flood crest (and rain and cloud would have impeded photography at that time), when we visited the island, we did not see evidence of flooding such as debris wrapped around trees, as was extensive in downstream woodlands that were inundated.

With slumping cut-banks on three of the four sides of Wooded Island, it would be expected that the island area would be shrinking. However, the size and position of the main island section appear very similar in the pre- versus post-flood aerial photographs suggesting very gradual erosion (Figure 10). There was apparent scour of shrubby vegetation on the 'gooseneck' from the upstream end of the island and this portion was lower in elevation and inundated with the 2013 flood.

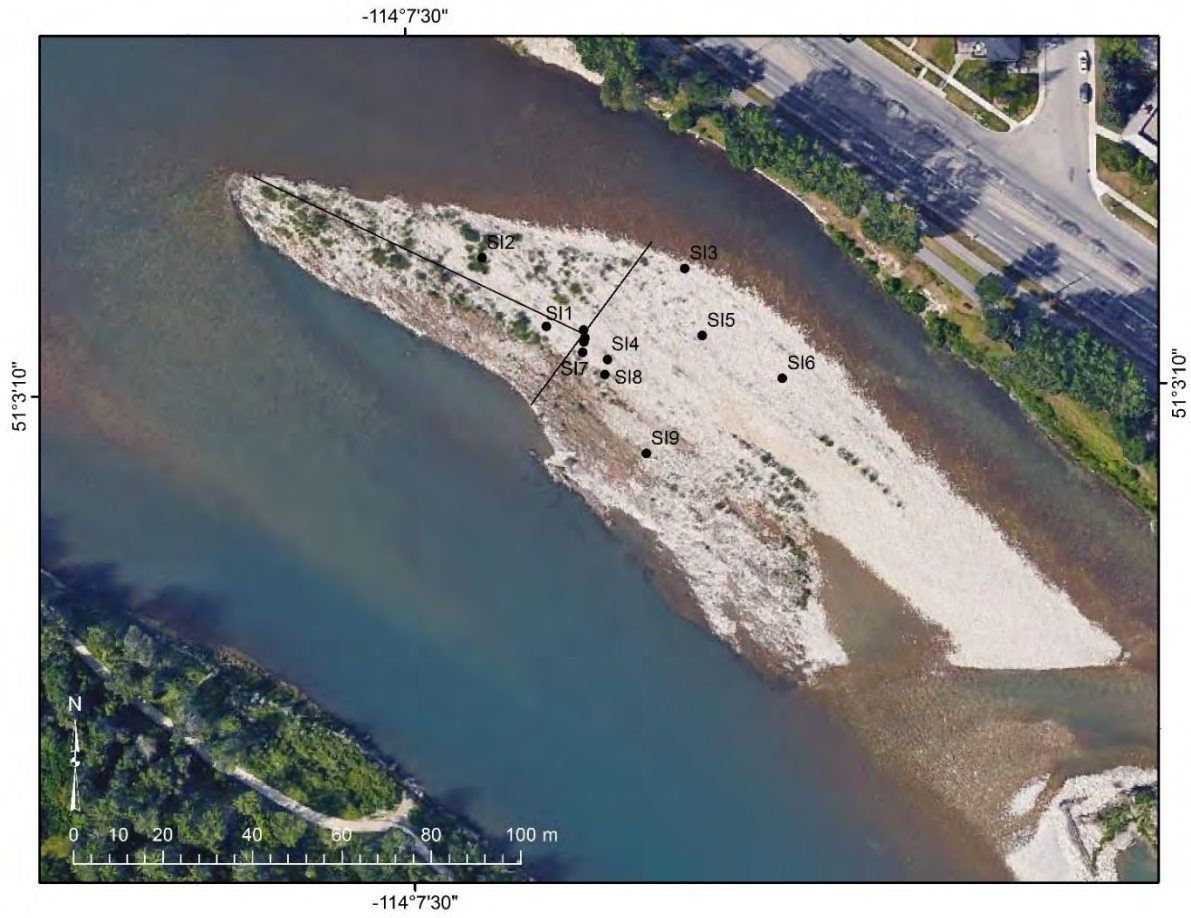
Figure 11. A post-flood aerial photograph of Shrub Island in the Bow River showing the study transects and quadrat locations.

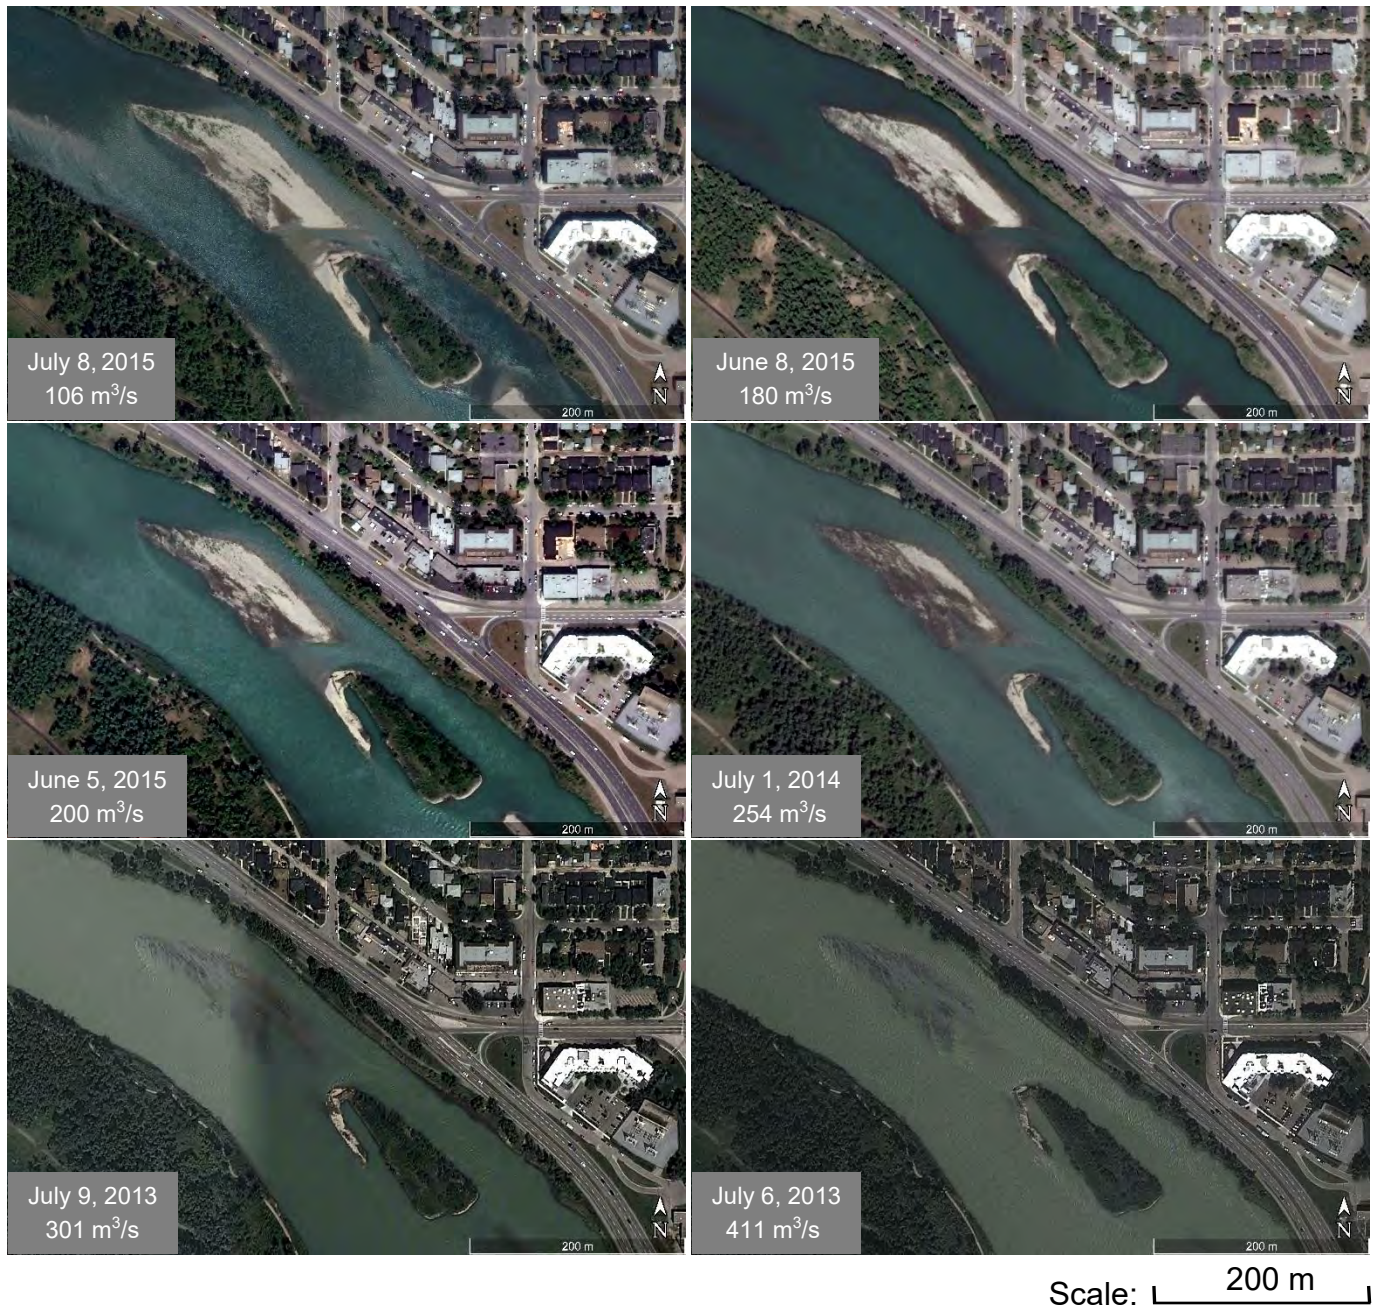
Figure 13. Post-flood aerial photographs of Shrub Island in the Bow River, which were used to coordinate inundation discharges for that study site.

We observed seedlings of 15 plant species in the quadrats (Table 3) and their elevational distributions were also coordinated with inundation patterns displayed in post-flood aerial photographs with different river flows (Figure 13). At this site the seedlings were predominantly woody plants, with balsam poplar seedlings occurring in all 9 quadrats, with a mean density of  $\sim 21/m^2$  (Table 4). Chokecherry seedlings were also abundant, occurring in all but one quadrat, while sandbar willow and Manitoba maple seedlings were less abundant. We observed two Jackii poplar (*Populus x jackii*) seedlings, with these being natural intersectional hybrids between *P. balsamifera* x *P. deltoides*, the balsam poplar and prairie cottonwood, respectively. Calgary is upstream from the natural range limit of the prairie cottonwood, but there have been plantings within the City and substantial plantings of male clones of fast-growing clones that had probably been artificially produced. However, mitochondrial molecular markers indicate that only the *P. deltoides* parent can be the female and this would greatly limit the extent of the *P. x jackii*, since there would be few female *P. deltoides* trees and the more common planted hybrids would be males.

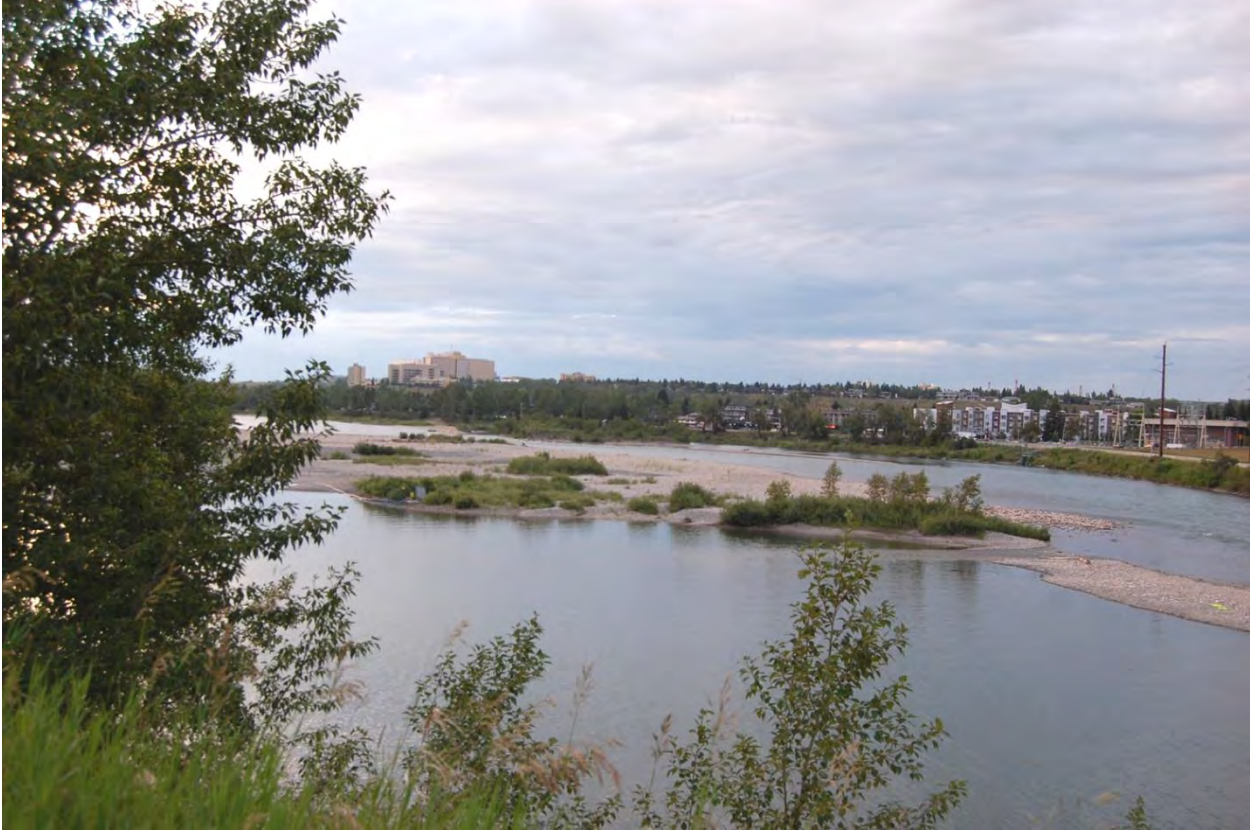
Figure 14. An upstream view of the Crowchild Island Bar study site in the Bow River, July 12, 2015.

Across the main channel and downstream from Wooded Island, the Crowchild Island Bar was the largest and most complex feature that we studied (Figure 14 and 15). It occurs at the downstream end of the large wooded bar situated between the CP Railway line and the main Bow River channel. It represents a massive gravel bar with a back channel that extends from the downstream end and partially cuts off the bar from the river valley floodplain at low flows and with higher flows a channel severs the feature, creating an island. There is substantial sorting of surface sediments with some scrolls with scour or deposition and some curved bands with finer sediments.

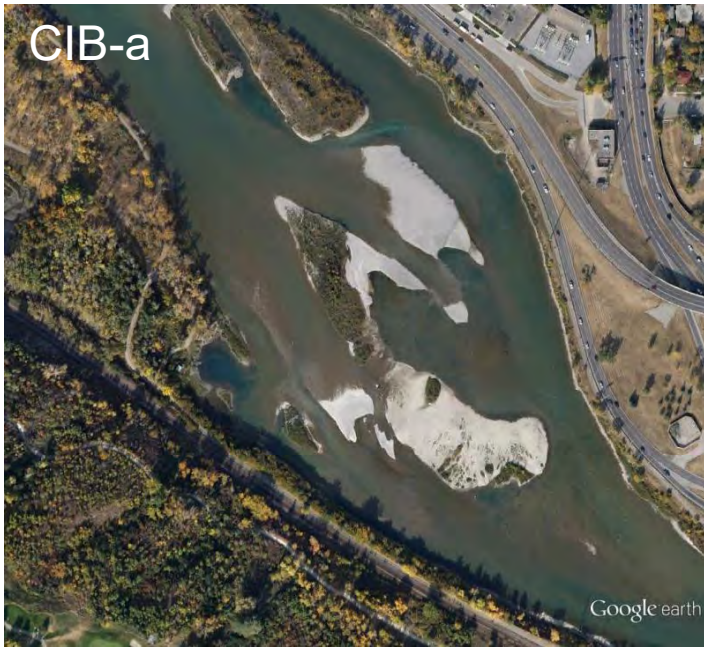
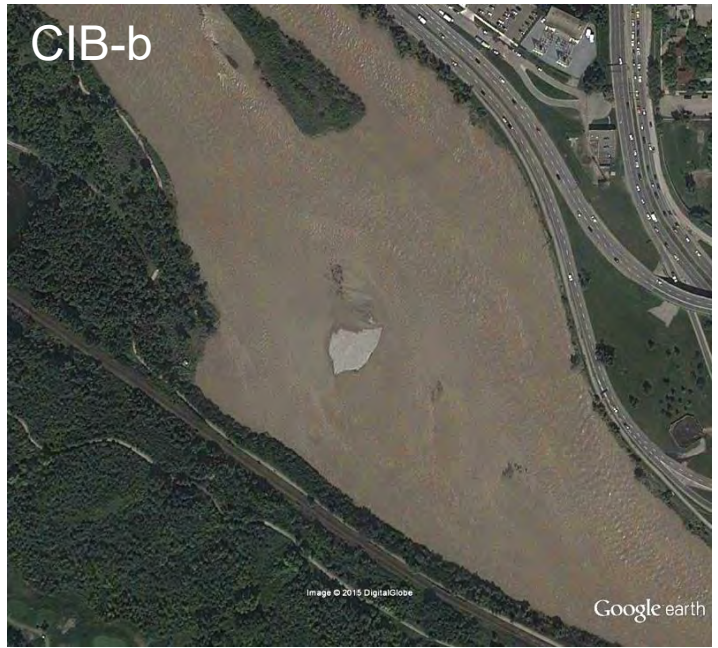
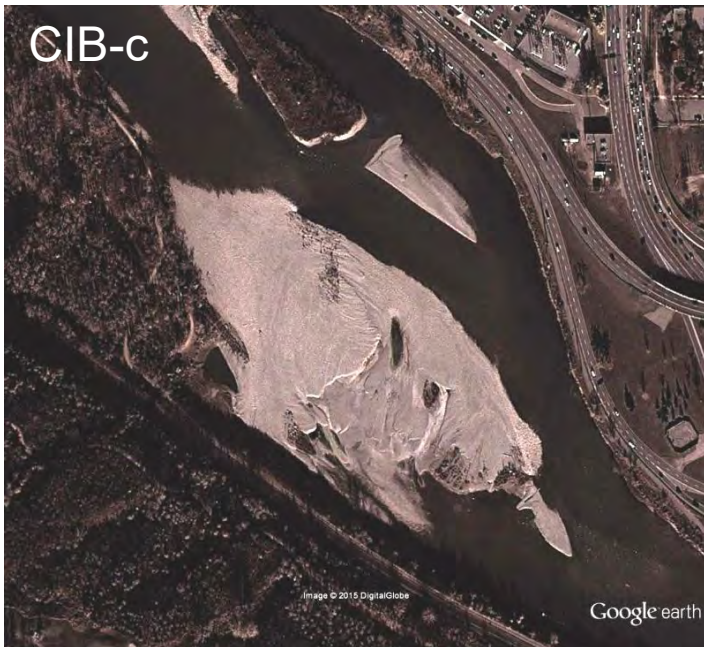
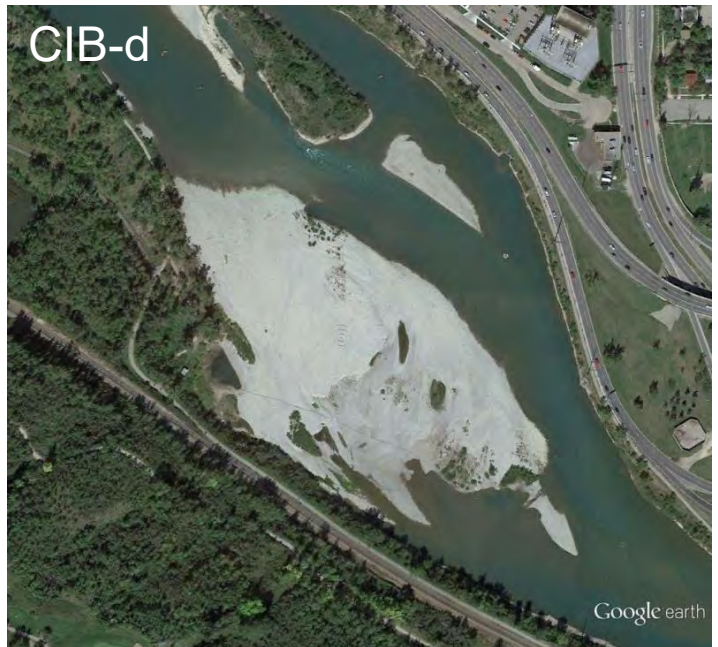
Figure 15. Aerial photographs of the Crowchild Island Bar (CIB) study site along the Bow River. These display conditions prior to the 2013 flood (CIB-a) and during the flood. The 2013 photograph displays the depositional features and the final photograph displays conditions at about the time of the field sampling.

Prior to the flood the complex consisted of a cluster of islands, with a substantial channel separating these features from the river bank, even at low flows (Figure 15 CIB-a). On the higher surfaces there were substantial zones of shrubs and trees, with a fairly large woodland patch situated slightly below the centre of the zone between the higher banks.

With the 2013 flood the whole complex was submerged (Figure 15, CIB-b, which was about four days after the crest) and there was extensive vegetation scour and deposition of gravels and cobbles. The depositions and scours are more vividly displayed with the nearly black and white aerial photograph of October 24, 2013 during the autumn following the flood (CIB-c). That post-flood photograph also displays the pond towards the centre of the island bar.

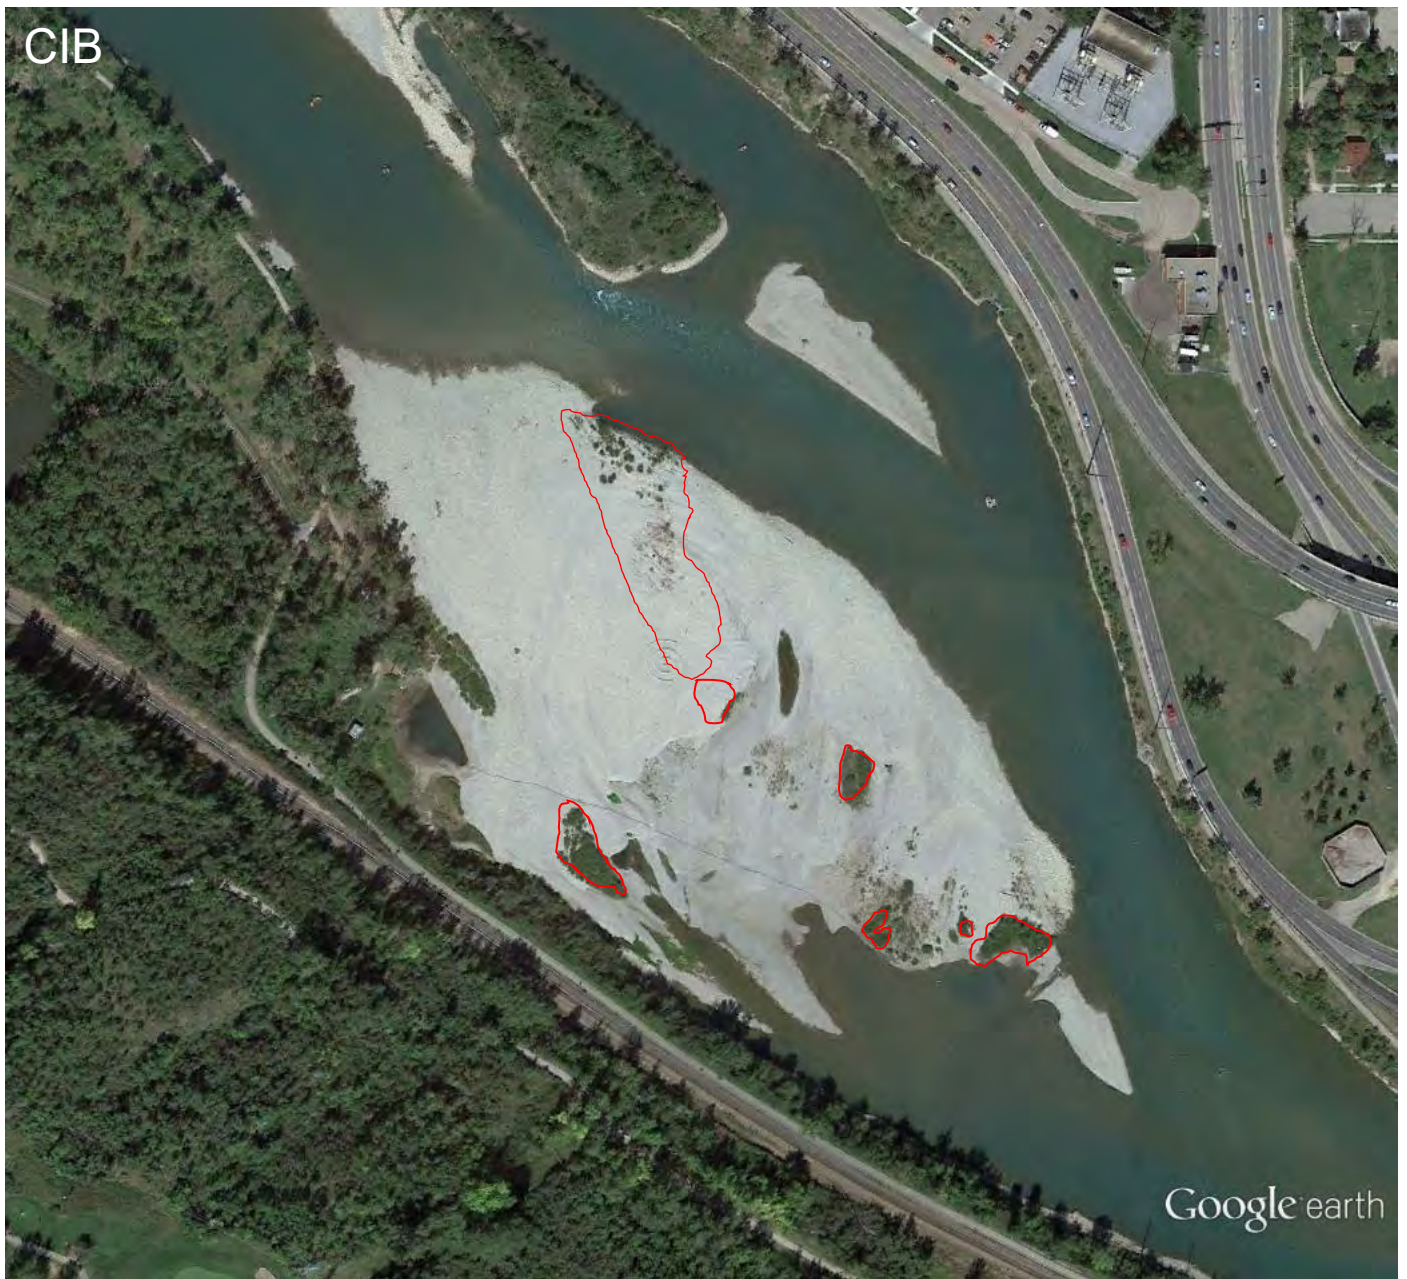
Figure 16. An aerial photograph of the Crowchild Island Bar with outlines showing woodland patches from Sept. 22, 2012 (Figure 15).

Figure 16 provides the same, August 22, 2015 aerial photograph, with the shrub and woodland patch outlines from the pre-flood photograph of September 22, 2012. As shown, the major woodland patch was largely eliminated, with only a few scattered shrubs and trees remaining at the upstream end. The adjacent smaller patch has had the vegetation removed and this is probably due to deposition, with a band of willows surviving at a steeper slope falling away at the downstream end. This interesting feature resembled a sand dune but built with coarse gravel transported by water, rather than involving wind-borne sand.
