# Analyzing and Projecting Post-Flood Vegetation Colonization along the Bow River through Calgary, Alberta

Stewart B. Rood, Soba Kaluthota, Laurens J. Philipsen and Karen P. Zanewich  
Chinook Environmental Resources, RR9 Site 1 Box 1, Lethbridge, AB T1J 4R9, and  
Environmental Science Program, University of Lethbridge, AB

This report was undertaken as part of the *Calgary Rivers Morphology and Fish Habitat Study*, sponsored by the City of Calgary and led by Klohn Crippen Berger; and the Alberta Environment and Parks Watershed Resiliency and Restoration Program project, *Post-Flood River Regulation for Riparian Enhancement*.

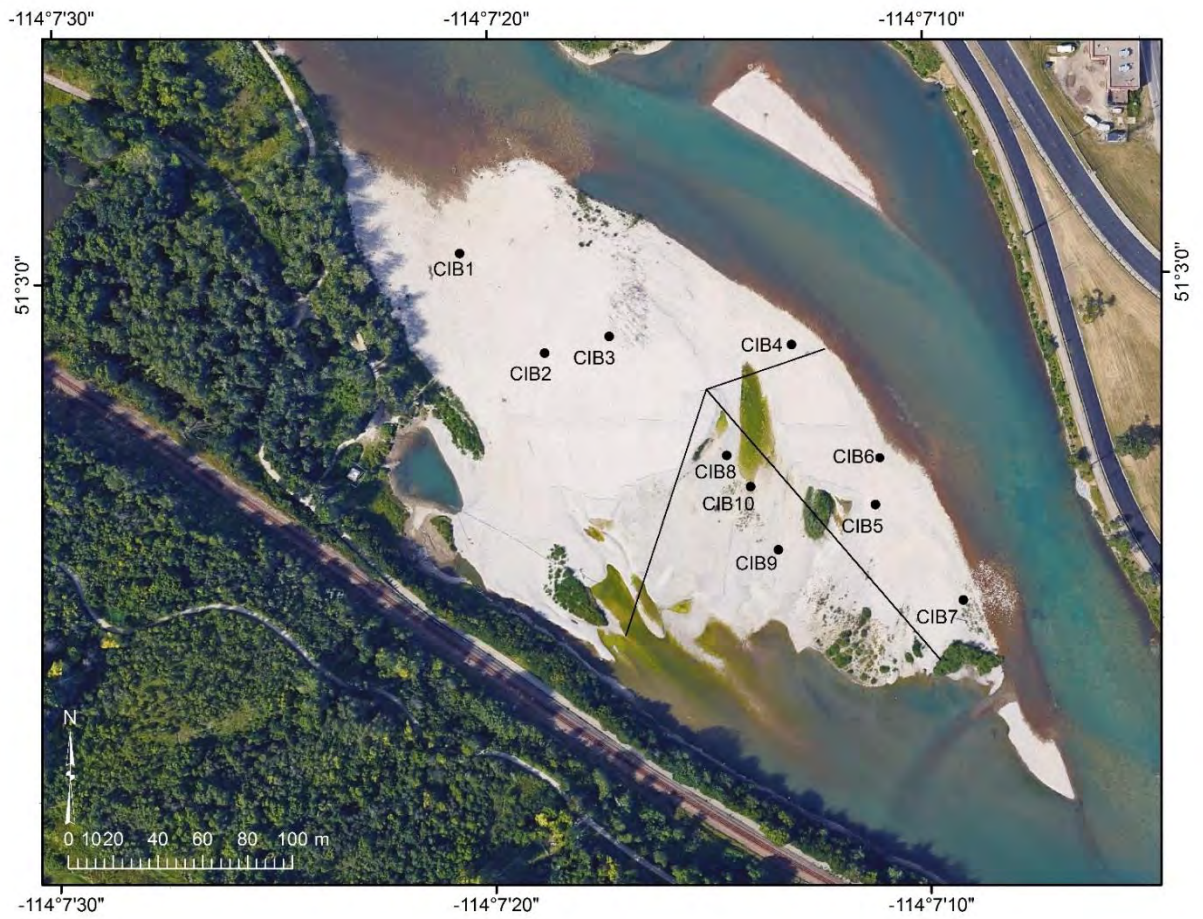
Figure 17. A post-flood aerial photograph of Crowchild Island Bar along the Bow River, with the study transects and quadrat locations plotted.

The positions of transects and quadrats on the Crowchild Island Bar are plotted in Figure 17. We deliberately crossed the pond (Figure 17, near CIB5; Figure 18, CIB1 'a'). We found that the water surface elevation was similar to that adjacent river surface to the northeast (by Figure 17 CIB6). This indicates high hydraulic conductivity across this portion of the island, as we had expected. From this finding, we would anticipate that the groundwater table would represent a near-horizontal extension from the river and there would be rapid rise and fall in groundwater, in

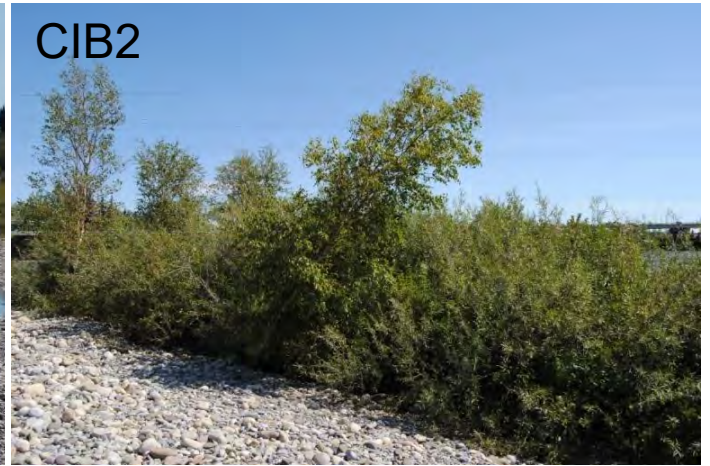
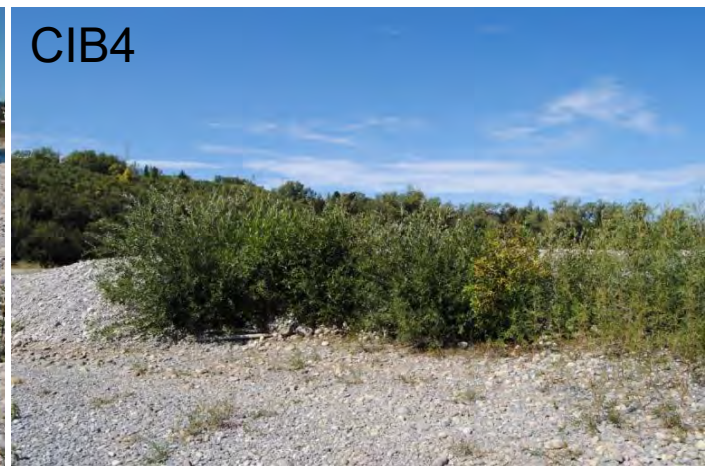
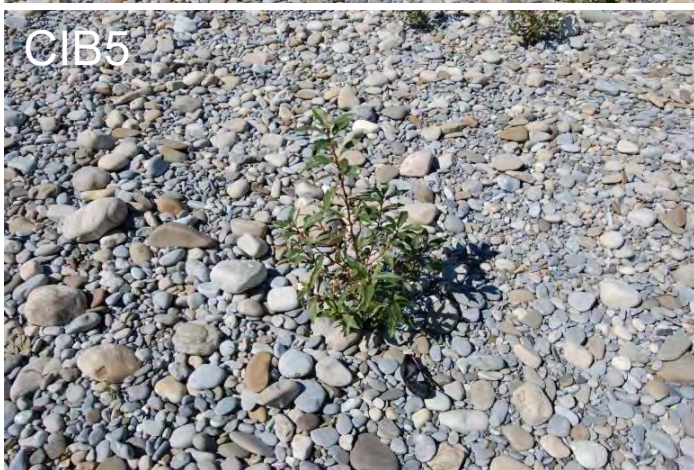
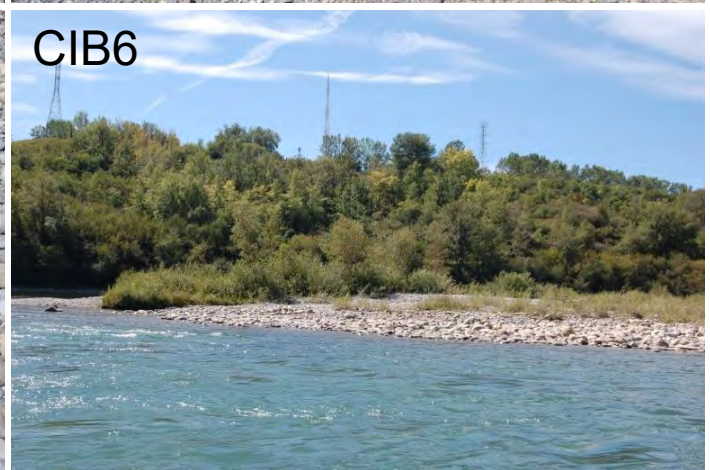
Figure 18. Ground level photographs at the Crowchild Island Bar.

We observed abundant new balsam poplar seedlings and saplings on the Crowchild Island Bar as displayed in photographs (Figure 18, CIB3 'e', including those of sufficient size to indicate establishment in the flood year, 2013 (Figure 18, CIB5). Willows represented the primary surviving plants and balsam poplar represented the primary colonizers, with willow seedlings also occurring (Tables 5 and 6). We thus anticipate extensive woodland development on the Crowchild Island Bar, in addition to the colonization and expansion of shrubland zones dominated by willows. As this shrubland and woodland patches develop we would also expect some sediment trapping and colonization and succession to produce a more biodiverse riparian zone. While we didn't find seedlings of other woody plants such as birch or Manitoba maple, there are abundant mature shrubs and trees on the adjacent hillslope (Figure 18, CIB6). While there may be concerns relative to directing the river flow to the north bank, with the anticipated riparian vegetation development, we would expect that the Crowchild Island Bar could develop into a very rich riparian habitat for birds and other wildlife.

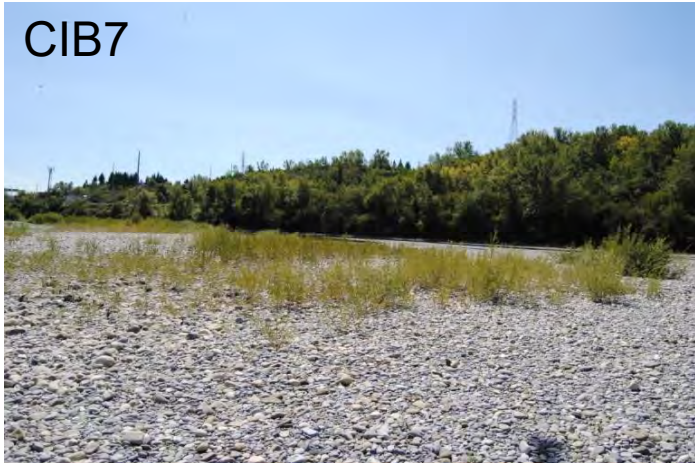
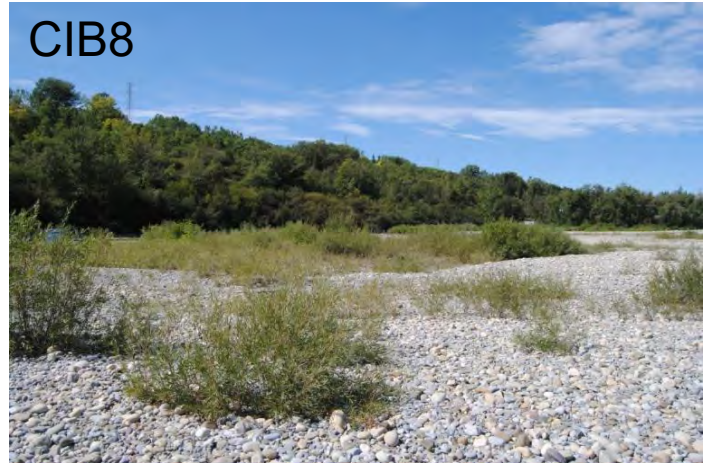
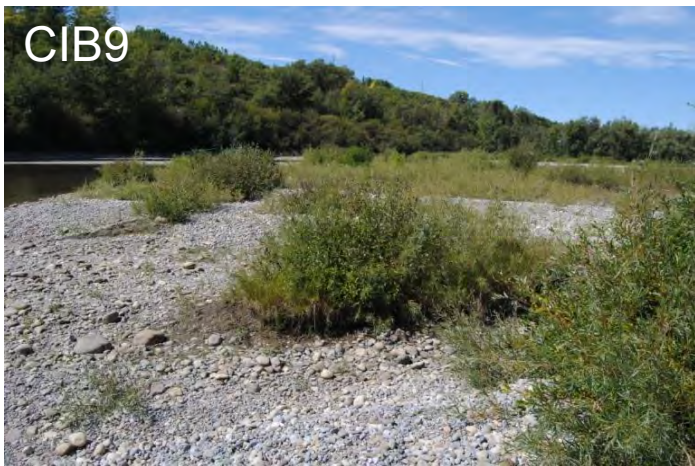
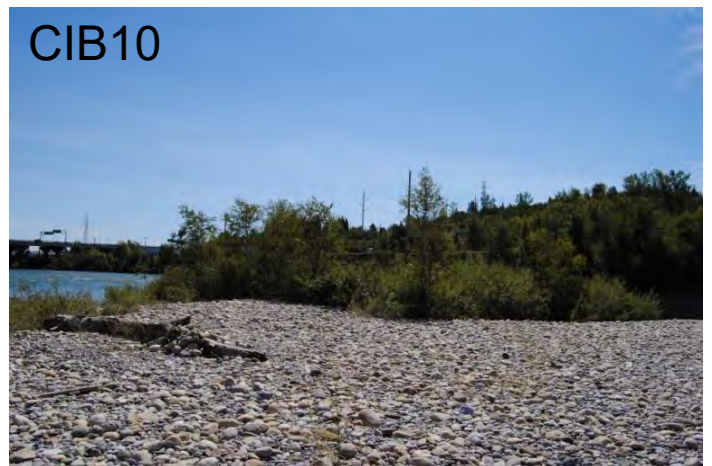
Figure 19. Ground level photographs at the Crowchild Island Bar continued.

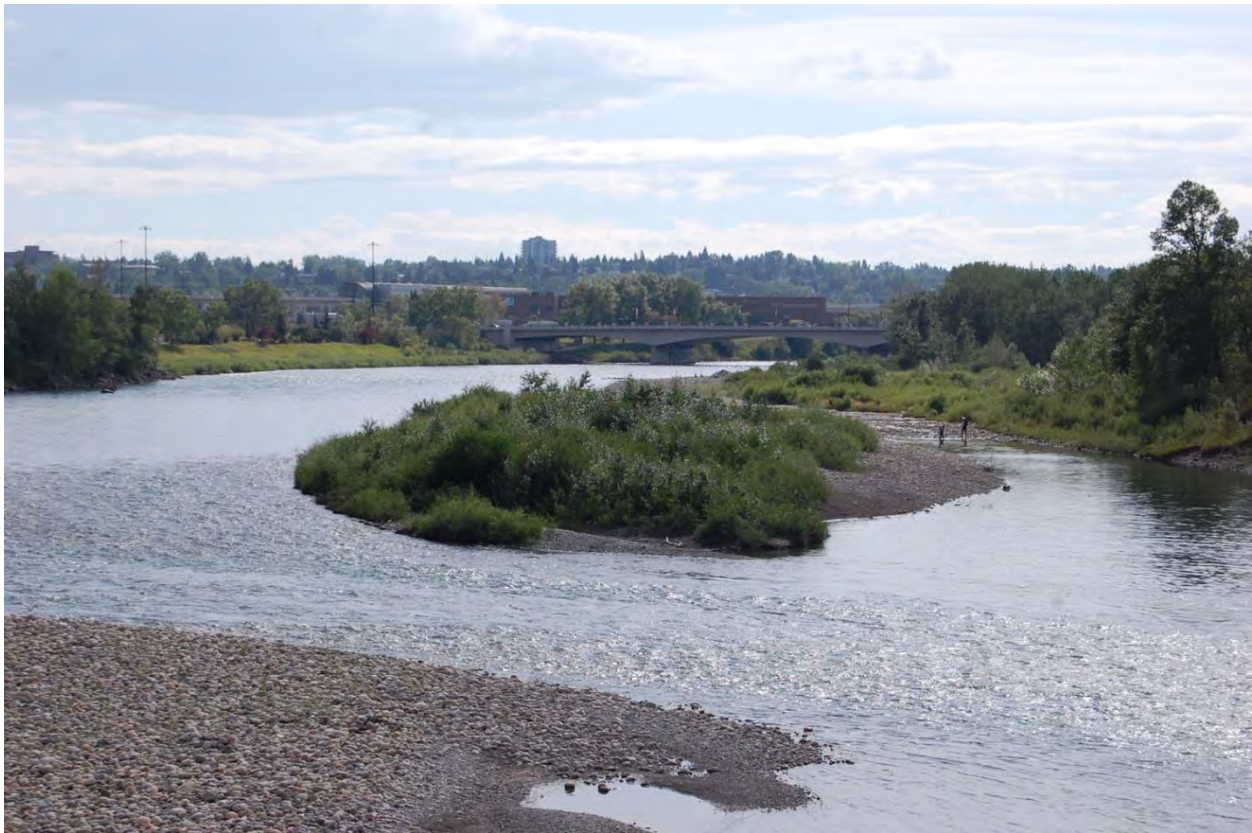
Figure 20. An upstream view of the Bar Above 10<sup>th</sup> St. site in the Bow River, July 12, 2015.

We considered the island bar along the river-left side upstream of the 10<sup>th</sup> St. Bridge as a useful reference site relative to flows and elevations related to that bridge (Figure 20). Prior to the 2013 flood, that feature involved an elongated island zone with a substantial back channel between it and the left bank (Figure 21, TSI-a). It was densely covered with shrubs but apparently not with trees, as evidenced by the more homogeneous cover than the woodland patch at the 10<sup>th</sup> St. Bridge, which supports trees as well as shrubs (Figure 12, TSI-a).

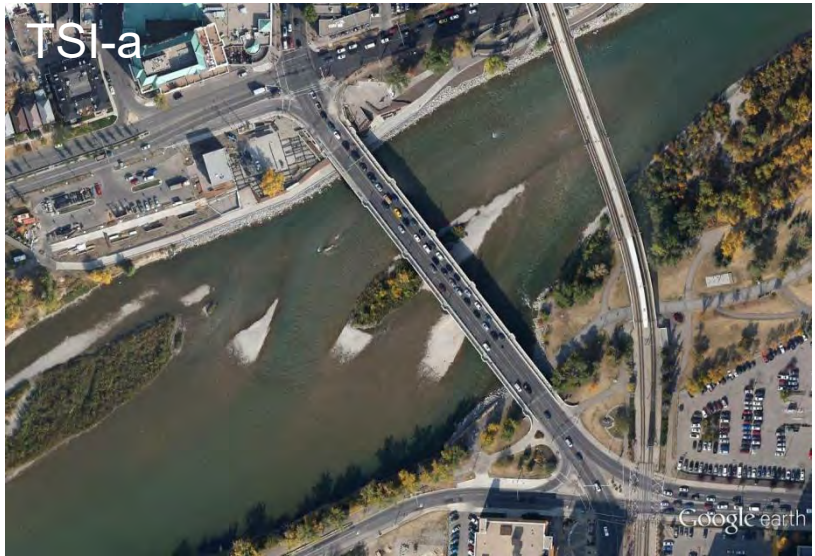
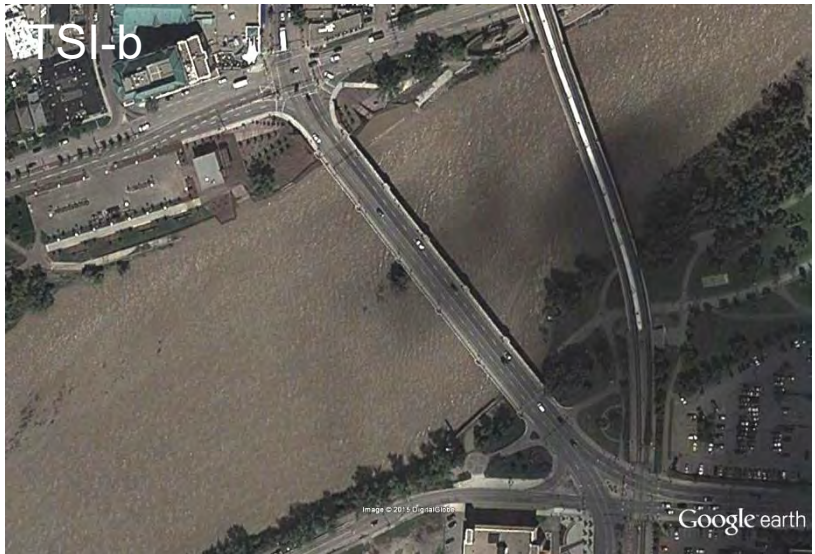
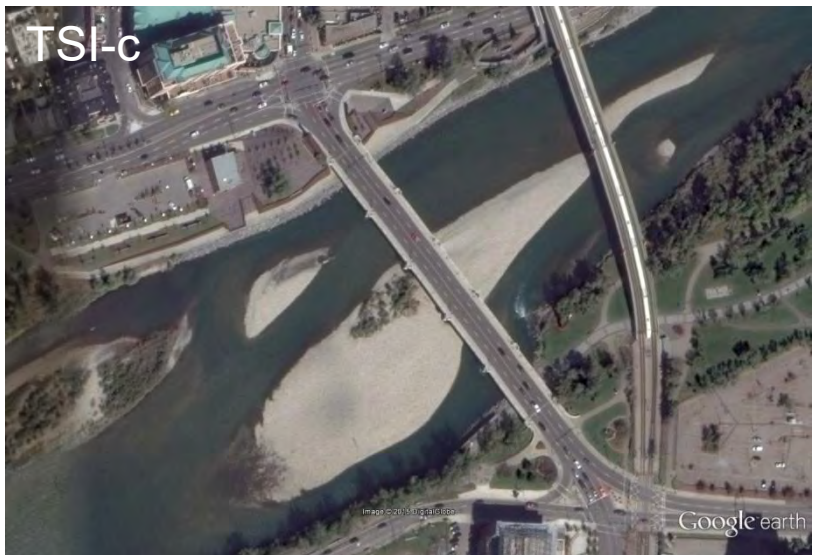
Pre-flood  
Sept. 22, 2012  
60 m<sup>3</sup>/s  
eye alt 4672 ft

Flood  
June 25, 2013

Post-flood  
Field visit  
Aug. 21, 2015

Figure 21. Aerial photographs of the 10<sup>th</sup> Street Island (TSI) study site in the Bow River. These display conditions prior to the 2013 flood (TSI-a) and during the flood (TSI-b). The 2013 photograph displays the depositional features and the final photograph displays conditions at about the time of the field sampling

Prior to the flood, an island complex existed below the 10<sup>th</sup> St. Bridge and this supported a woodland grove with shrubs and balsam poplar (Figure 21, TSI-a). The woodland occupied much of the prior island surface, with some barren, lower elevational zones extending upstream and downstream. The whole island was probably inundated during the 2013 flood, with the shrub and tree shoots emerging from the flood waters (TSI-b). There was apparently extensive sediment deposition and consequently the island was greatly expanded by the 2013 flood (Figure 21, TSI-c; Figure 22). The island expanded upstream and downstream and was enlarged to river right and thus attached to a prior smaller island to provide a large island that extended from the 10<sup>th</sup> St. Bridge downstream to the LRT Bridge and even further downstream at low river flows. In the sequence of aerial photographs it is noteworthy that the pre-flood photo represents the island exposure at 60 m<sup>3</sup>/s, while the post-flood photo reveals the much more extensive island exposure even with the slightly higher river discharge (about 80 m<sup>3</sup>/s). Thus, the 10<sup>th</sup> St. Island was vastly expanded by the 2013 flood.

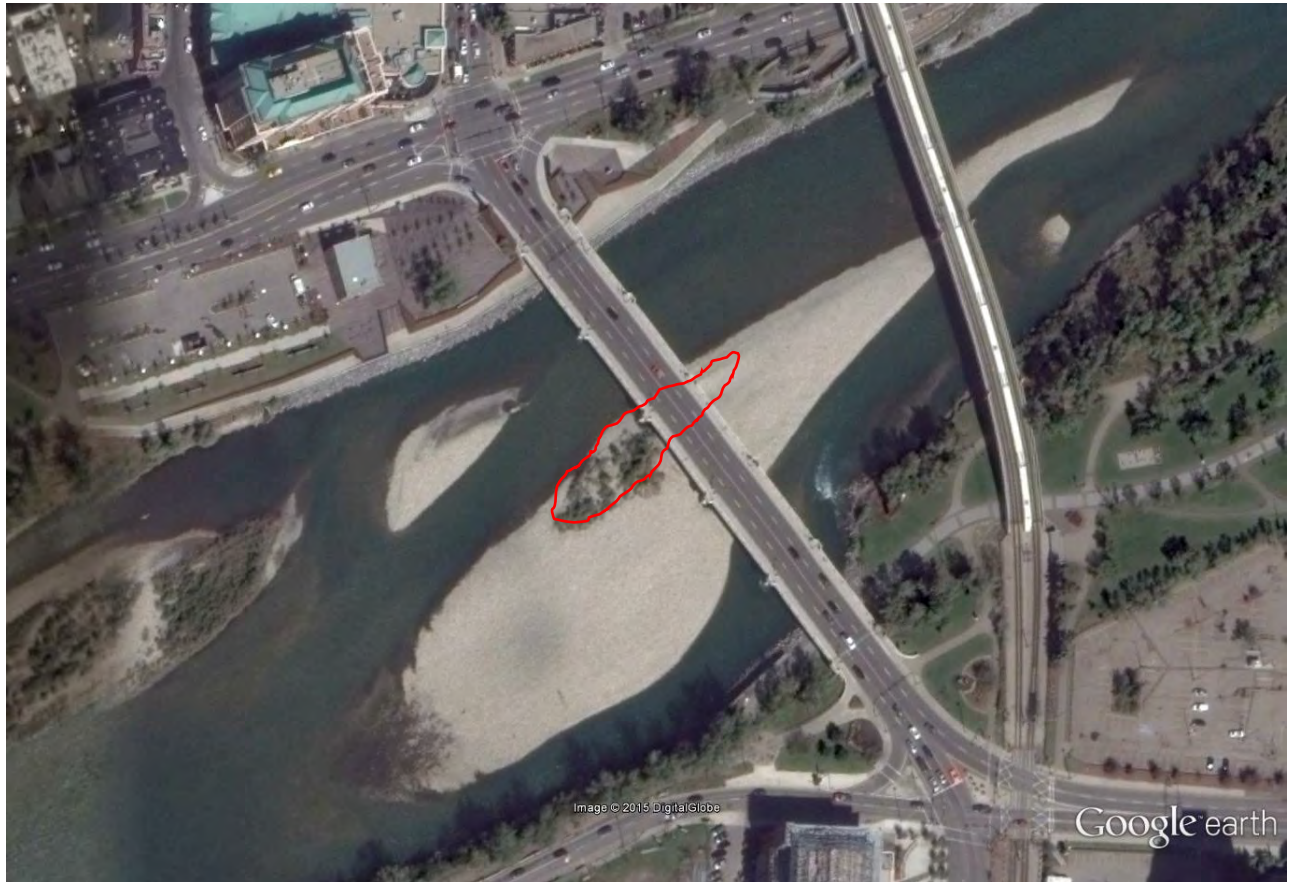
Figure 22. An aerial photograph of the 10<sup>th</sup> Street Island (TSI) with an outline showing the woodland patches from Sept. 22, 2012 (Figure 21).

The woodland grove upstream of the 10<sup>th</sup> St. Bridge that existed before the 2013 flood largely survived the flood (Figure 22). In contrast, the smaller shrub patch downstream of the bridge pier was completely lost (Figure 22). This was probably scoured away since there was no evidence of remaining material that had been toppled and covered. Supporting this interpretation, we did not see remnant material, as we observed at the Crowchild Island Bar, or new clonal shoots that would be emerging from covered shrubs.

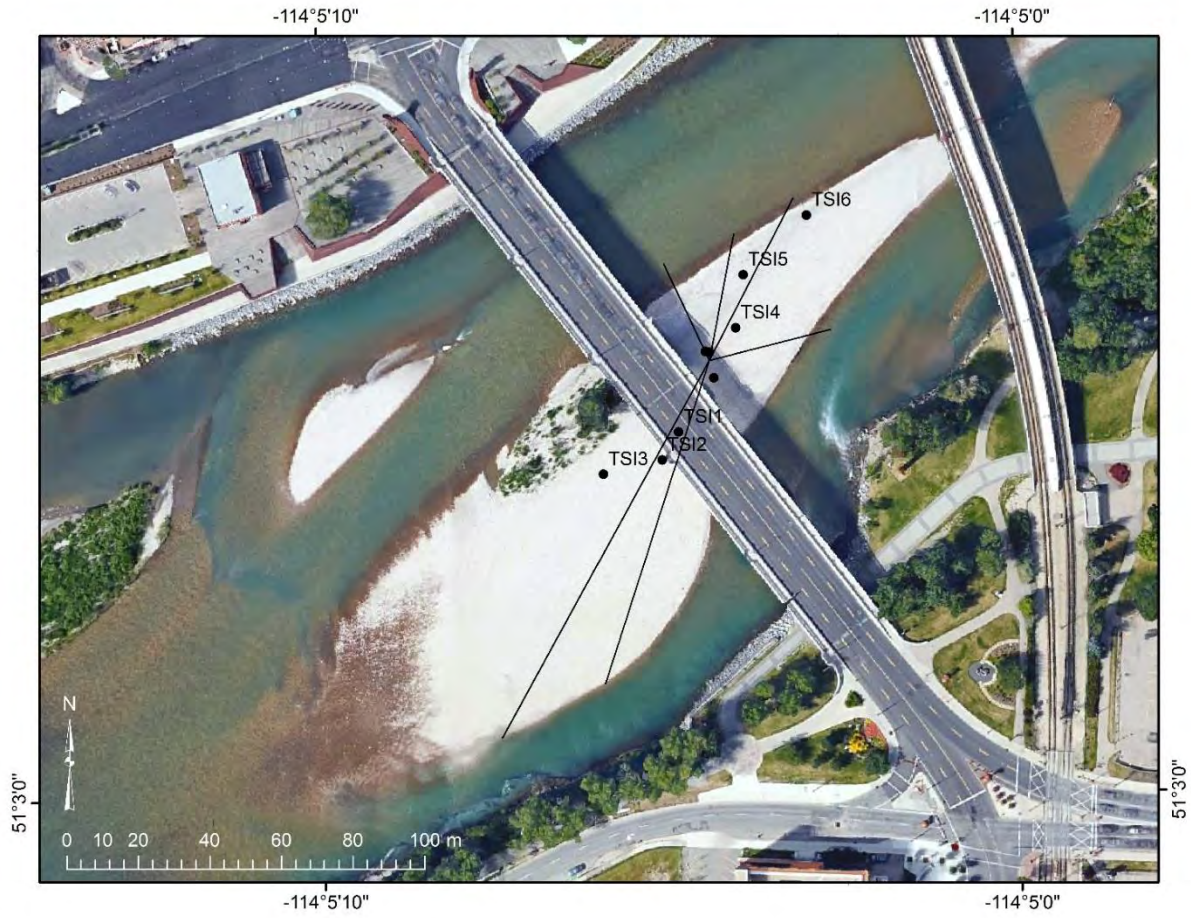
Figure 23. A post-flood aerial photograph of 10<sup>th</sup> St. Island in the Bow River showing the study transects and quadrat locations.

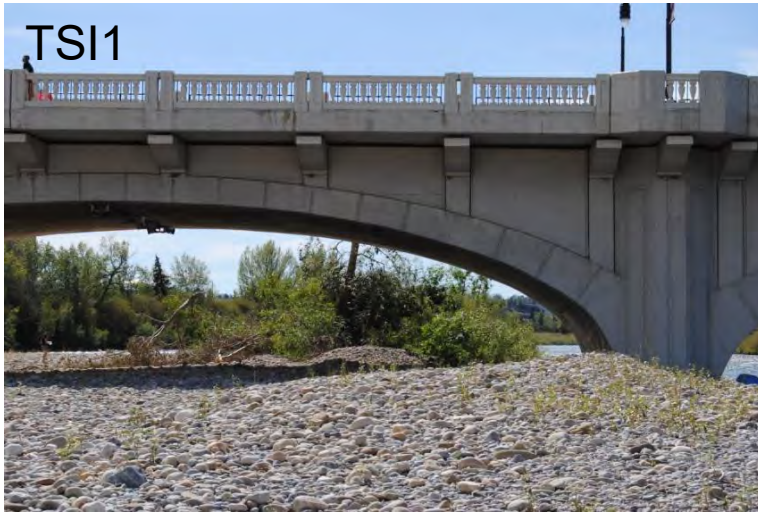
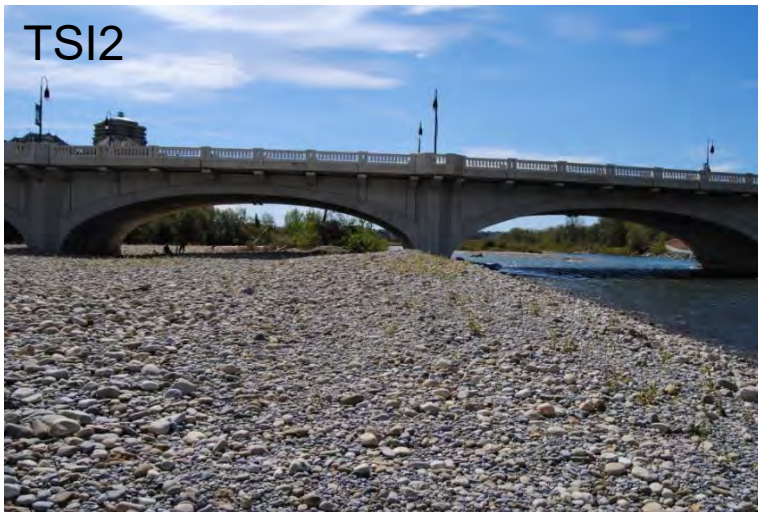
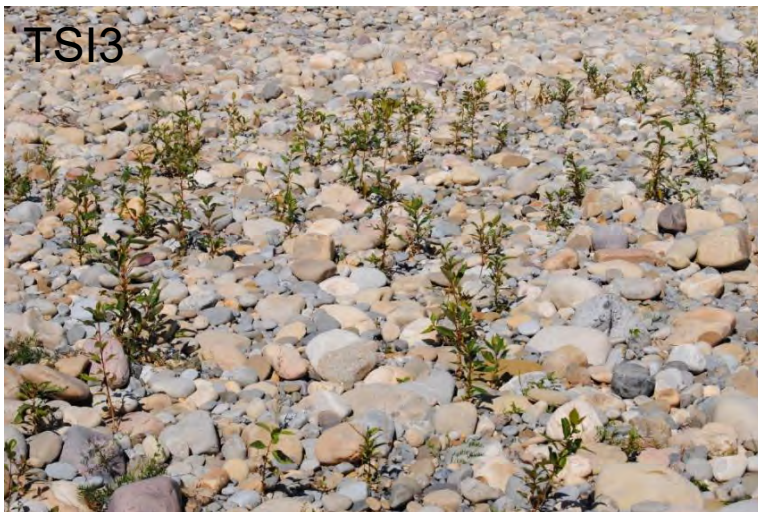
Facing upstream, the prospect of flow impedance is shown below the 10<sup>th</sup> St. Bridge. A woodland patch existed upstream prior to the 2013 flood and survived that scour. Sediment was deposited downstream from the patch and on the island, expanding it, as evidenced by sequential aerial photographs and very probably elevating it through deposition of cobbles and other sediments (Aug. 8, 2015).

Probably due to the bridge support, combined with flow blockage from the prior woodland patch, an elevated ridge occurs downstream and that now supports a new patch of balsam poplar saplings. These are high enough relative to the river that they are likely to survive and result in an elongated woodland band that extends downstream from the bridge support. This woodland band would trap sediments from future high flows, and thus further elevate the ridge, enabling expansion of the woodland patch (Aug. 19, 2015).

Figure 24. Ground level photographs at the 10<sup>th</sup> St. Island in the Bow River.

On the newly expanded island zone upstream from the 10<sup>th</sup> St. Bridge, the surface was predominantly coarse gravel to small cobble (Figure 24), and this was relatively flat and at fairly low-elevation relative to the adjacent river surface. In mid-July, this upstream zone was sparsely colonized by sweetclover and those plants had senesced by the field visit in late August (Figure 24, TSI4). There were some small seedlings of balsam poplars and other woody plants on the upstream zone, with the small size indicating establishment in 2015 and there might be limited prospect for survival due to the low elevation.

The zone was higher than the rest of the island downstream of the 10<sup>th</sup> St. Bridge and it is likely that this reflects some sediment settling in the protected location downstream of the bridge pier. We observed many balsam poplar saplings on this raised crest that was parallel to the river channel (Figure 24, TSI3; Figure 26, TSI9 and TSI10; Table 8). Some of these new poplars had

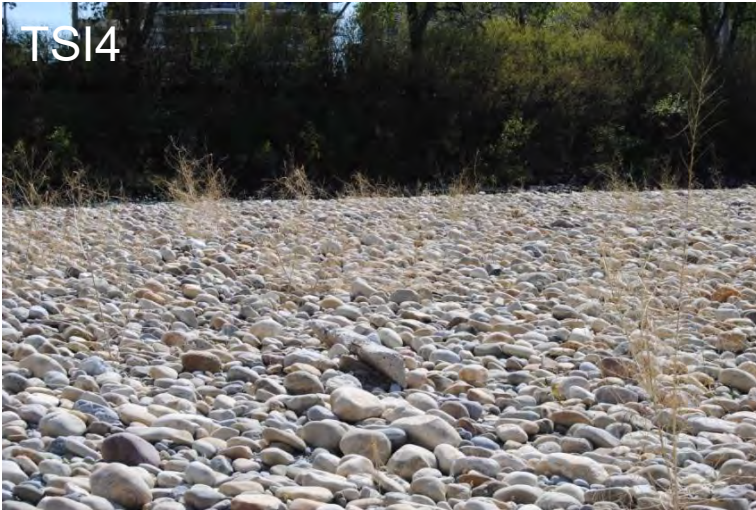
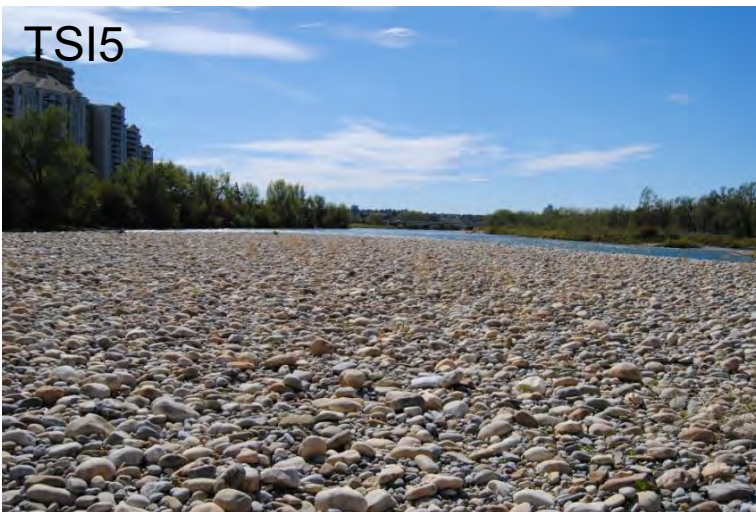
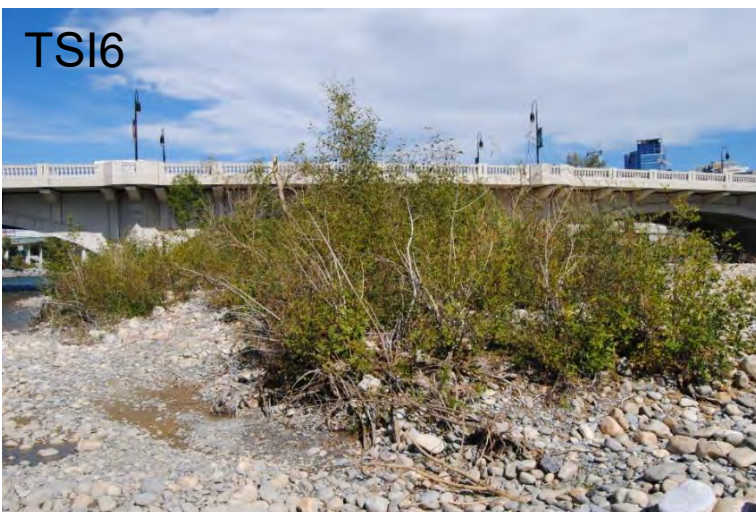
The predominant vegetation on island the 10<sup>th</sup> St. Bridge was white clover and this had died back by August. Sparse woody saplings occurred but these zones are lower and survival may be less likely.

The woodland patch on the island immediately upstream from the 10<sup>th</sup> St. Bridge includes willows, river birch and balsam poplar and was not removed by the 2013 flood. Shrubs were toppled but have regrown more upright. The single large balsam poplar was decapitated between late July and mid-August, probably due to strong wind or possibly a lightning strike.

Figure 25. Ground level photographs at the 10<sup>th</sup> St. Island continued.

The island surface was progressively higher near the Bridge and highest near the bridge pier at the river left edge of the island. This was the zone where the woodland grove previously existed. The grove had been scoured by the flood flow and some of the shrubs and trunks were toppled, but were regrowing upright and thus rebounding from the scour. A single large balsam poplar occurred just upstream from the bridge and its canopy extended above the bridge in July 2015. By mid-August it had been decapitated, possibly due to strong wind (Figure 25, TSI6).

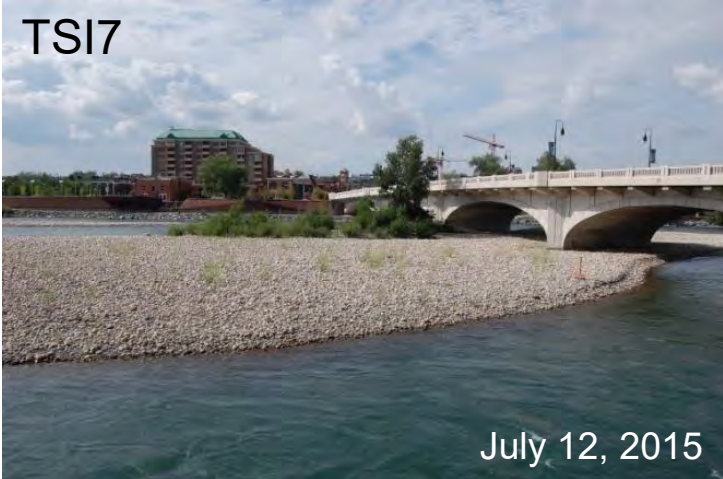
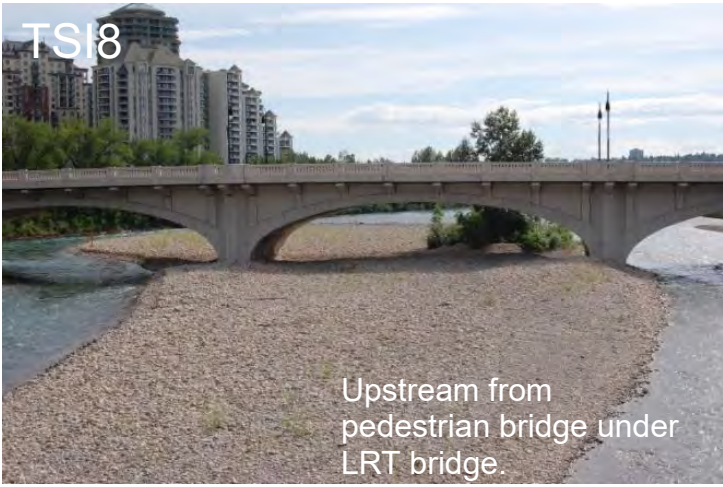
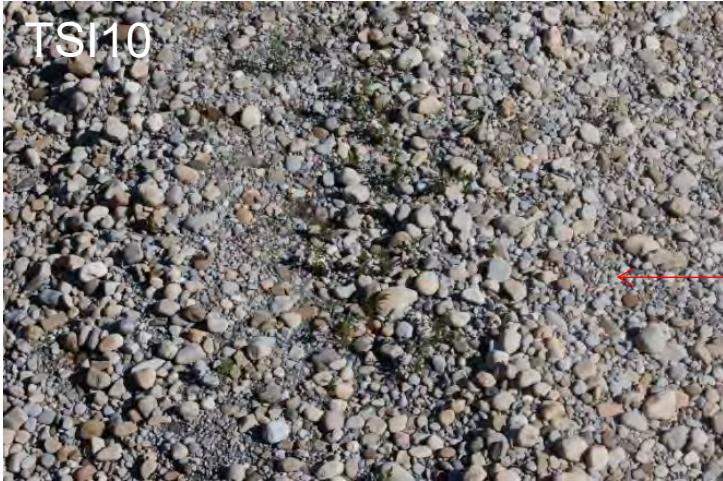
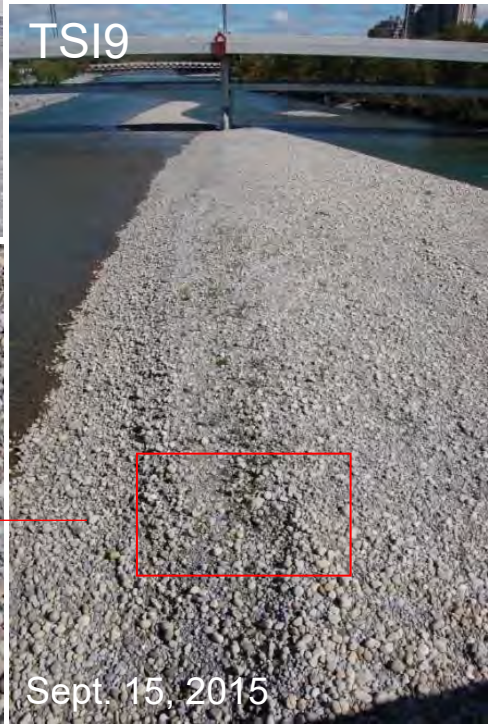
Figure 26. Further ground level photographs of the 10<sup>th</sup> St. Island study site.

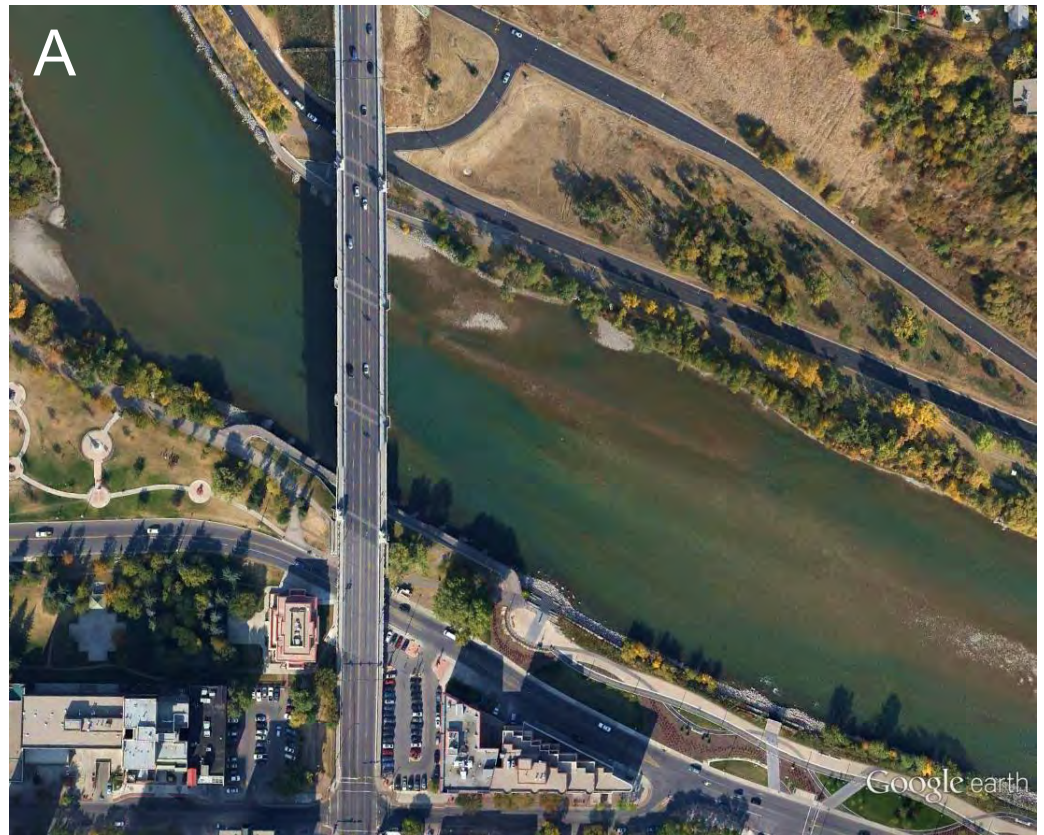
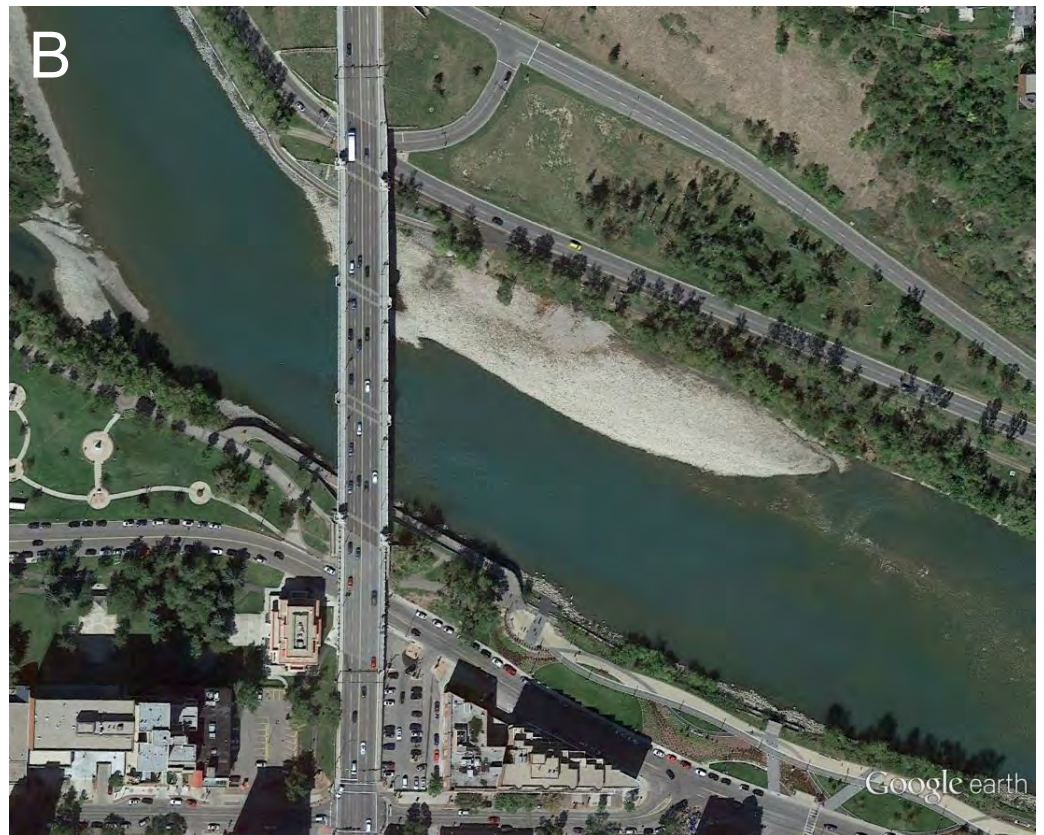
Figure 27. Aerial photographs of the Centre Street Bar (CSB) study site along the Bow River. These display conditions prior to the 2013 flood (A). The final photograph (B) displays conditions at about the time of the field sampling.

Prior to the 2013 flood there was a small bar under the left edge of the Bridge, and a shallow submerged bar, with islands emerging at very low flows (Figure 27). Following the 2013 flood, this shallow zone has emerged and has become an extensive shallow bar that represents about one-third of the channel width and extends through the left span, one of three below the bridge (Figures 27 and 28). If this bar were wooded it would be likely to restrict the flow through the left span.

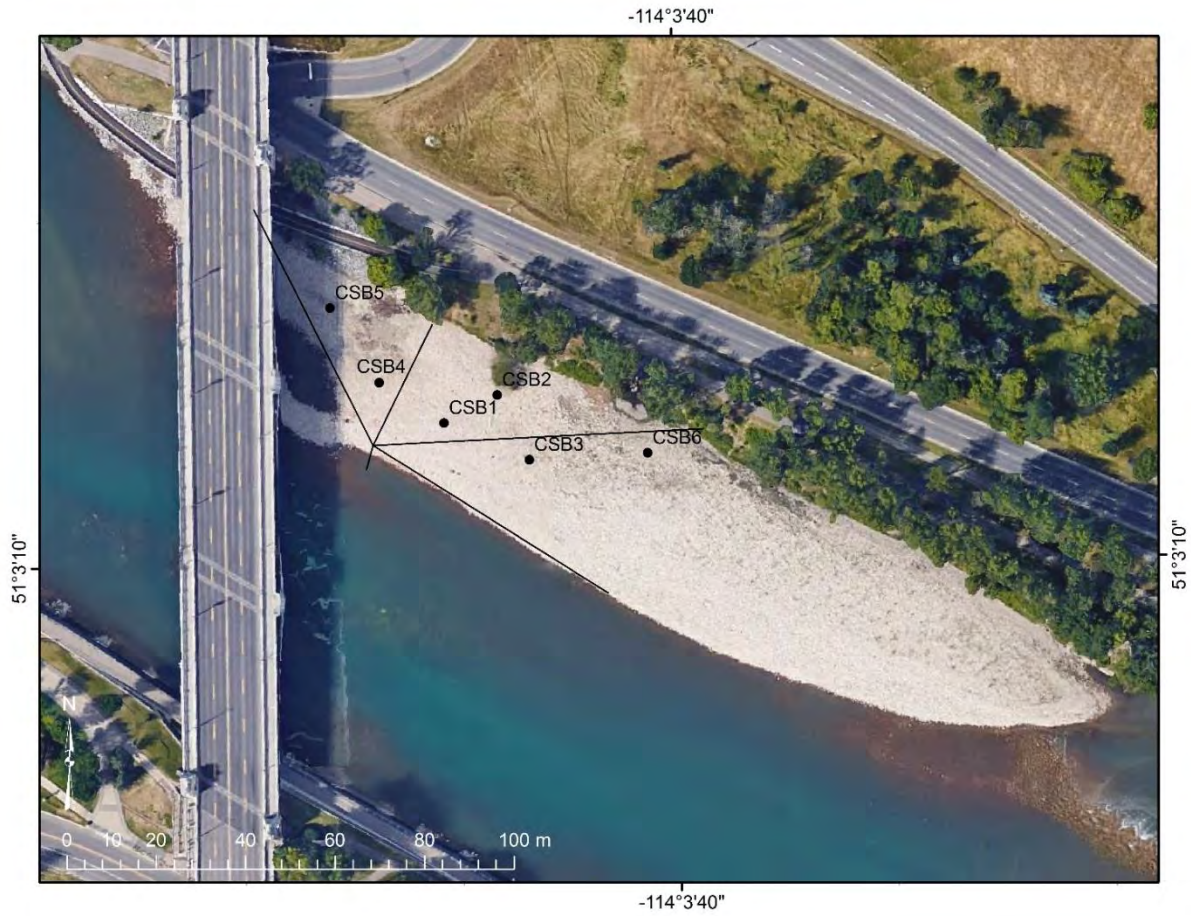
Figure 28. A post-flood aerial photograph of Centre Street Bar along the Bow River showing the study transects and quadrat locations.

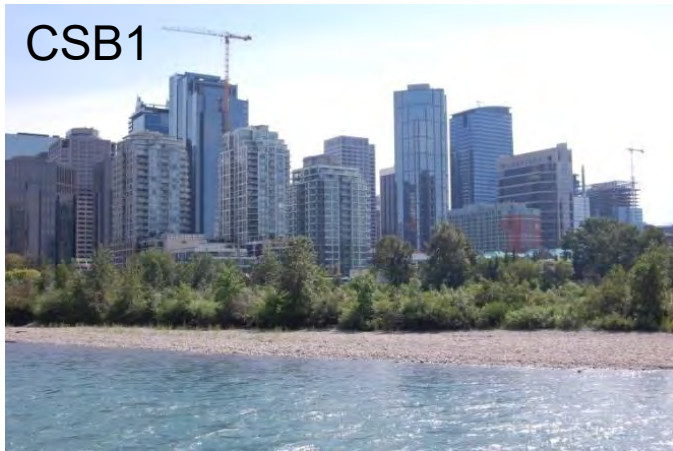
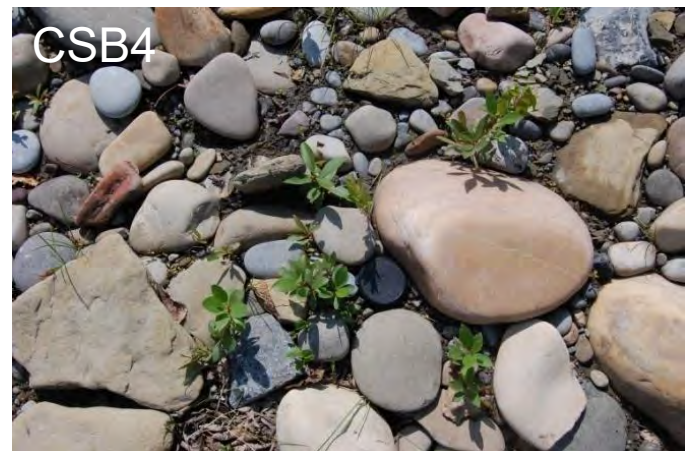
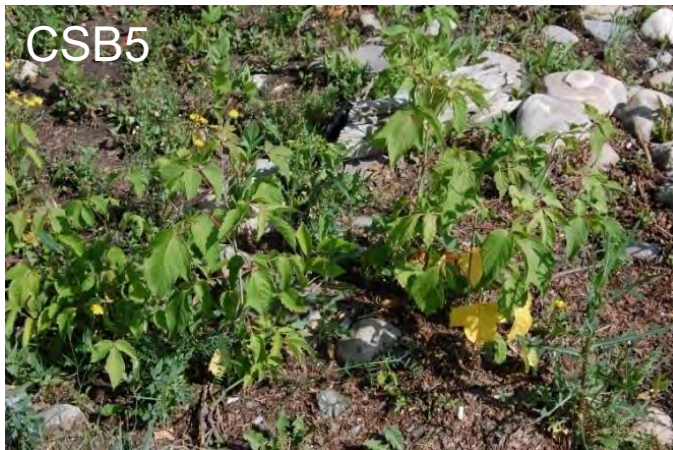
Figure 29. Ground level photographs of the Centre St. Bar study site along the Bow River, July 12, 2015.

The vegetation on the CSB was substantial and diverse (Figure 29). We observed 15 plant species within only five quadrats (Table 9); we regarded these outcomes as representative for the bar. Balsam poplar seedlings were common, along with other woody plants, river birch, alder, and chokecherry (Table 9). While only one Manitoba maple seedling occurred in the quadrats, we observed many more saplings closer to the bank where some larger Manitoba maples were well established, and probably provided the seed source. No willow seedlings occurred in the quadrats but these were observed on the bar, although sparsely. In addition to the woody plants there were abundant herbaceous plants, with various weeds occurring (Table 9) but these would probably not hinder the woodland colonization by the native balsam poplars and shrubs. Following from the abundance and diversity, it would be likely that the lower portions of this newly emerged bar could be colonized by a complex woodland community with a blending of native and introduced plants.

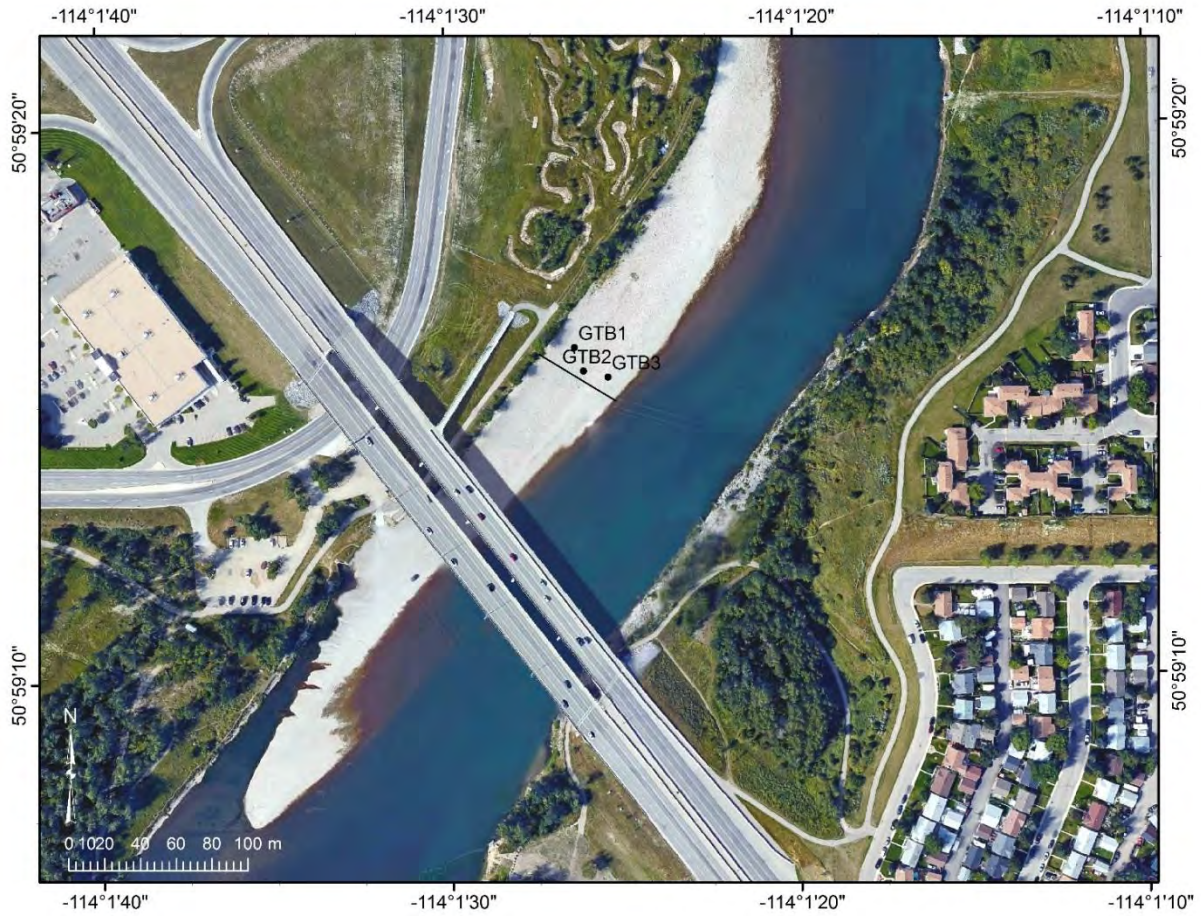
Figure 30. A post-flood aerial photograph of Glenmore Trail Bar along the Bow River showing the study transects and quadrat locations.

The Glenmore Trail Bar was selected as a gradually sloping meander point bar, situated at the river put-in to access the Carburn Park Island (Figures 30 and 31). The bar is primarily upstream of the Glenmore Trail Bridge (Figure 32, GTB6) and continues to serve as a primary access location for launching boats into the Bow River. A prior concrete boat-ramp into a back channel is no longer useful due to extensive sediment deposition. Boats are now launched directly from the gravel bar and there is also a barren laneway as vehicles have driven to the upstream end (GTB2). The surface substrate includes two relatively distinctive particle size groups (GTB3, 4, 5, 7). There are large cobbles and much smaller gravels sifted in between. The pattern was widespread along the meander lobe (GTB1, 6).

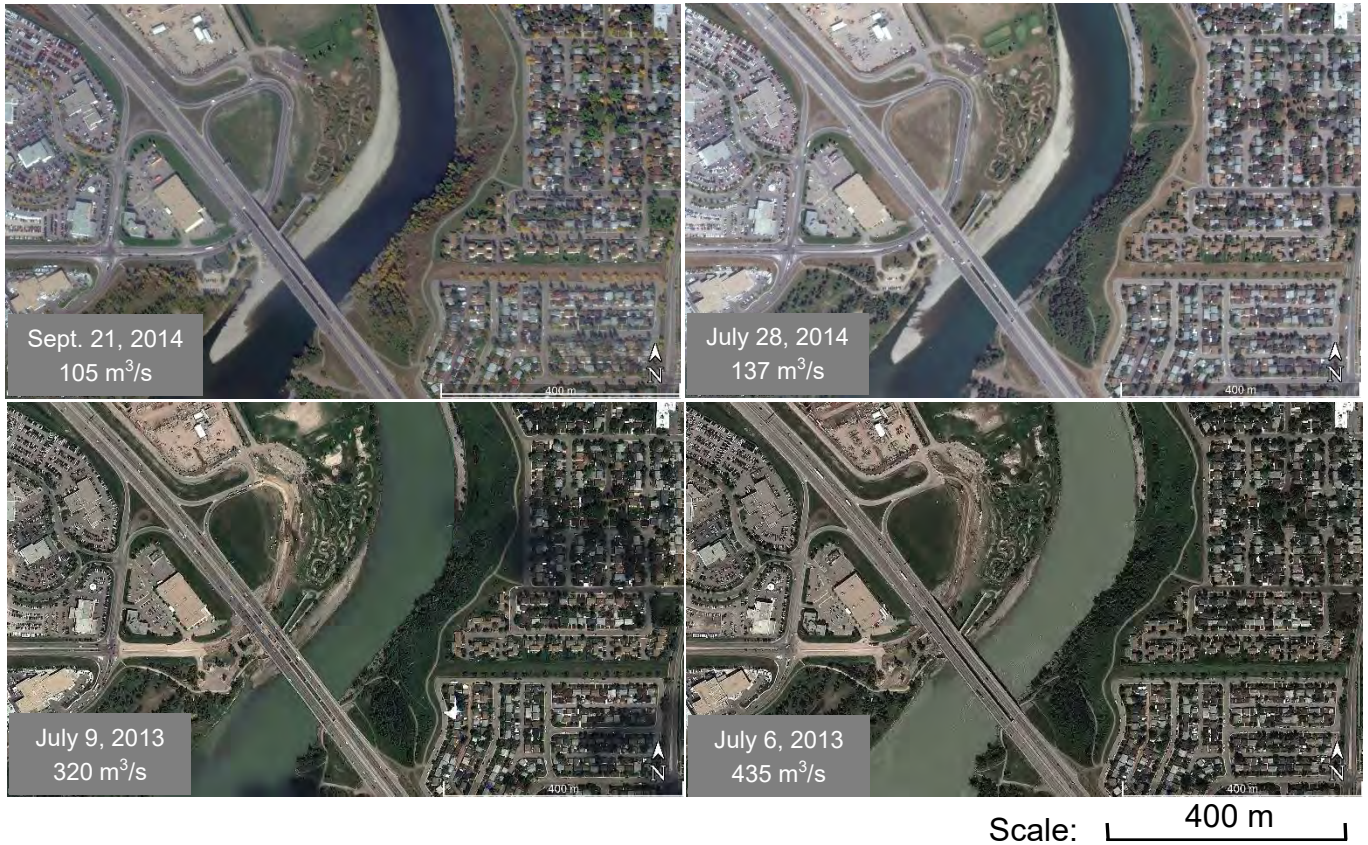
Figure 31. Post-flood aerial photographs of Glenmore Trail Bar in the Bow displaying the inundations at different river discharges that were used to project vegetation colonization patterns.

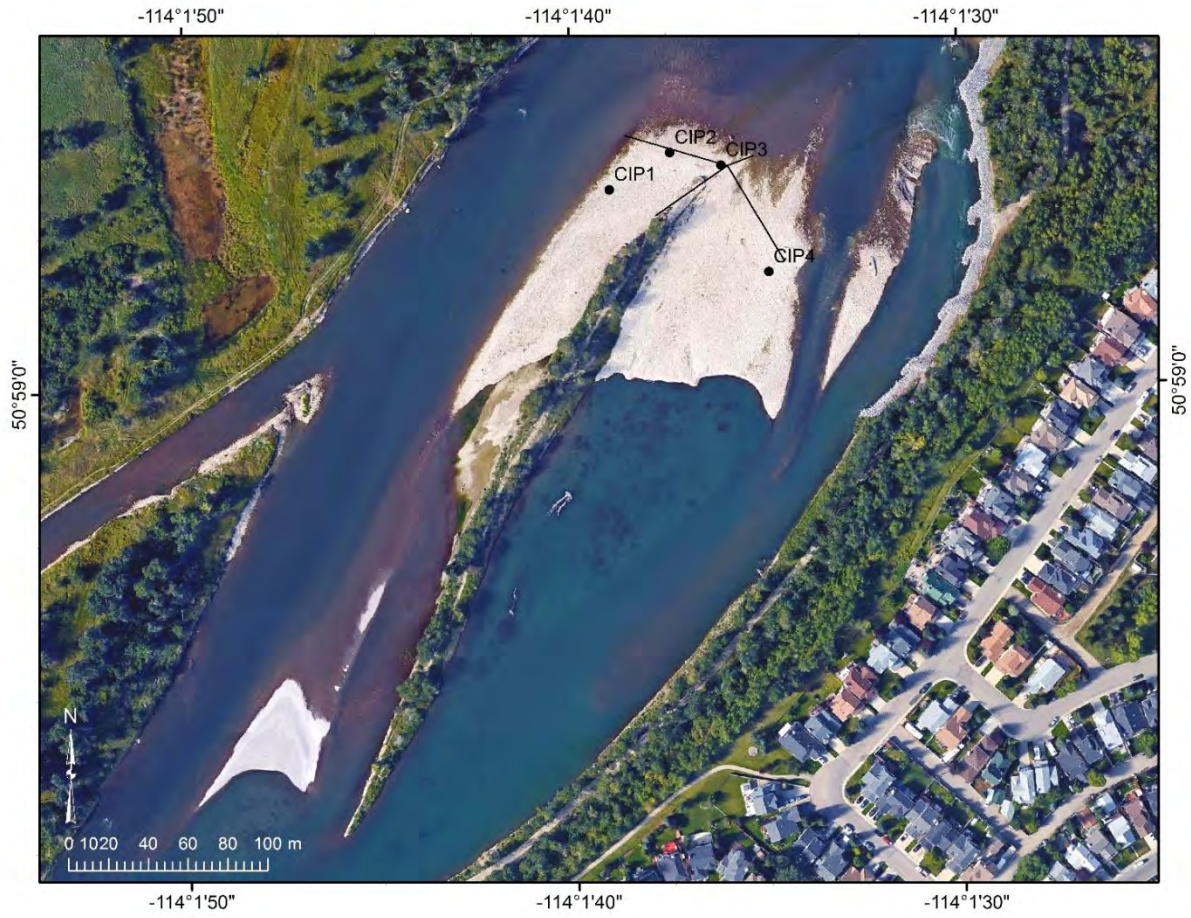
Figure 33. A post-flood aerial photograph of Carburn Park Island (CPI) in the Bow River showing the study transects and quadrat locations.

The Carburn Park Island represents the outcome from a very artificial situation, with a narrow ring of mature balsam poplar woodland around a pre-flood pond. With the 2013 flood, the upstream bank was breached and water flowed into and through the pond, breaking out through the downstream bank. There is still a remaining narrow, elevated band that follows the river route, with the prior channel down the right side and the new channel down the left, through the zone of the prior pond (Figure 33).
