# Analyzing and Projecting Post-Flood Vegetation Colonization along the Bow River through Calgary, Alberta

Stewart B. Rood, Soba Kaluthota, Laurens J. Philipsen and Karen P. Zanewich  
Chinook Environmental Resources, RR9 Site 1 Box 1, Lethbridge, AB T1J 4R9, and  
Environmental Science Program, University of Lethbridge, AB

This report was undertaken as part of the *Calgary Rivers Morphology and Fish Habitat Study*, sponsored by the City of Calgary and led by Klohn Crippen Berger; and the Alberta Environment and Parks Watershed Resiliency and Restoration Program project, *Post-Flood River Regulation for Riparian Enhancement*.

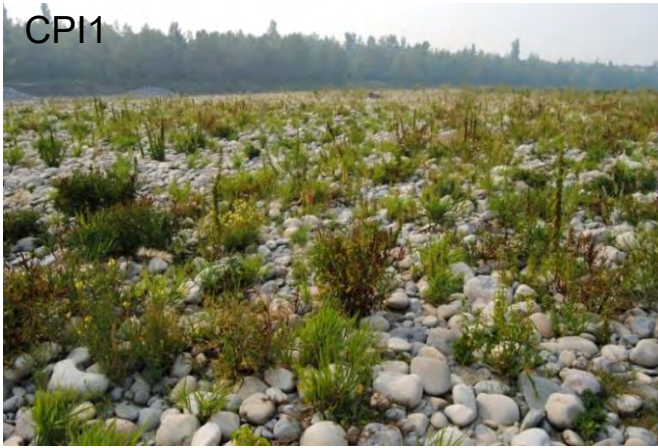
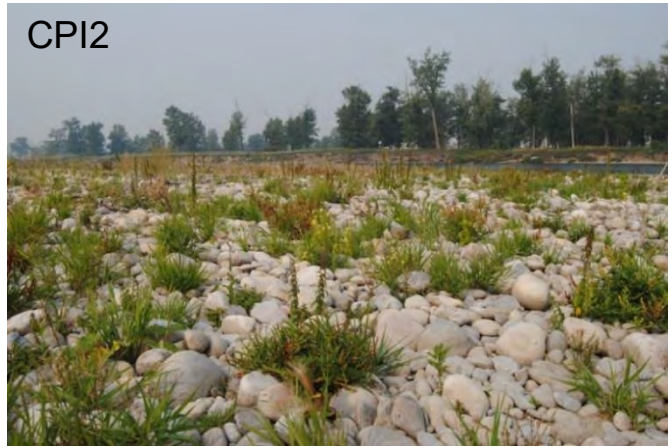
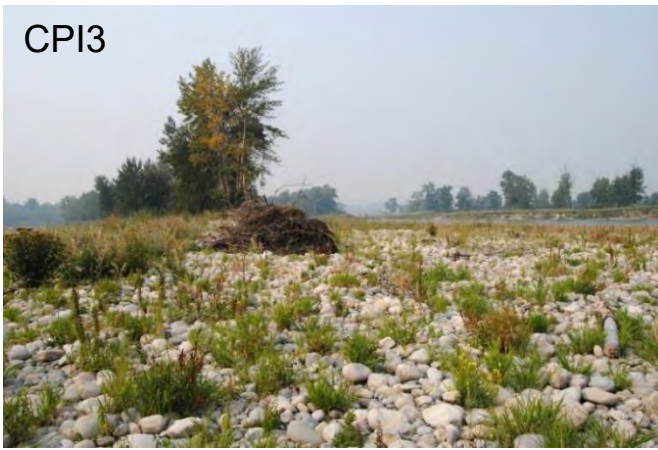
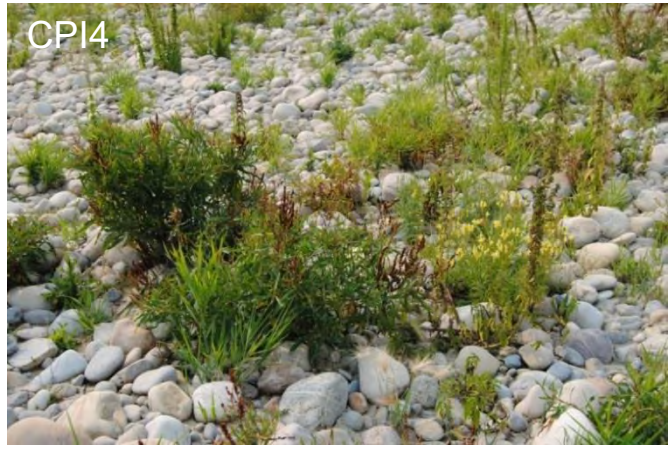
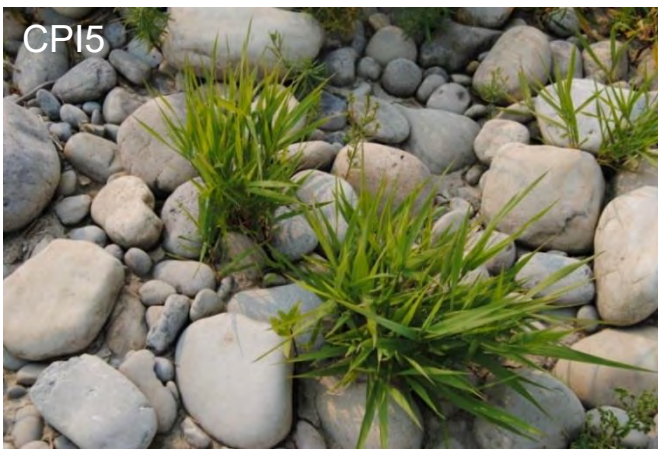
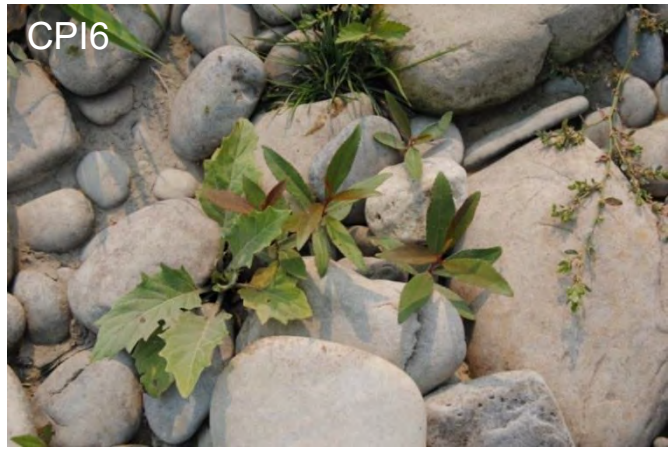
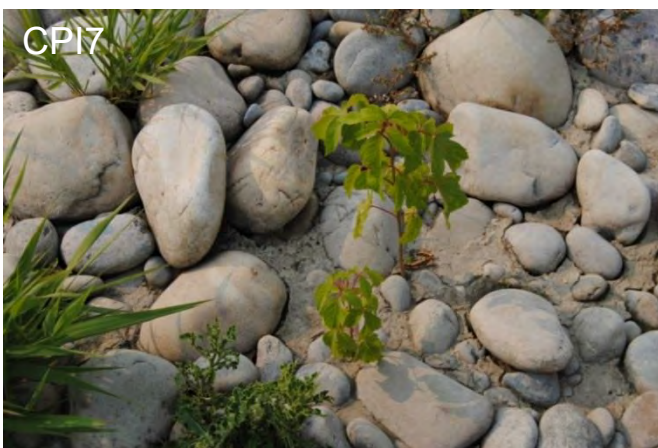
Figure 34. Ground level photographs at the Carburn Park Island.

The newly established zones are quite level with the surface substrate including the largest particles that we encountered, with abundant large cobbles and boulders (Figure 34). There were some gravels and also finer, interstitial sands and silts settled in between the larger sediments. This unusual substrate could reflect the artificial nature of the site.

The newly established riparian vegetation was rather different than at any other study site. It included a mixture of weeds (Figure 34, Table 13) with abundant reed canarygrass, along with stinging nettle, toadflax, dandelion and Canada thistle in the vegetation quadrats, and other weeds were also observed, but less abundant. There were some balsam poplar seedlings (Figure 34 CPI6, Table 14) as well as other woody seedlings, with some Manitoba maple seedlings appearing healthy (CPI7). However, the weeds were much more abundant and we anticipate that over the next few years, the newly formed, low-lying zone may become predominantly reed canarygrass. This island complex provided the most weed-infested site that we assessed and we did not observe another similar situation as we viewed other bars and islands along the Bow River through Calgary. The weed infestation at CPI was somewhat similar to that at the culvert outflow zone at the Carseland Weir Bypass, which also followed from the flood breach of an artificial structure.

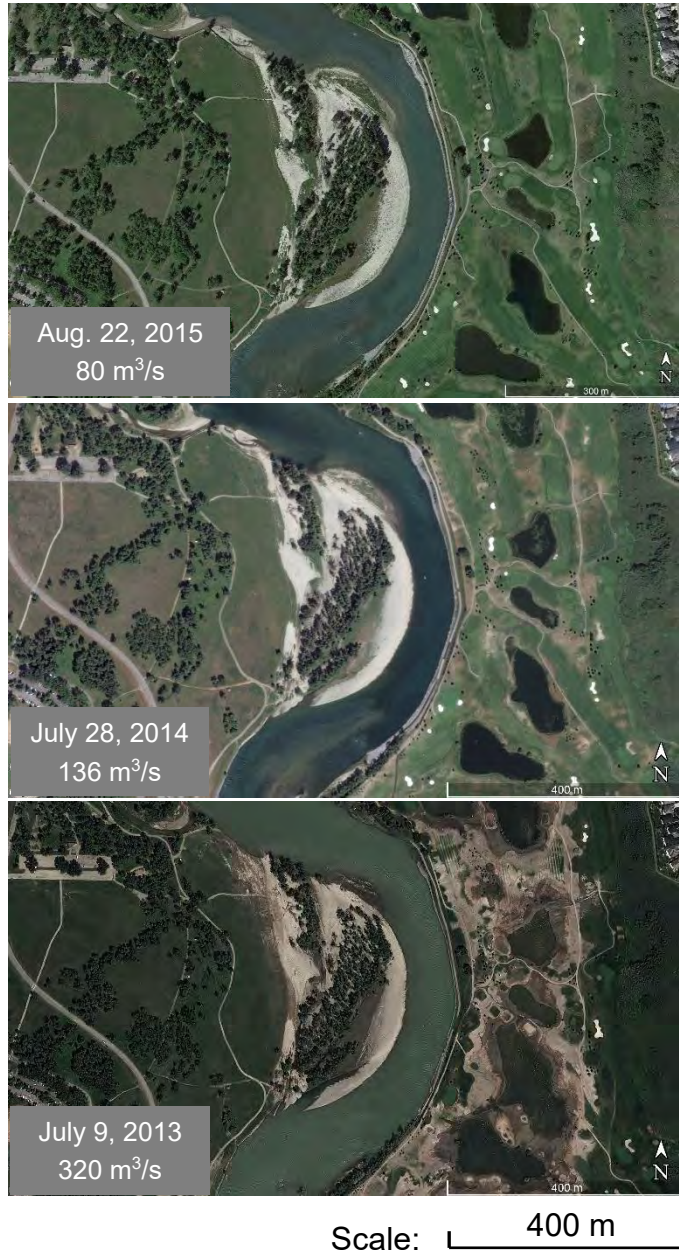
Figure 36. Post-flood aerial photographs of Hull's Wood Bar along the Bow River displaying the inundations at different river discharges that were used to assess vegetation colonization patterns.

We have been regularly revisiting the meander lobe at Hull's Wood (Figures 35, 36) since the autumn of 2013, in the summer of the flood year (Table 2). We observed many 2013 balsam poplar seedlings in the spring of 2014, as well as clonal suckers (Figure 37, HWB5) that were apparently stimulated with root scarification, the abrasion of the shallow, horizontal roots. This was not a priority site relative to risk to infrastructure or elevated flood stage and was more important for our analyses of the pulse of woodland recruitment following the 2013, which was the focus of the Watershed Resiliency and Restoration Program project.

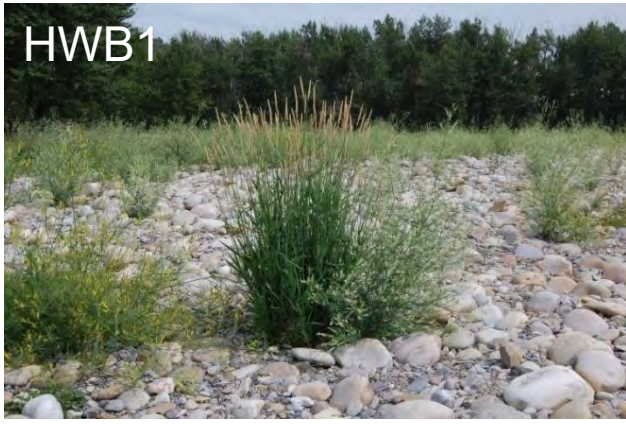
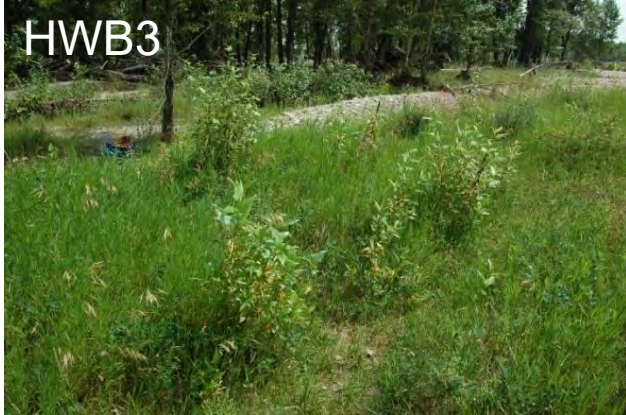
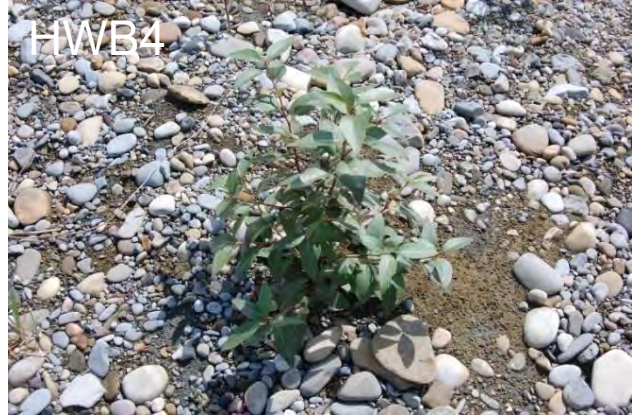
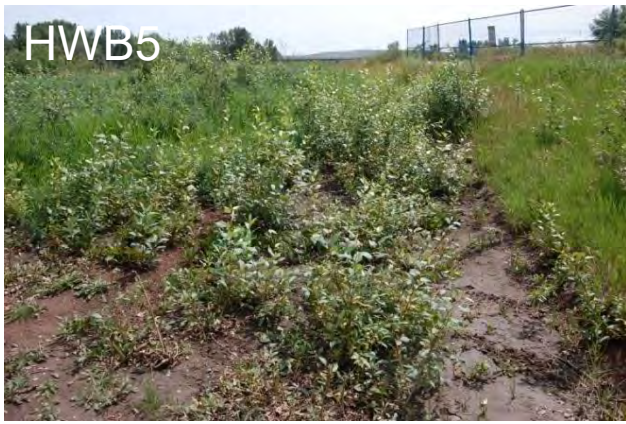
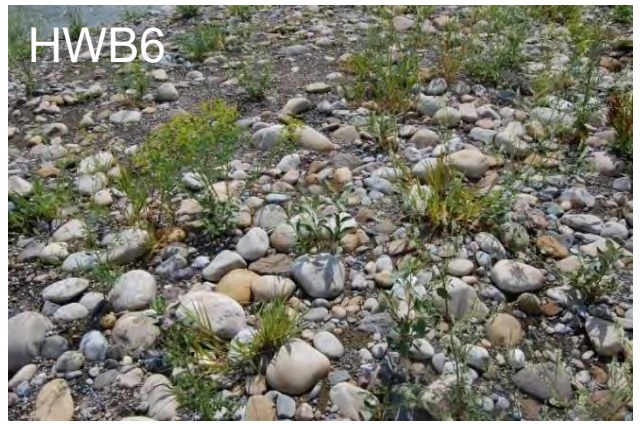
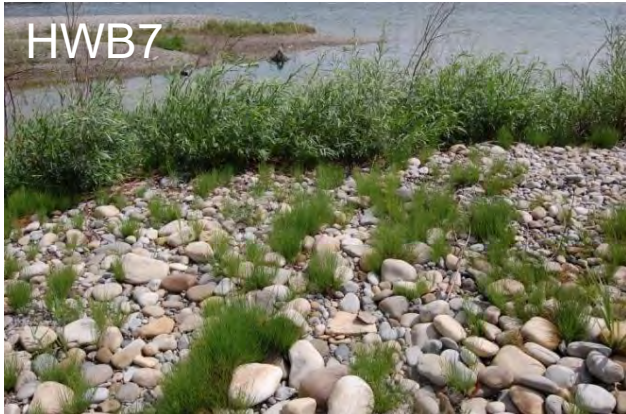
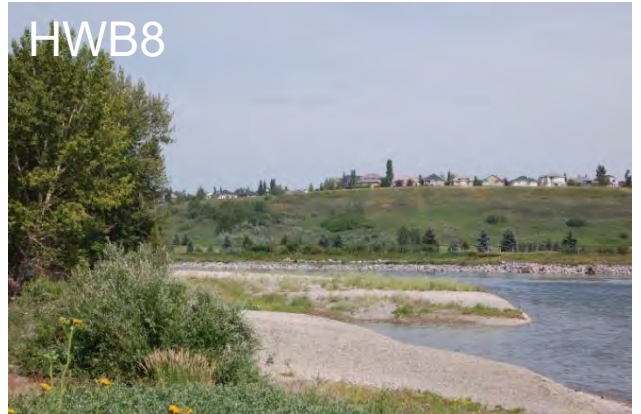
Figure 37. Ground level photographs taken on July 12, 2015 at the Hull's Wood Bar (HWB).

We observed abundant new seedling on the meander lobe point bar (Figure 35), which was expanded by the 2013 flood. Balsam poplar seedlings were common, and included a few from 2013, more from 2014 and abundant but very small seedlings from 2015 (Figure 37, Table 16). Two problem plants were also common, with new seedlings of reed canarygrass and the noxious weed, leafy spurge (Figure 37, Table 15). The seedlings were sparsely distributed and thus the weeds might not impede the new poplar seedlings. As the poplar seedlings grow in height, they will be above the weeds by about the fifth year and might subsequently not be hindered by the invasive plants. Instead, the growing balsam poplars would tower over the weeds and provide shading, thus stressing and possibly excluding the shade-intolerant weeds.

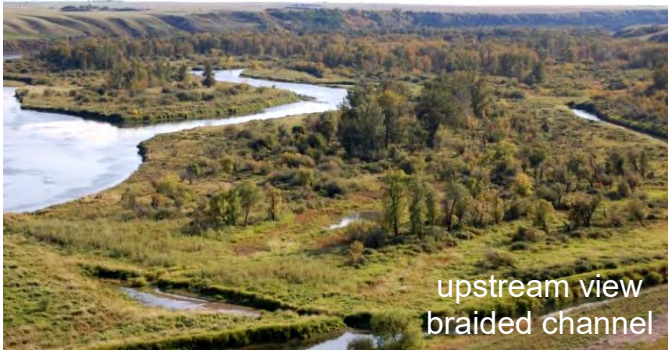
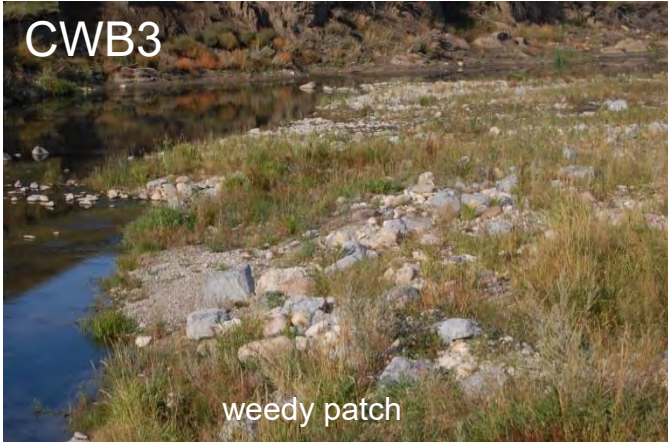
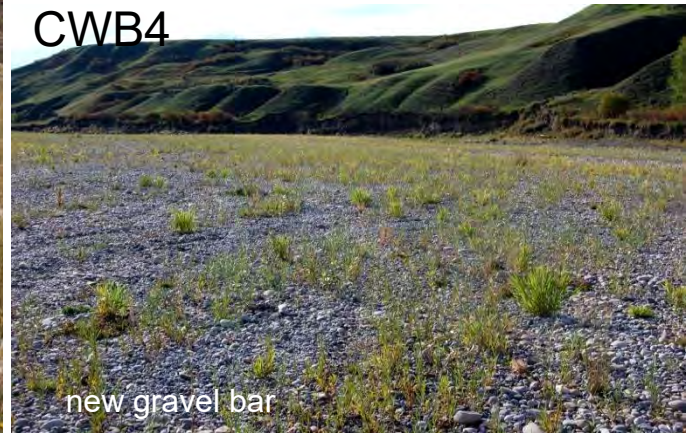
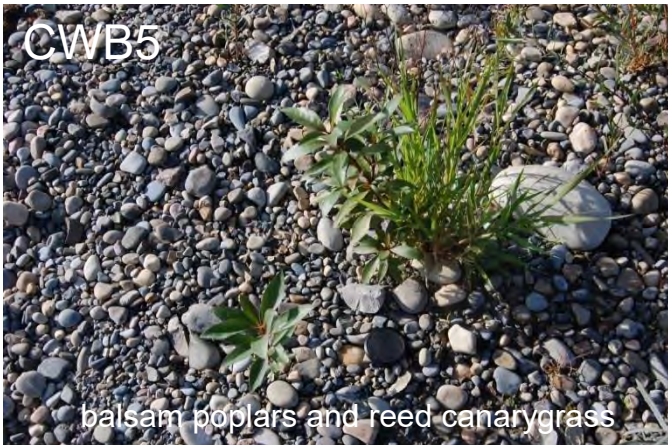
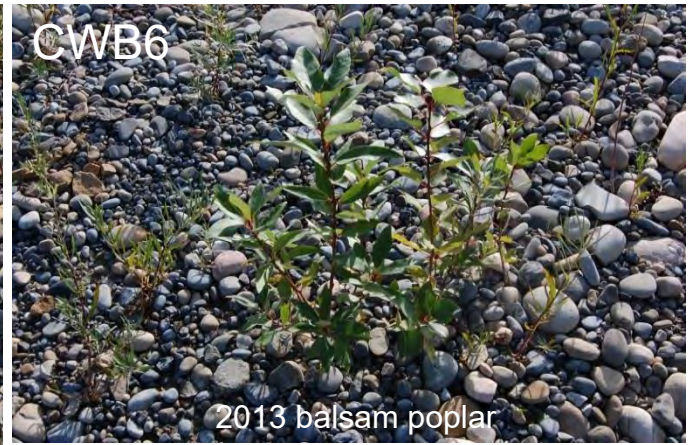
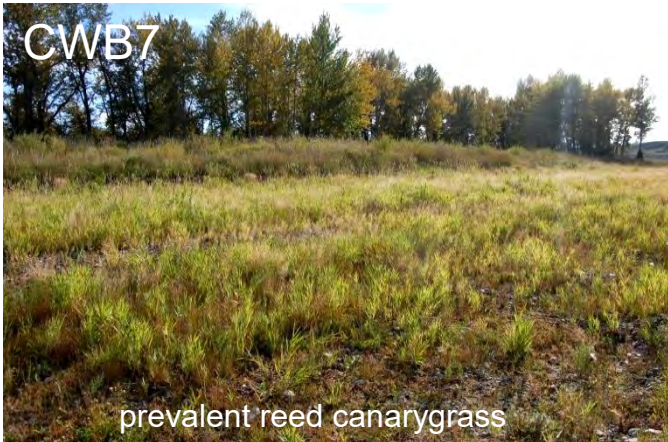
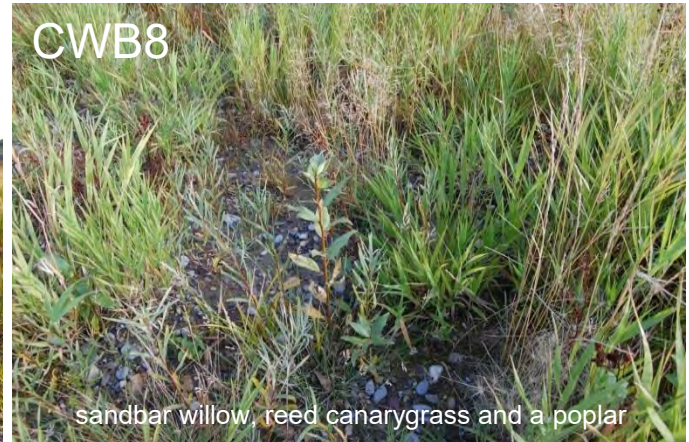
Figure 38. Ground level photographs taken at the Carseland Weir Bypass, Sept. 15, 2015.

For this comparison, we particularly investigated riparian conditions and vegetation colonization through a zone that provided a bypass channel to the left of the Carseland Weir (Figure 38, CWB2), after the berm was eroded and breached by the flood flow. This reconnected the prior, natural channel, which had had limited flow that was provided by culvert drains under the berm. The berm breaching would have contributed substantial material but the finer particles had apparently been flushed downstream and the reconnected bypass channel has a surface with

The zone immediately below the berm breach is especially heterogeneous, with patches ranging from very coarse cobbles and boulders to sand deposits (CWB3). The water regime is also diverse, with a culvert providing flow through the plant growth and thus providing wetter conditions while zones above and away are drier. Around the culvert channel and especially with coarser sediments, the riparian condition resembled that of the Carburn Park Island. There were abundant seedlings of a number of introduced plants species, providing a complex weed patch (CWB3). This suggests that very artificial sites with destructive erosion of artificial structures produce correspondingly non-natural riparian zones, which may favor encroachment of introduced plants, including weeds.

Along the transitional zones between the lower and relatively flat zone of scour and deposition and the woodland island, the intermediate elevations and sloping banks are covered primarily with reed canarygrass (CWB7). These zones have finer surface sediments and while there has been some seedling colonization by sandbar willow and balsam poplar, the reed canarygrass is predominant. If some balsam poplars survive the competitive juvenile phase, these would grow taller than the reed canarygrass, which is shade intolerant. It is thus possible that in some zones the balsam poplars may gain dominance but the conditions in 2015 suggest that these transitional would become bands of reed canarygrass. Related to this prediction, it is notable that the fringes of the islands upstream of the weir and berm are often characterized by dense reed canarygrass.

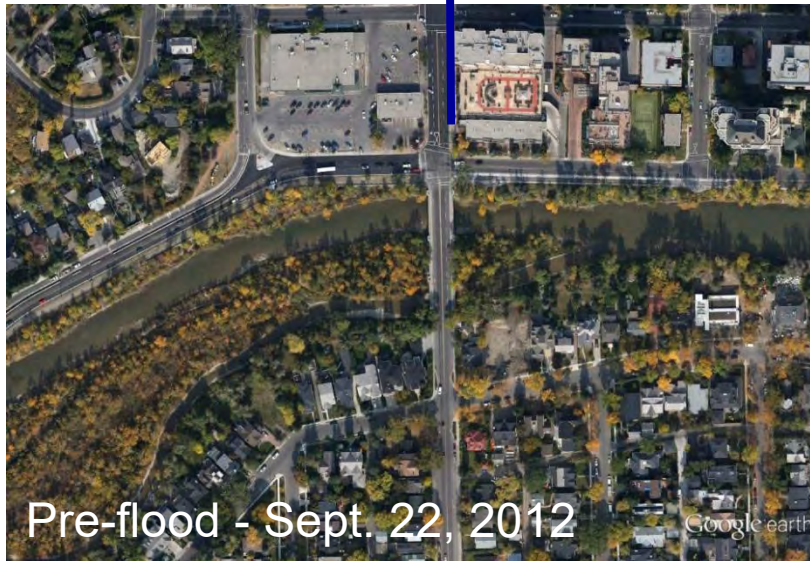
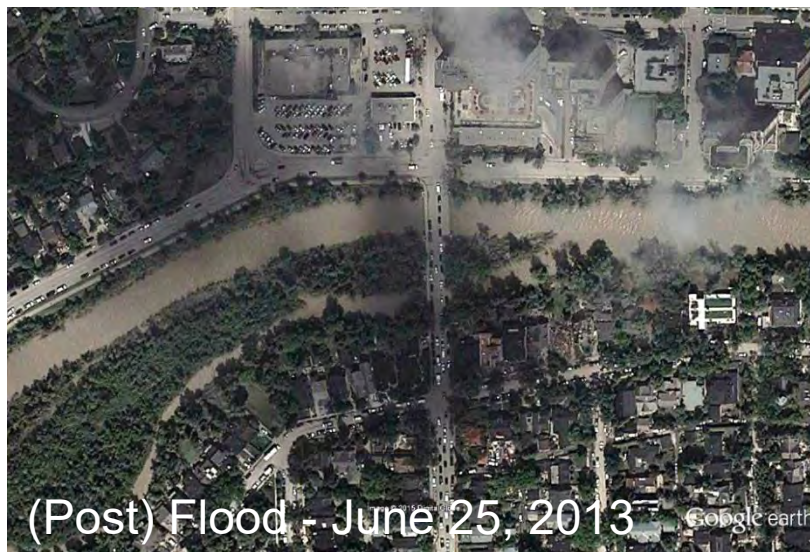
Figure 39. Aerial photographs of the 4<sup>th</sup> St. Bridge (Mission Bridge) spanning the Elbow River pre- and post- 2013 flood.

There are numerous bridges, including those for vehicles and pedestrians. Of these, the Mission Bridge, or 4<sup>th</sup> St. Bridge, is notable (Figure 39, Figure 40 EPI3, 4, 6). From upstream, the main flow is in a channel along the left bank (EPI2) and this flows below the arched bridge span near the left bank (EPI3, facing upstream). The bridge has three other arched spans, with the two middle spans being substantially smaller. A large, elongated island extends to and through the bridge, to continue as a smaller island extension downstream. This Elbow Park Island is heavily wooded, and includes white spruce (*Picea glauca*) as well as balsam poplars and a range of riparian shrubs. This vegetation composition and the sizes of the trees indicate that the island has been in place and stable for many decades. The woodland would choke off the middle two smaller spans (EPI4). A secondary channel extends to the right of the island (EPI5) and flows into the right span but this has substantial sediment deposition (EPI 6).

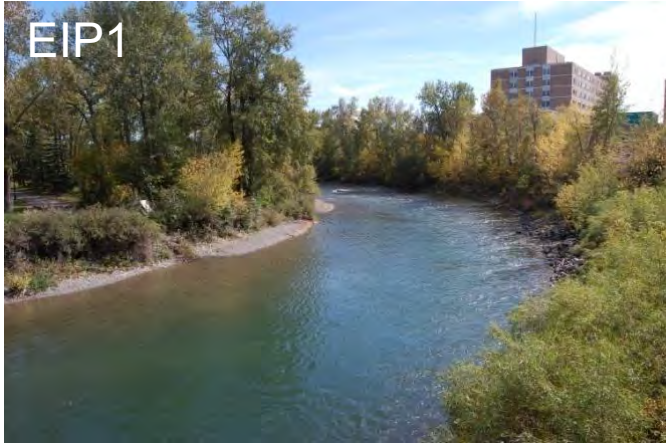
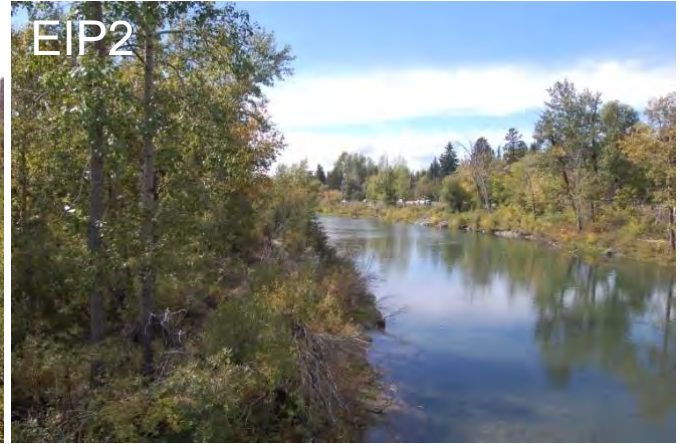
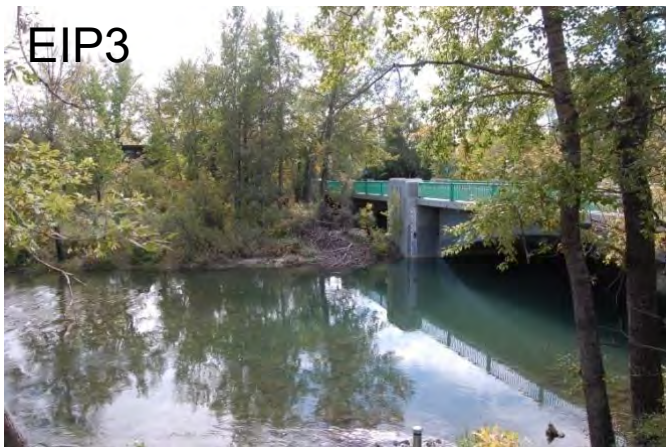
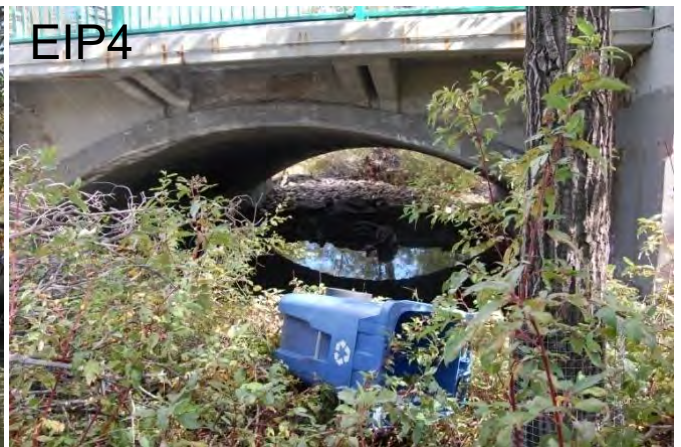
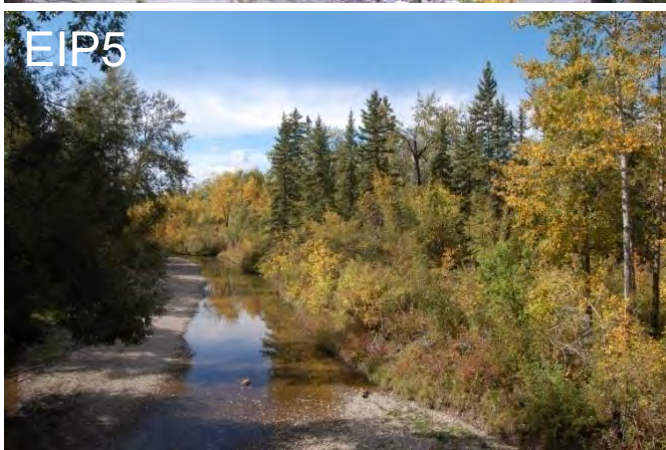
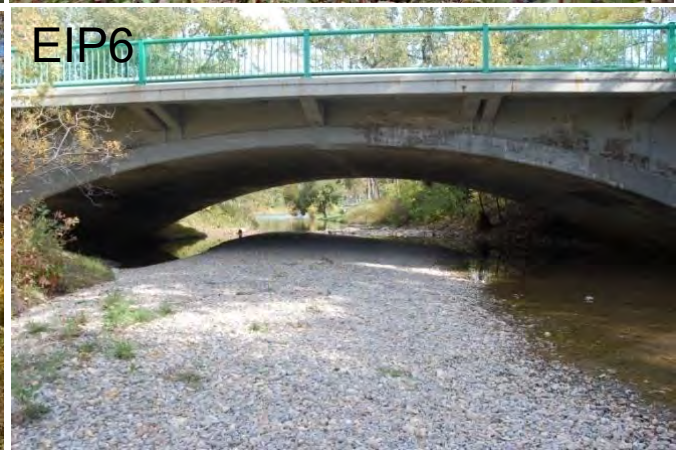
Figure 40. Ground level photographs of the Elbow Island Park (EIP) on Sept. 15, 2015.

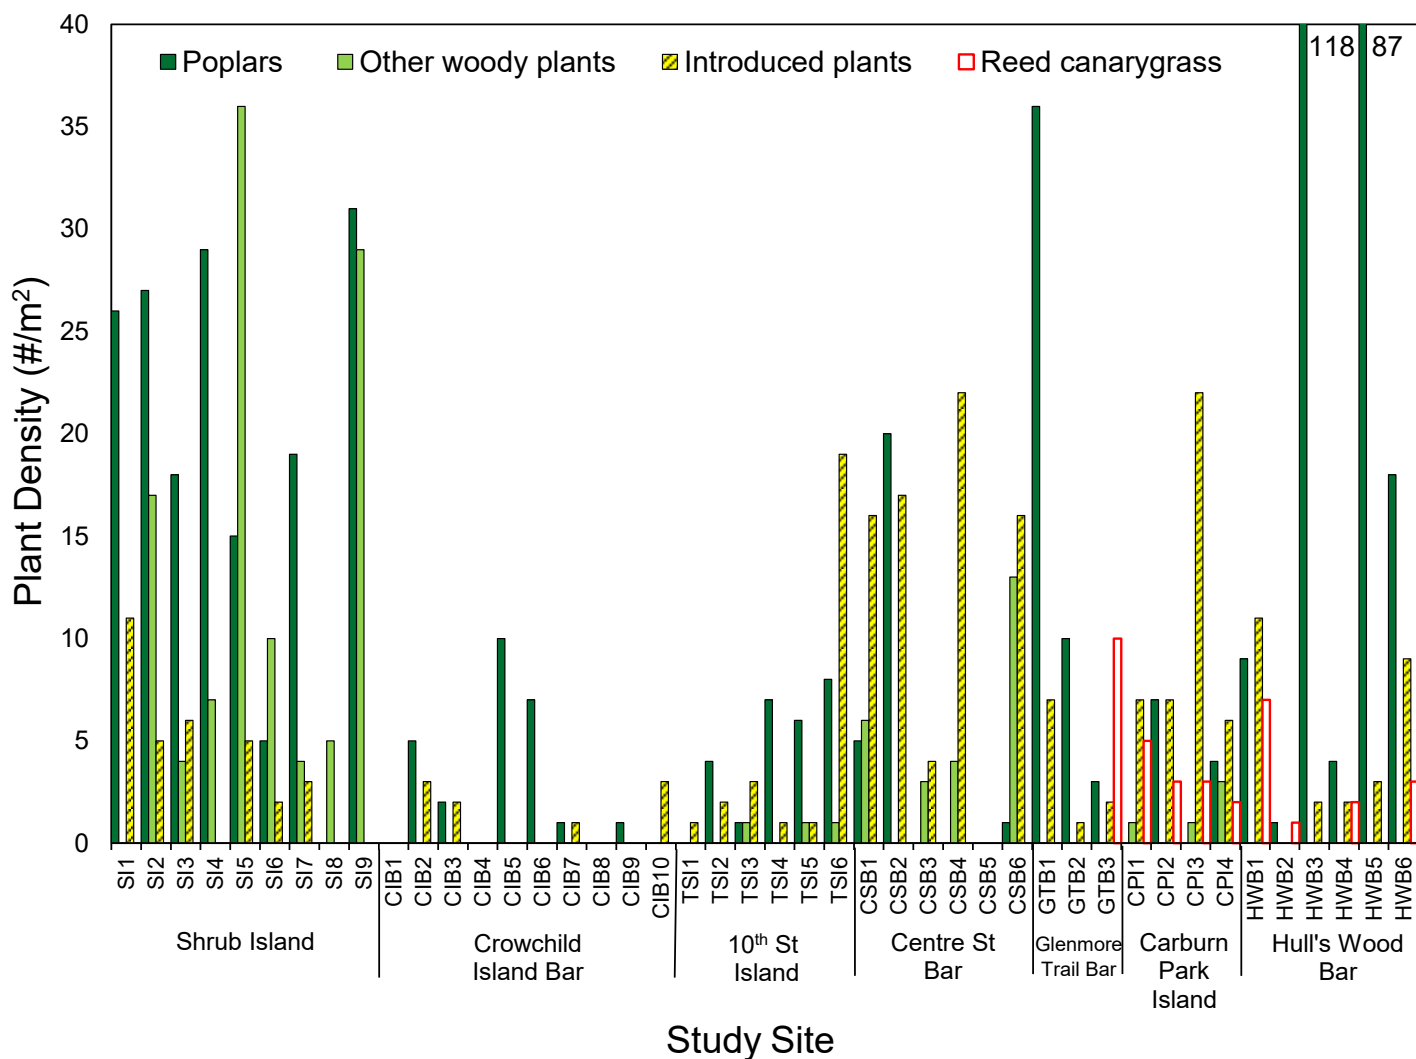
Figure 42. Poplars, woody, introduced, and reed canarygrass seedling densities in each study quadrat along the Bow River. Note that these are not equally spaced along the downstream length.

Figure 42 displays the longitudinal, or downstream pattern with the various quadrats indicated. Note that this plotting is does not represent the spatial patterning since the multiple quadrats are plotted for particular sites and the sites are not evenly distributed along the downstream profile.

As shown, the upstream sites supported primarily poplars and other woody plant seedlings. At the Centre St. Bar, there were far more herbaceous plants, including common introduced plants. We were especially interested in the balance between balsam poplars versus reed canarygrass and there was an abrupt change for the sites downstream of the Centre St. Bar. We did not observe reed canarygrass in the quadrats or elsewhere on the upstream sites, and in contrast the problem plant was abundant at the Glenmore Trail Bar, and downstream (Figure 42). By biking along the Bow River we have surveyed other sections and believe that reed canarygrass particularly joins the riparian vegetation communities with the inflow from Nose Creek. That Creek is characterized by prolific reed canarygrass along its banks and this would provide a prolific source of seeds and clonal propagules. There might also be some contribution from the Elbow River and much more contribution from Fish Creek. Thus, while we observed no reed canary grass at the upstream sites, this plant occurred in almost all vegetated quadrats at the Carburn Park Island and at the Hull's Wood Bar. As we described, it was also abundant further downstream near the Carseland Weir.

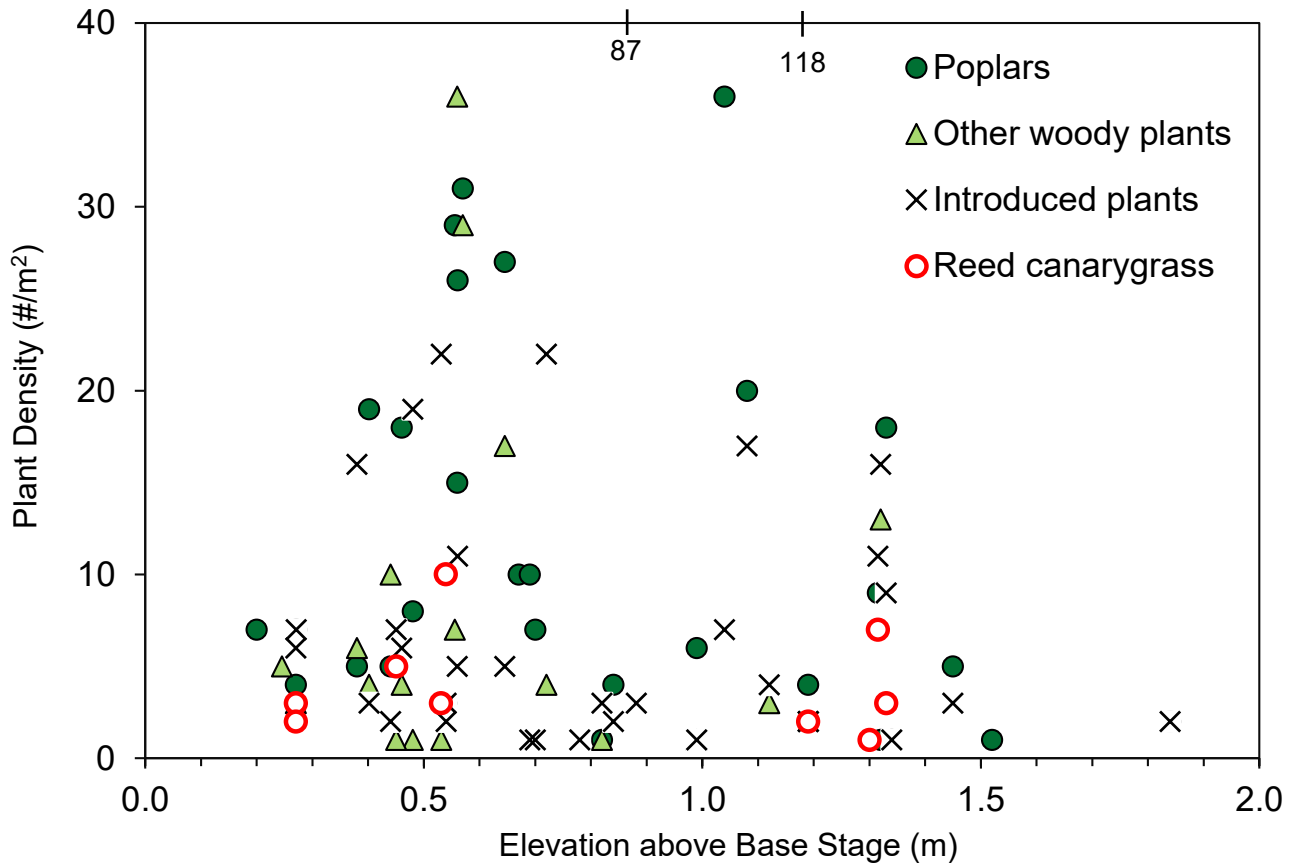
Figure 43. Densities of poplars, other woody plants, introduced plants, and reed canarygrass versus elevation above the base stage, with results by quadrat for sites along the Bow River.

Relative to the recruitment band, we expected more differentiation across the different plant types than we observed (Figure 43). This may be more readily compared with separate plots for the plants types, as indicated in Figure 44. As shown, balsam poplar seedlings occurred from 0.2 to 1.9 m above the augmented base stage, and were more abundant from ~ 0.4 to 1.3 m. Other woody plants displayed a narrower recruitment band, primarily from 0.2 to 0.7 m above the base stage. This included different species, and we might have expected this diversity to broaden the band.

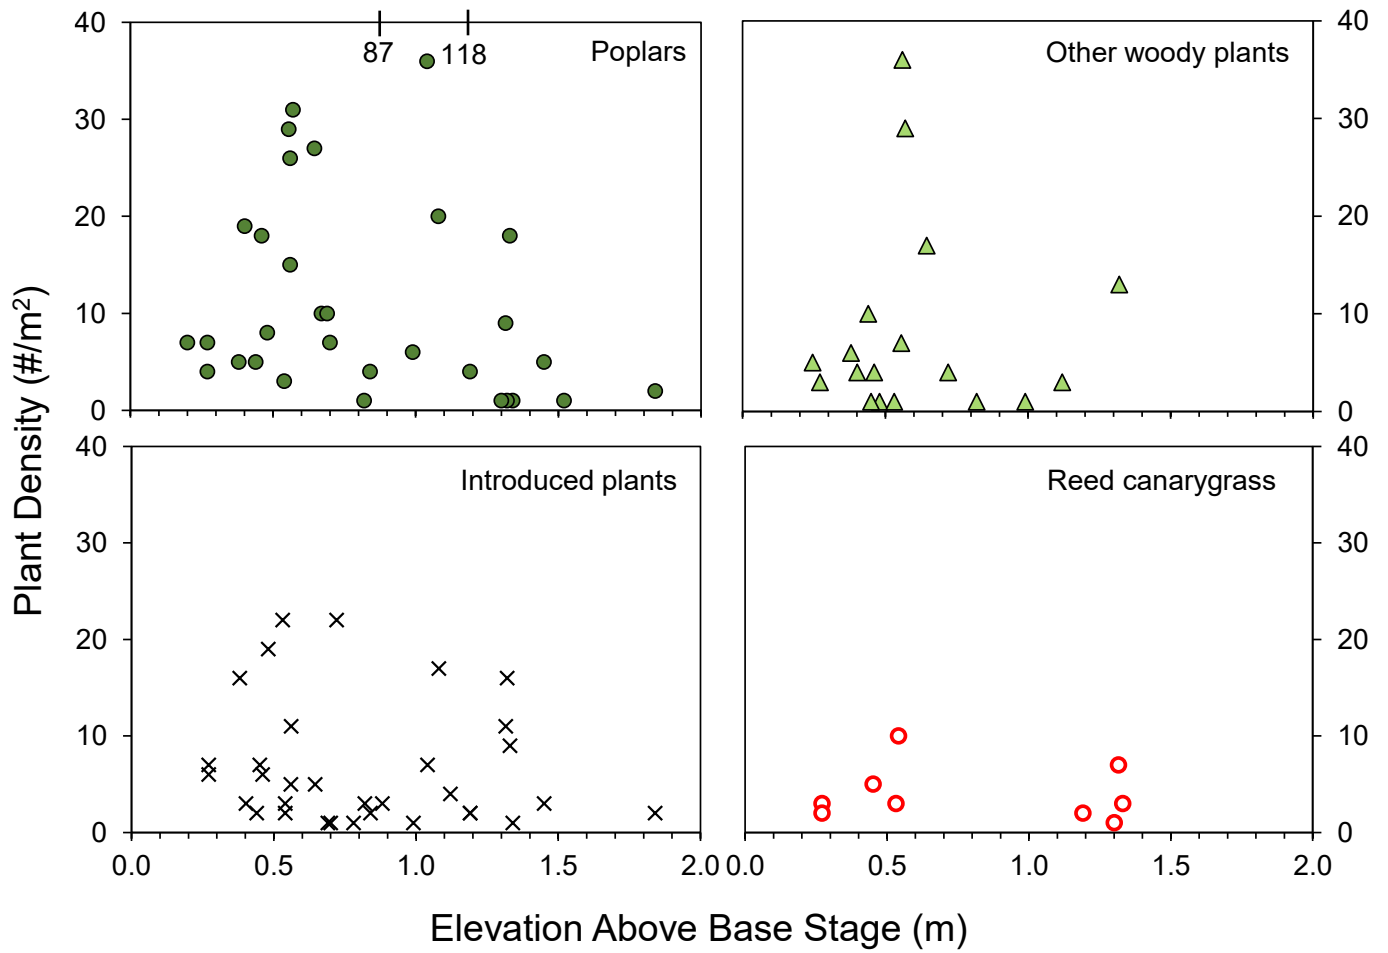
Figure 44. Densities of poplars, other woody plants, introduced plants, and reed canarygrass versus elevation above the base stage for quadrats at study sites along the Bow River.

The introduced plants are often weedy and thus ecological generalists, tolerating a broader range of physical environmental conditions. Consistent with this, these occurred across a broad elevation band, with less evidence of preferential elevation than for the other woody plants (Figure 44). This again involves a blending of different species and this would contribute to the elevational range.

We had expected that reed canarygrass might particularly colonize lower elevational surfaces. This was the case for the plants at the Carburn Park Island but the new seedlings at Hull's Wood were almost one m higher in relative elevation (Figure 44). Since reed canarygrass was only observed at the downstream sites, there was more limited sampling and conclusions about its elevational preferences are correspondingly limited. Recognizing this limitation, the overall field occurrences suggest that reed canarygrass may colonize as broad a range of elevations as balsam poplar. Conversely, there was fairly discrete banding of the lower reed canarygrass versus a broader, higher band of balsam poplars at the Glenmore Trail Bar and we observed similar differentiation at some other, non-inventoried locations.

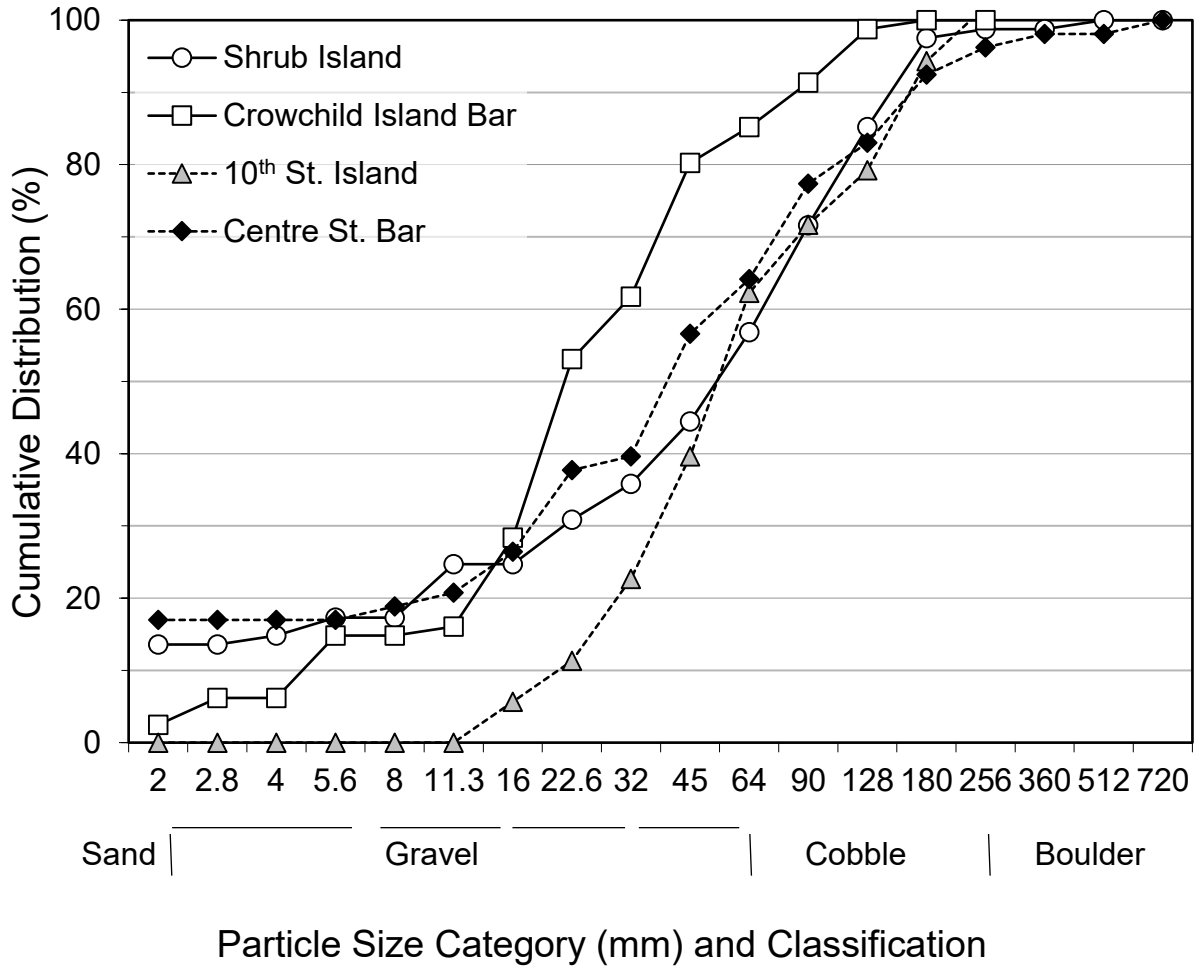
Figure 45. Distribution of sediment sizes at four study sites along the Bow River through Calgary.

Cumulative distributions of the particle sizes are plotted for four upstream sites in Figure 45. As indicated, the particle distributions were quite similar on Shrub Island and the Centre St. Bar. These had higher proportions of sands and then predominantly coarse gravels to small cobbles. The Crowchild Island Bar was more homogeneous, lacking sand and then having predominately coarse gravels. The 10<sup>th</sup> St. Island was also relatively homogeneous but with very coarse gravels to small boulders.

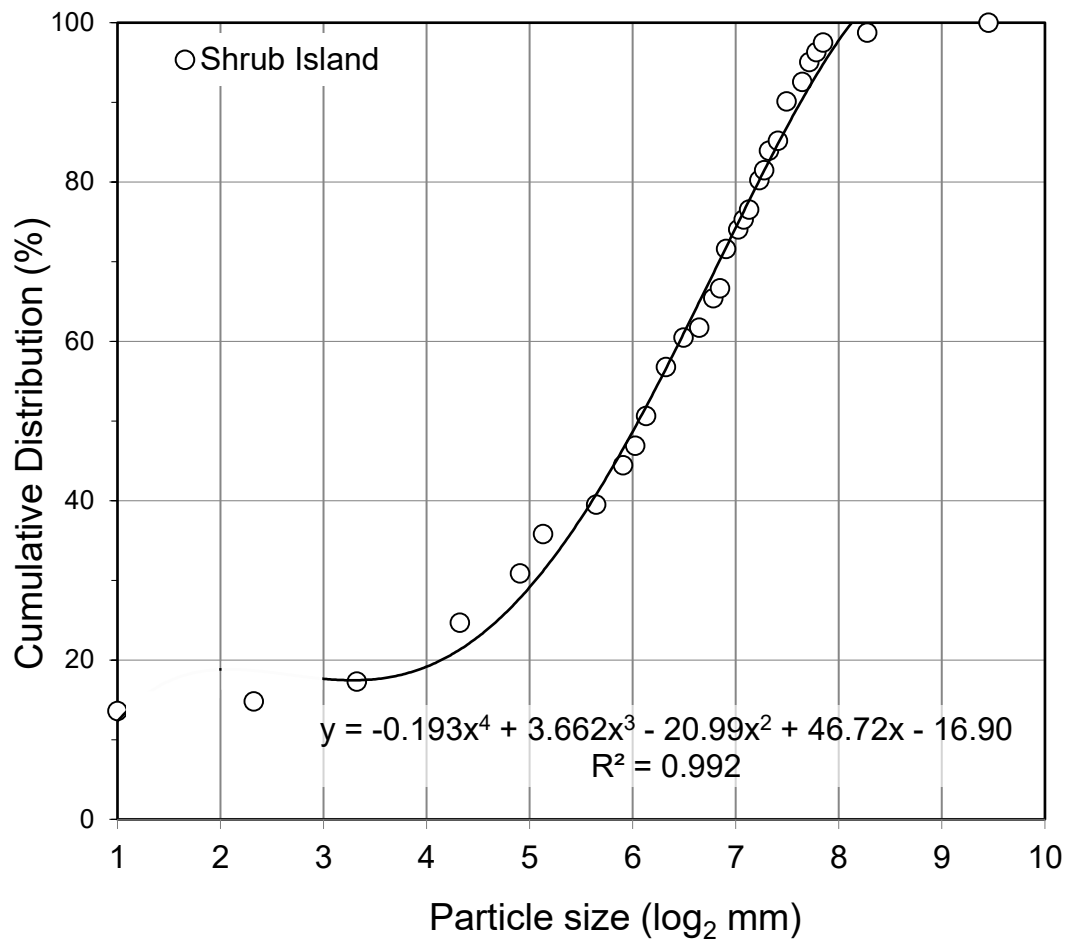
Class	log <sub>2</sub> mm	mm
D16	1.3	2.5
D25	4.7	25.8
D50	6.1	66.7
D75	7.0	130
D84	7.4	165
Heterogeneity	2.3	104

Figure 46. The cumulative distribution of sediment particle sizes at the Shrub Island study site in the Bow River, Calgary, AB.

We subsequently provided smoothed distributions fit with polynomials that allowed for the determination of the common particle size distribution thresholds (Figures 46 to 52). Note that our analysis did not involve ‘binning’, or the clustering of values with ‘larger than’ thresholds that is commonly applied to results from a gravelometer. We chose not to use that method since our initial observations indicated very coarse sediments with relatively homogeneous distributions. This reflects the extensive upstream damming and particularly the short distance below Bearspaw Dam, along with the extensive bank stabilization through this urban corridor.

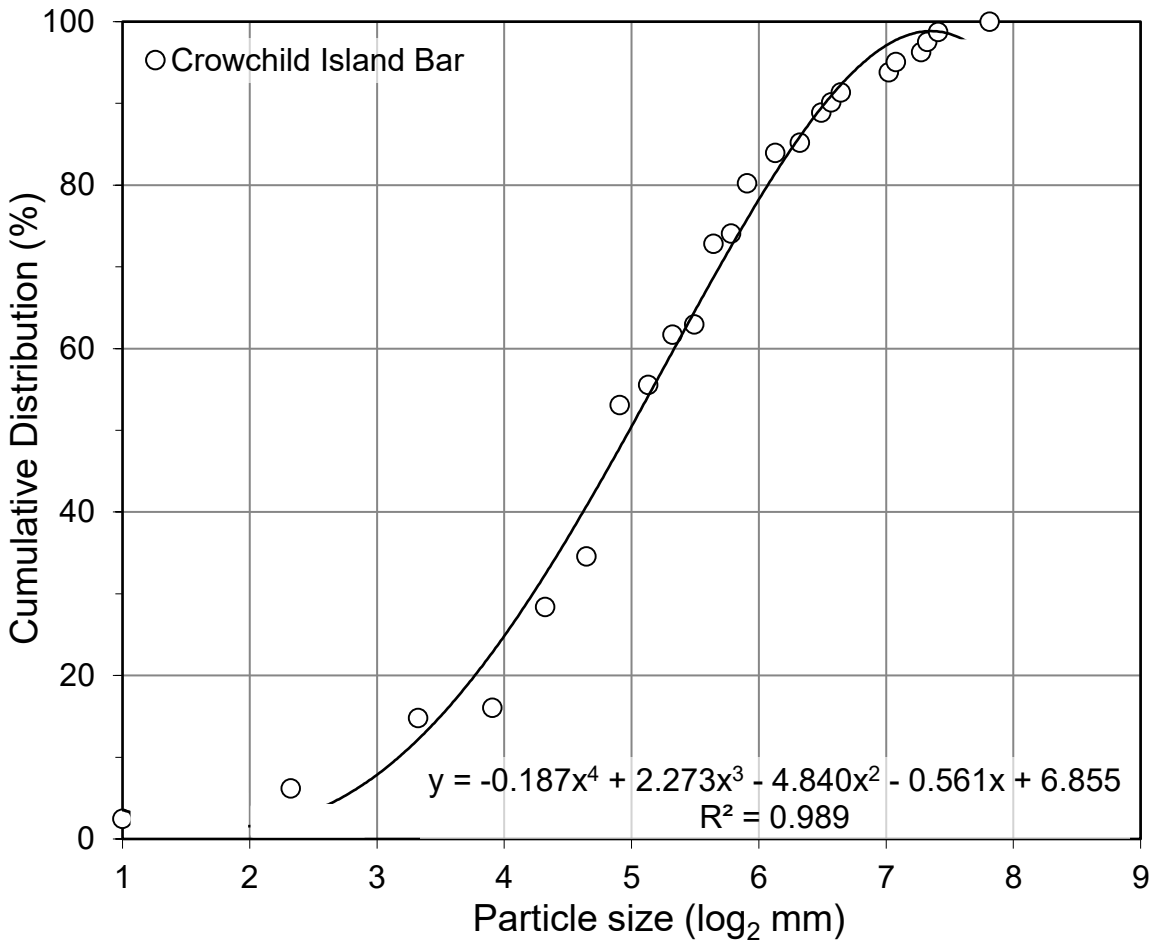
Class	log <sub>2</sub> mm	mm
D16	3.6	11.7
D25	4.0	16.0
D50	5.0	31.6
D75	5.9	58.9
D84	6.2	75.6
Heterogeneity	1.9	42.9

Figure 47. The cumulative distribution of sediment particle sizes at the Crowchild Island Bar study site along the Bow River, Calgary, AB.

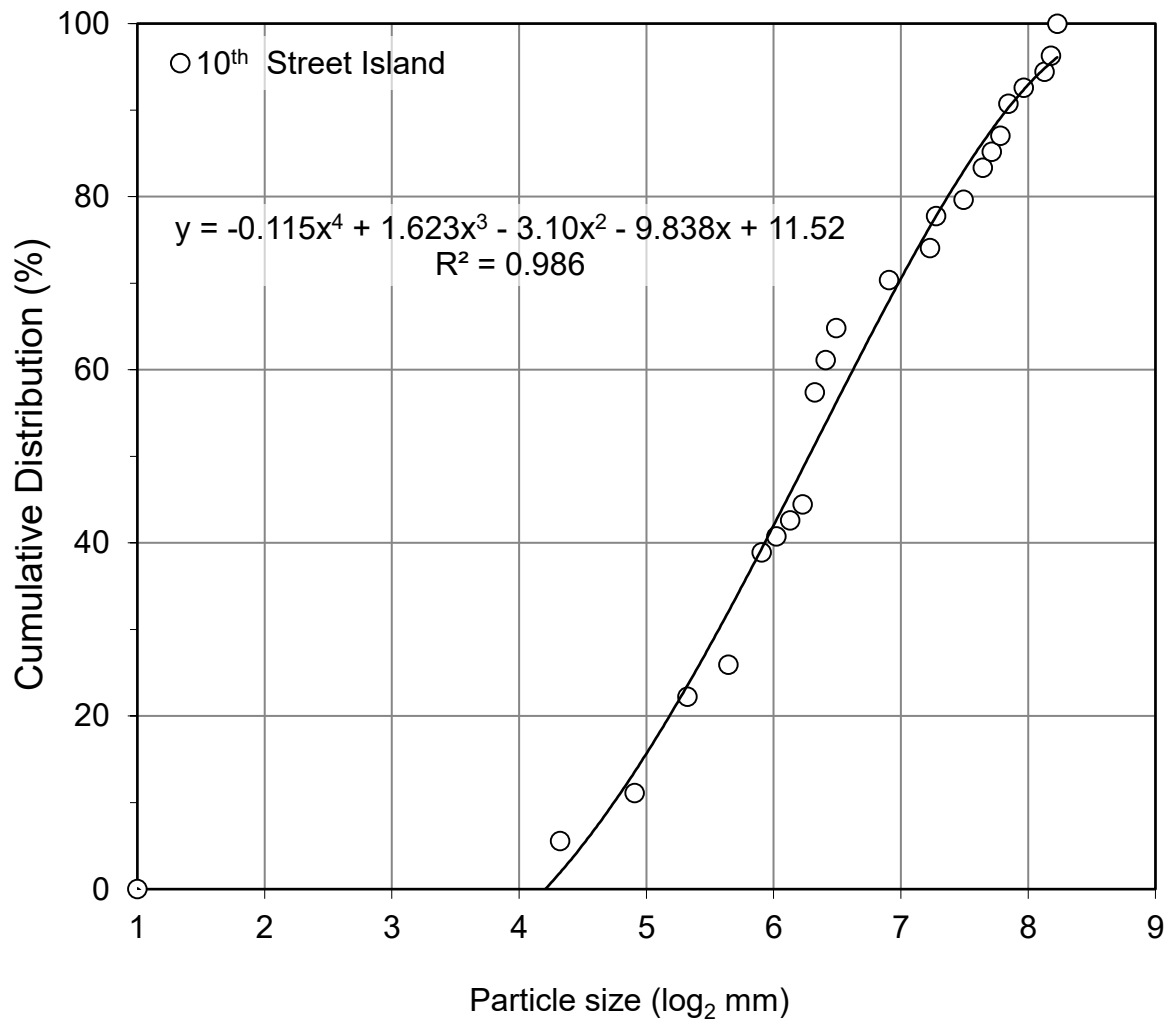
Class	$\log_2$ mm	mm
D16	5.0	32.2
D25	5.3	40.5
D50	6.3	77.7
D75	7.2	144
D84	7.5	186
Heterogeneity	1.8	104

Figure 48. The cumulative distribution of sediment particle sizes at the 10<sup>th</sup> Street Island study site in the Bow River, Calgary, AB.

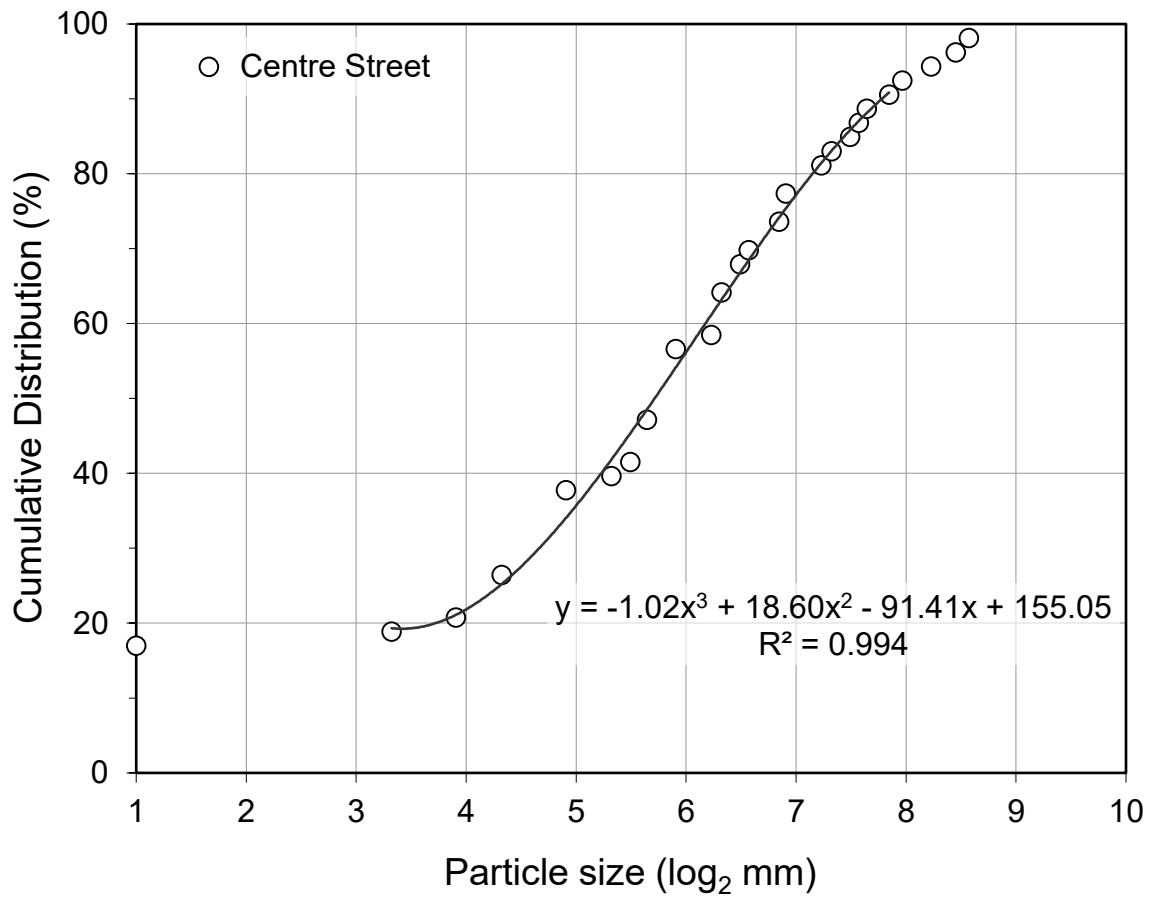
Category	log <sub>2</sub> mm	mm
D16	1.0	< 2.0
D25	4.31	19.8
D50	5.71	52.3
D75	6.89	119
D84	7.38	167
Heterogeneity	2.58	98.8

Figure 49. The cumulative distribution of sediment particle sizes at the Centre Street Bar study site along the Bow River, Calgary, AB.
