# Analyzing and Projecting Post-Flood Vegetation Colonization along the Bow River through Calgary, Alberta

Stewart B. Rood, Soba Kaluthota, Laurens J. Philipsen and Karen P. Zanewich  
Chinook Environmental Resources, RR9 Site 1 Box 1, Lethbridge, AB T1J 4R9, and  
Environmental Science Program, University of Lethbridge, AB

This report was undertaken as part of the *Calgary Rivers Morphology and Fish Habitat Study*, sponsored by the City of Calgary and led by Klohn Crippen Berger; and the Alberta Environment and Parks Watershed Resiliency and Restoration Program project, *Post-Flood River Regulation for Riparian Enhancement*.

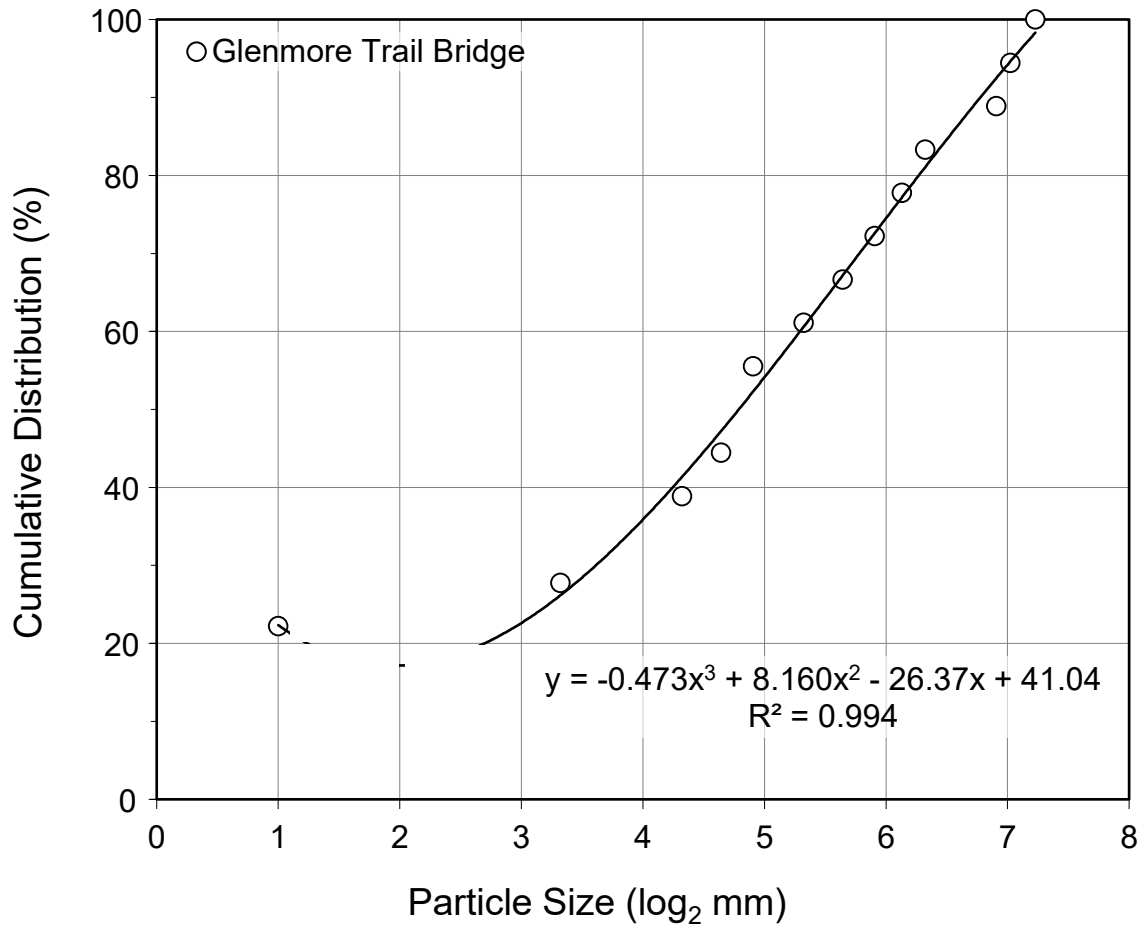
Category	log <sub>2</sub> mm	mm
D16	1.0	2.0
D25	3.2	9.3
D50	4.8	27.7
D75	6.1	66.3
D84	6.5	91.8
Heterogeneity	2.8	56.9

Figure 50. The cumulative distribution of sediment particle sizes at the Glenmore Trail Bridge study site on the Bow River, Calgary, AB.

We subsequently provided smoothed distributions fit with polynomials that allowed for the determination of the common particle size distribution thresholds (Figures 46 to 52). Note that our analysis did not involve ‘binning’, or the clustering of values with ‘larger than’ thresholds that is commonly applied to results from a gravelometer. We chose not to use that method since our initial observations indicated very coarse sediments with relatively homogeneous distributions. This reflects the extensive upstream damming and particularly the short distance below Bearspaw Dam, along with the extensive bank stabilization through this urban corridor.

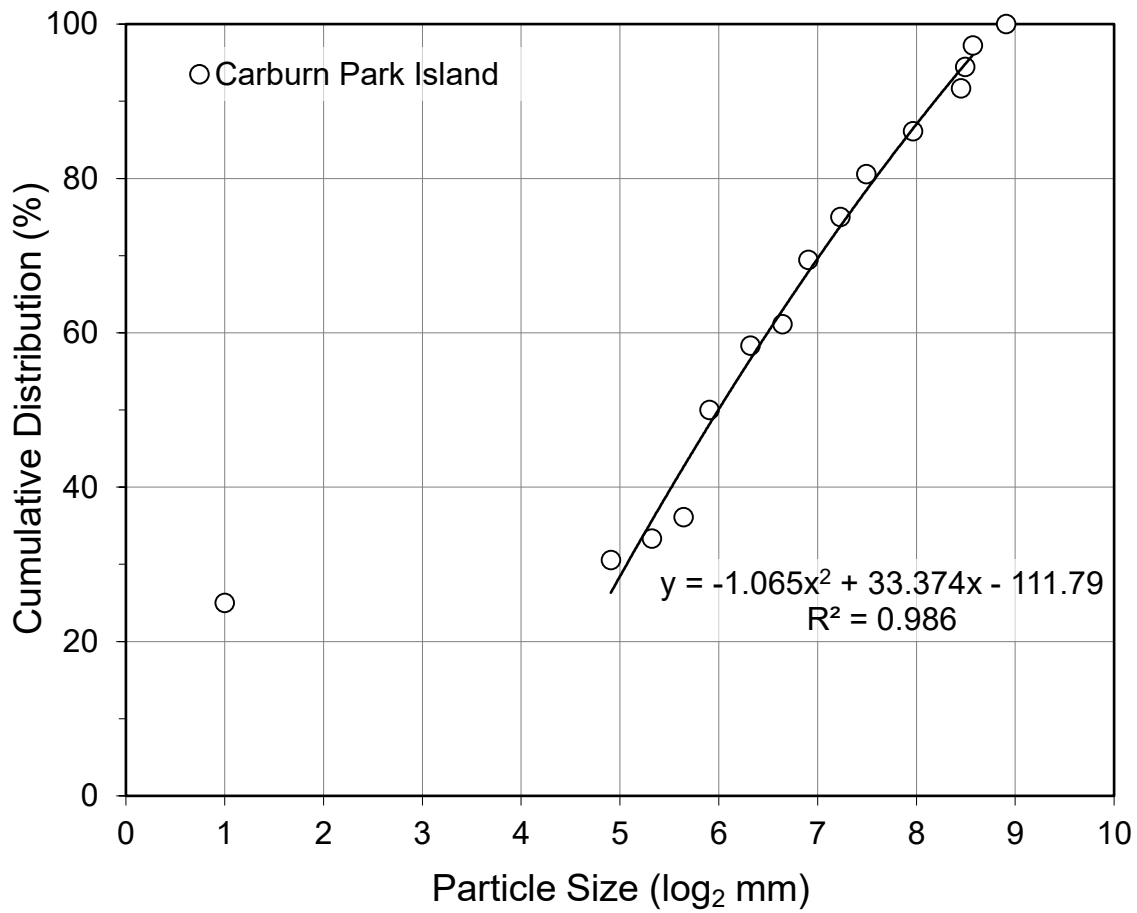
Category	log <sub>2</sub> mm	mm
D16	1.0	2.0
D25	4.9	28.8
D50	6.0	63.6
D75	7.3	158
D84	7.9	236
Heterogeneity	2.5	129

Figure 51. The cumulative distribution of sediment particle sizes at the Carburn Park Island study site on the Bow River, Calgary, AB.

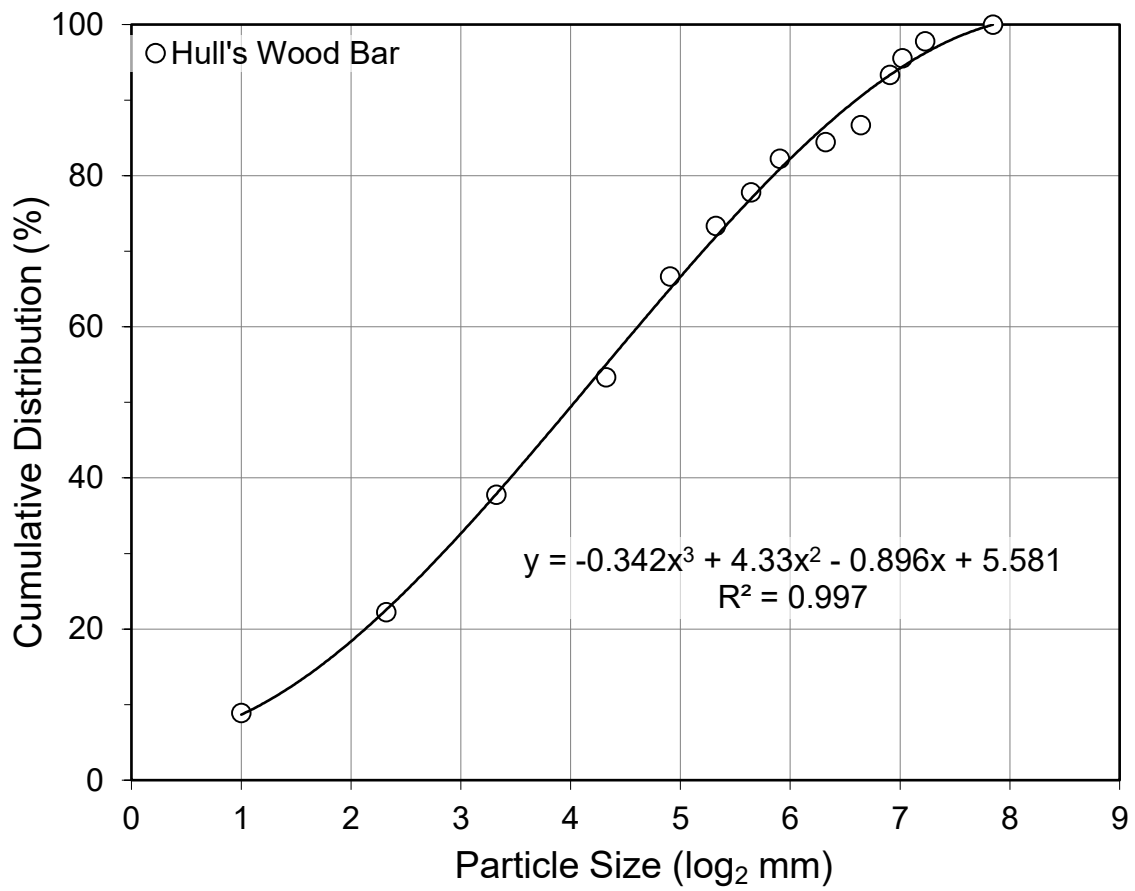
Category	log <sub>2</sub> mm	mm
D16	1.8	3.5
D25	2.5	5.7
D50	4.0	16.4
D75	5.5	45.9
D84	6.1	69.6
Heterogeneity	3.0	40.2

Figure 52. The cumulative distribution of the sediment particle size at the Hull's Wood Bar study site on the Bow River, Calgary, AB.

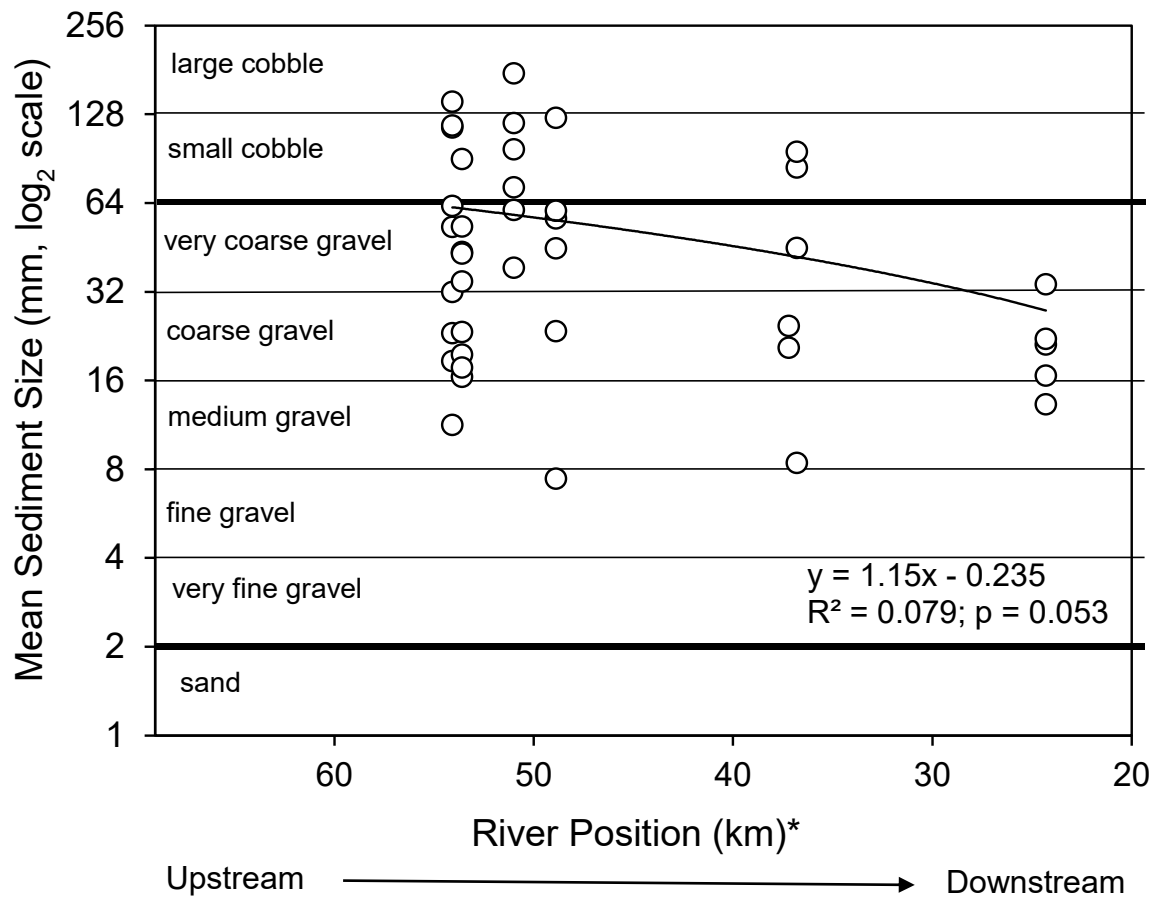
\* River position was measured upstream from the Highwood inflow.

Figure 53. Distribution of sediment particle sizes along the Bow River from upstream to downstream. These are derived means, with log<sub>2</sub> transformations, averaging and then back conversion (2<sup>n</sup>).

Along the Bow River through Calgary, the surface sediment textures become progressively finer downstream (Figure 53). Figure 53 provides the derived mean sediment particle sizes, with averaging of the  $\log_2$  values, to account for the exponential variation and to lessen the influence of very large particles. This plot also displays the substantial variation across the different quadrats at particular sites.

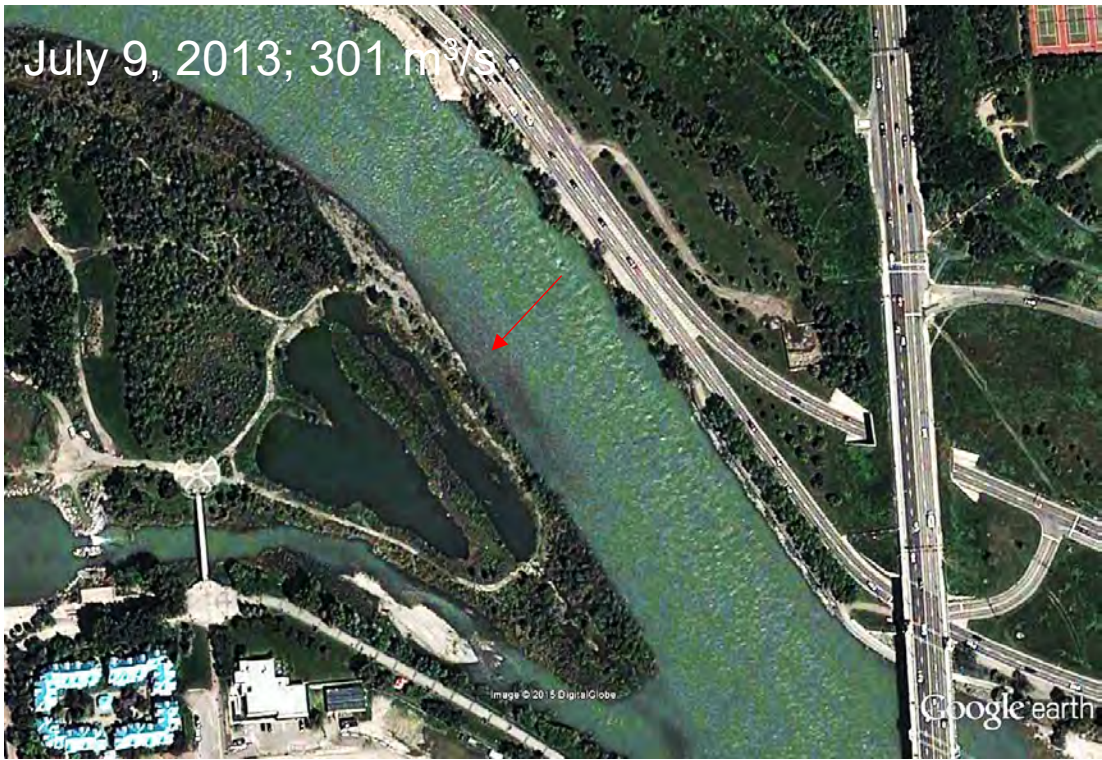
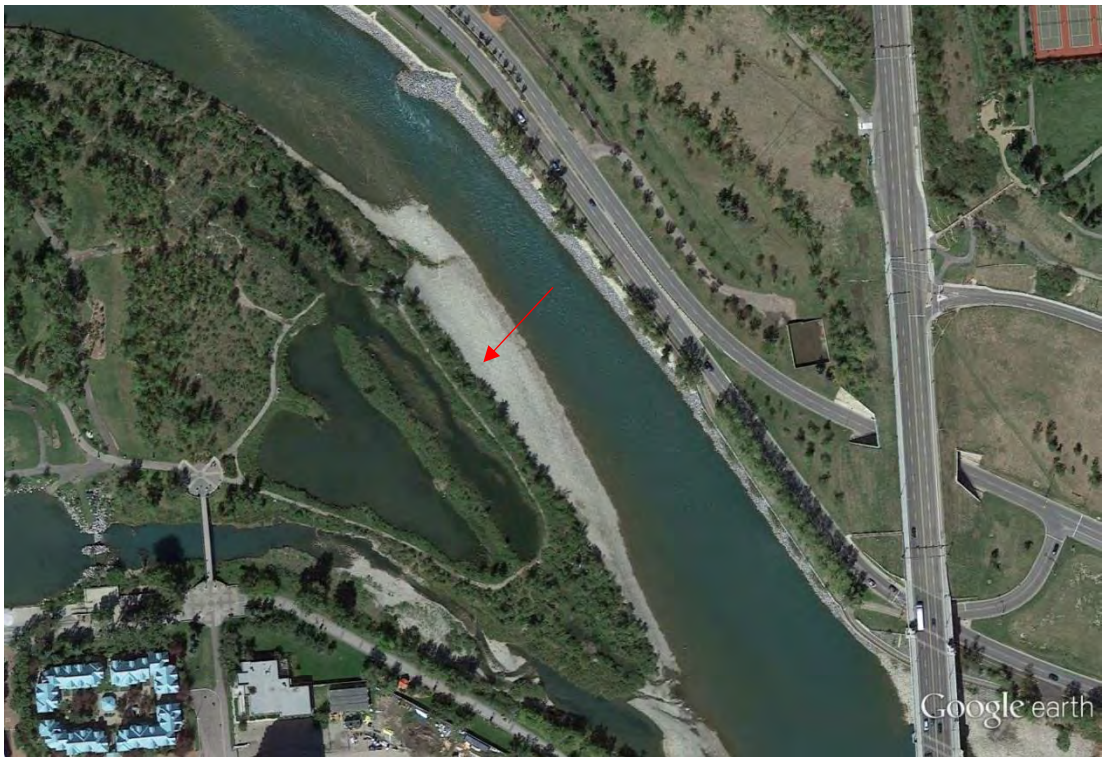
Figure 56. Aerial photographs of the zone displayed in the Figure 54 photograph, illustrating the transition from the barren gravel bar to the band of perennial riparian vegetation. The red arrows indicate the direction of the ground level photo. The upper photo displays the river inundation at around the  $Q_2$ , or average annual peak discharge, supporting the association between this and the Ordinary High Water Line (OHWL).

However, that location represents a somewhat unusual position, with a well-defined channel and extensive armouring along the river left bank, which would alter the river characteristics (Figure 56). That transition from the barren gravel bar to the dense riparian vegetation involves a slight step and it is very probably the combination of inundation pattern and shear stress, the erosive force corresponding with flow velocity, which normally defines the riparian transition (Benjankar et al. 2015). In zones with more complex surfaces, the transition is less abrupt, as displayed at the longer-term study site of the Point McKay Bar (Figure 57). In that location, some willows are inundated at discharges lower than the  $Q_2$ , as illustrated in Figure 57 (top), with a discharge of  $\sim 250 \text{ m}^3/\text{s}$ . That observation is confirmed by the study of Amlin and Rood (2001), with some positions with sandbar willow that inundated in most years and often for extended intervals (Figure 57, bottom). Thus, the OHWL provides a useful reference but with more complex, shallow riparian surfaces, the transition from barren zones to perennial vegetation is less abrupt than occurring as a sharp transition at the shoreline position corresponding to the  $Q_2$  peak stage.

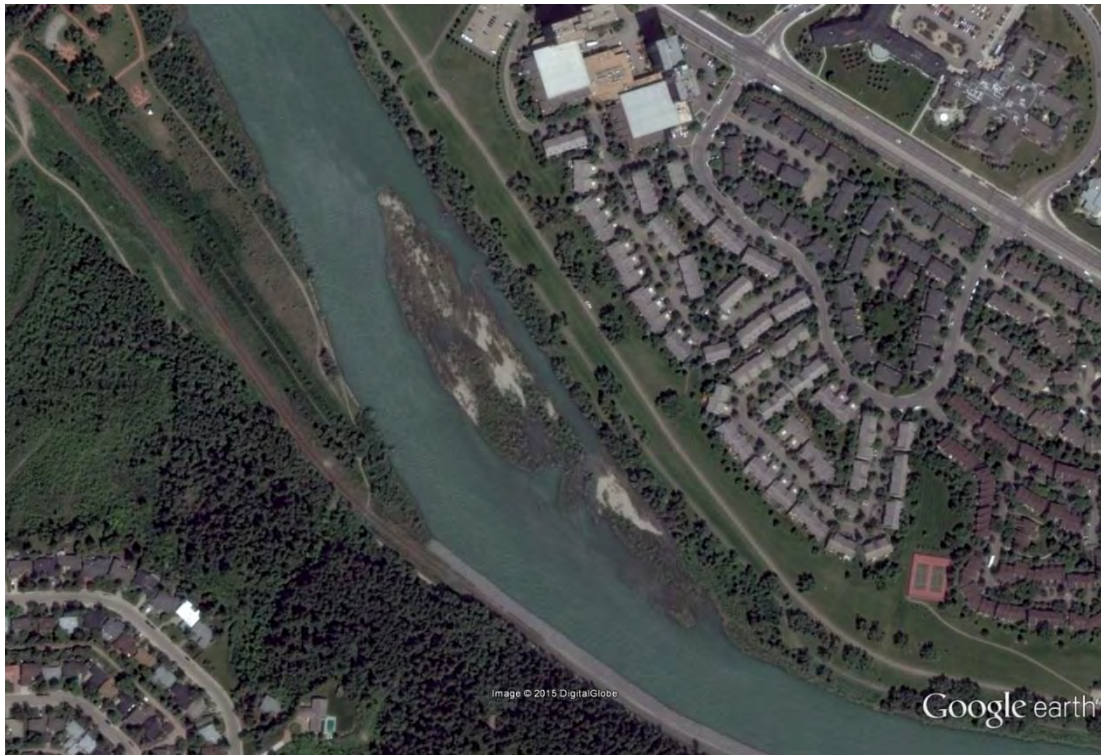
Figure 57. (Top) An aerial photograph of the Point McKay Bar, July 1, 2014, with a Bow River discharge of  $254 \text{ m}^3/\text{s}$ , somewhat below the  $Q_2$  recurrence. Some zones with willows and especially sandbar willows were inundated at this flow. (Bottom) Sandbar willows in the Point McKay Bar, May 28, 2001, inundated with a discharge of only  $114 \text{ m}^3/\text{s}$ . Some plants are cloaked with debris from recently higher flows. With a low-flow interval there was probably downward expansion of these willows.

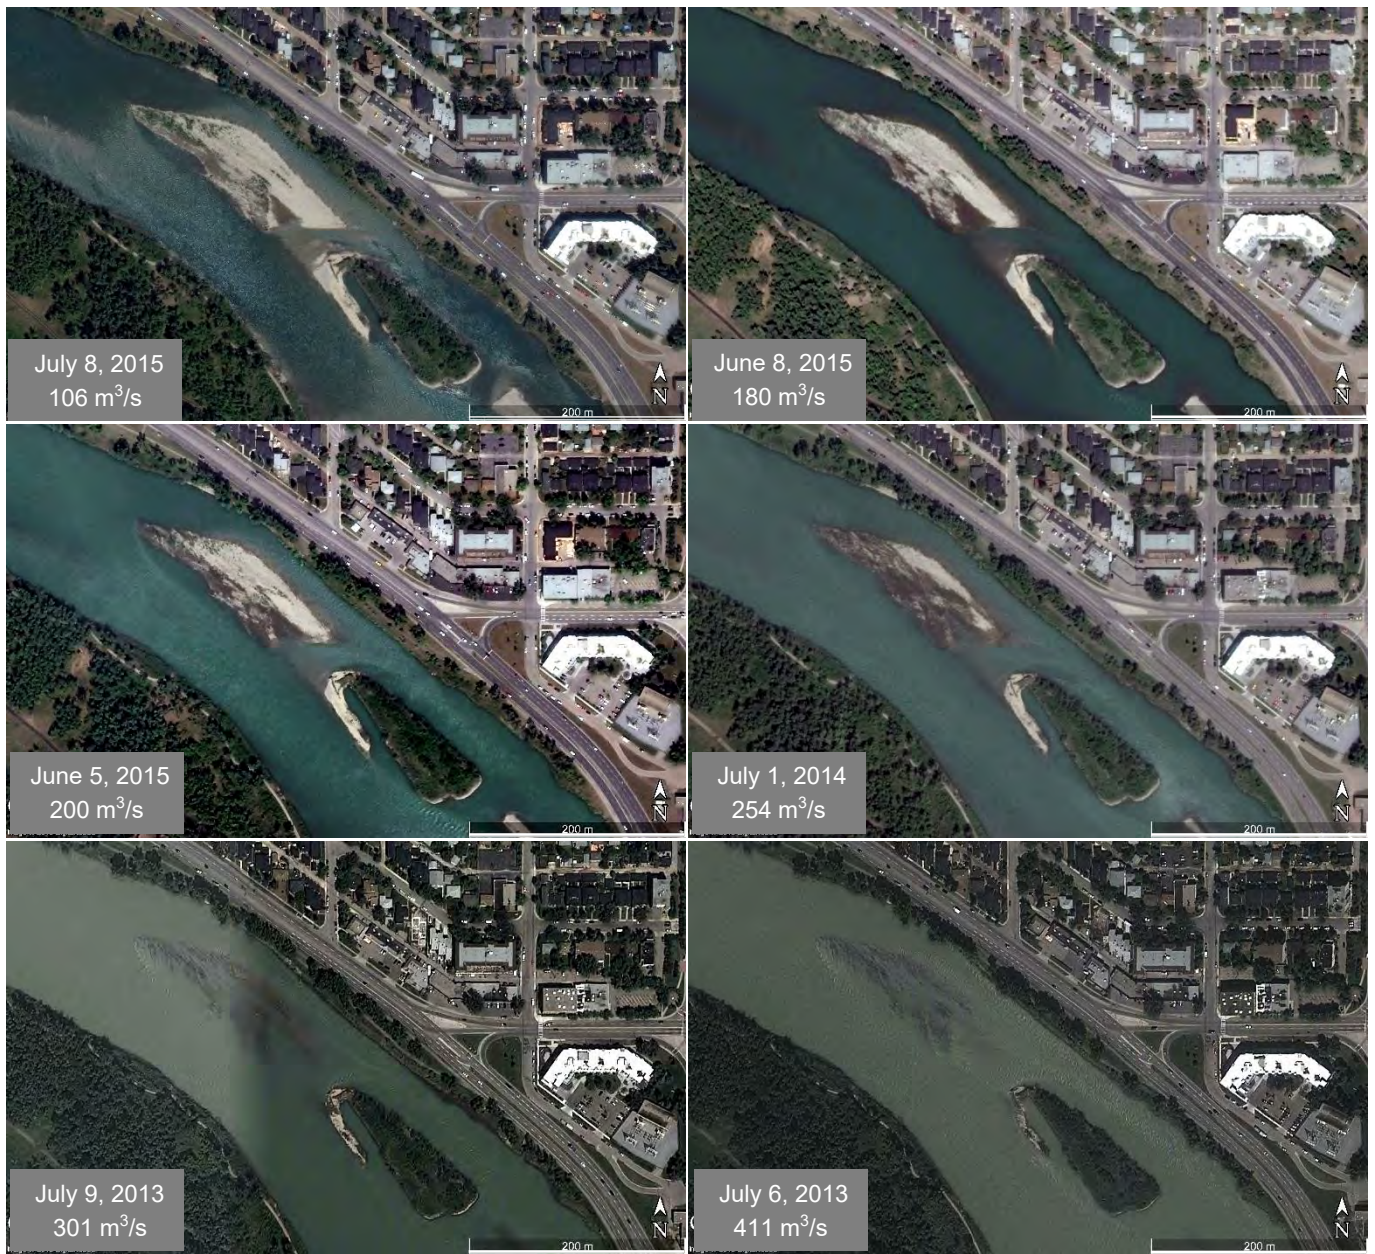
Scale: 200 m

Figure 59. Post-flood aerial photographs of Shrub Island and Wooded Island displaying the inundations at different river discharges that were used to project vegetation colonization patterns.

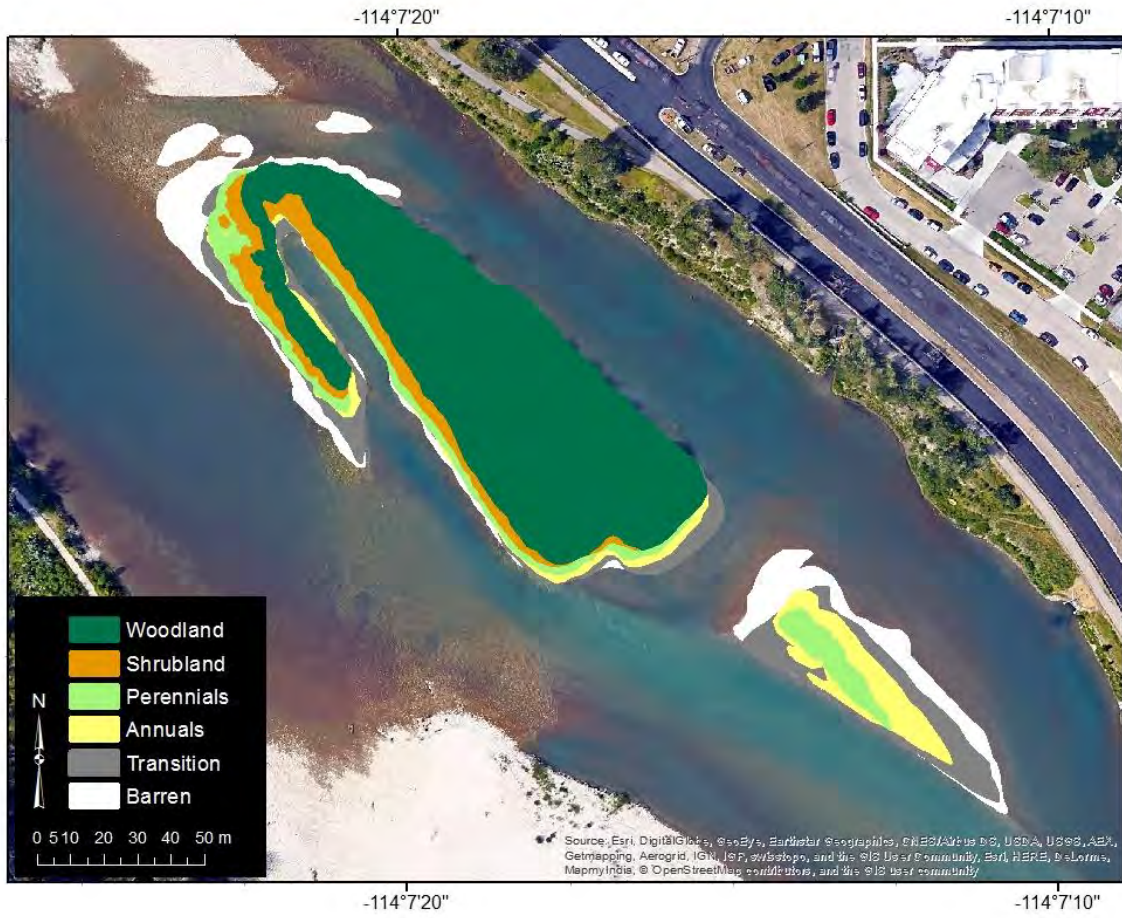
Figure 60. 'Camo-map' showing projected riparian vegetation types on the Wooded Island.

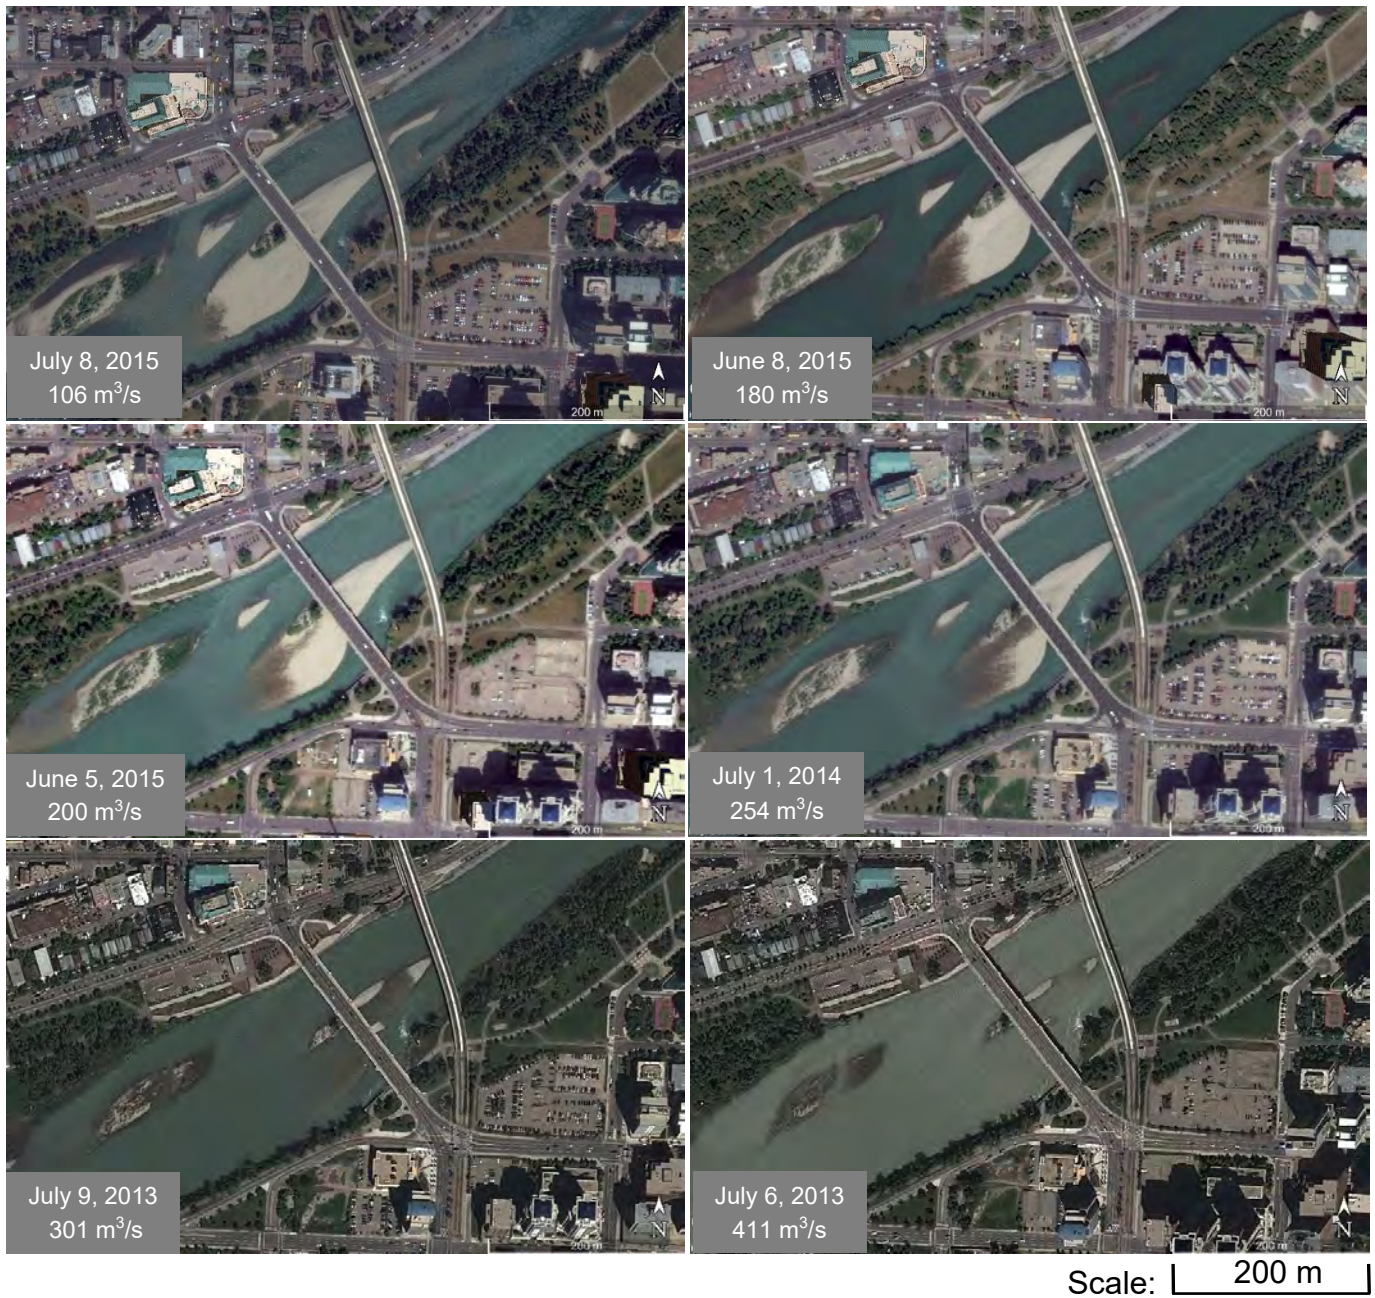
Figure 63. Post-flood aerial photographs of the 10<sup>th</sup> St. Island displaying the inundations at different river discharges that were used to project vegetation colonization patterns.

The 10<sup>th</sup> St. Island was particularly identified as a location of concern, as we described in our prior consideration of the island development and vegetation colonization. Following from those observations we applied the inundation thresholds of Table 20 and considered the historic inundation patterns (Figure 60). Our subsequent projection indicates that there will be substantial woodland and shrubland development on this elevated and expanded island (Figure 61). An elongated woodland patch existed upstream of the bridge pillar at the left (north) edge of the island prior to 2013 flood (Figure 21). That patch persisted through the 2013 flood although it was thinned and an extension downstream of the pillar was substantially scoured (Figure 22). This island was substantially elevated and expanded by the flood and we observed substantial colonization by poplar seedlings, and by some other riparian plants (Tables 7 and 8). This new colonization supports the projection based on elevations and inundation and we thus strongly predict substantial expansion of perennial cover, which would also stabilize the island.

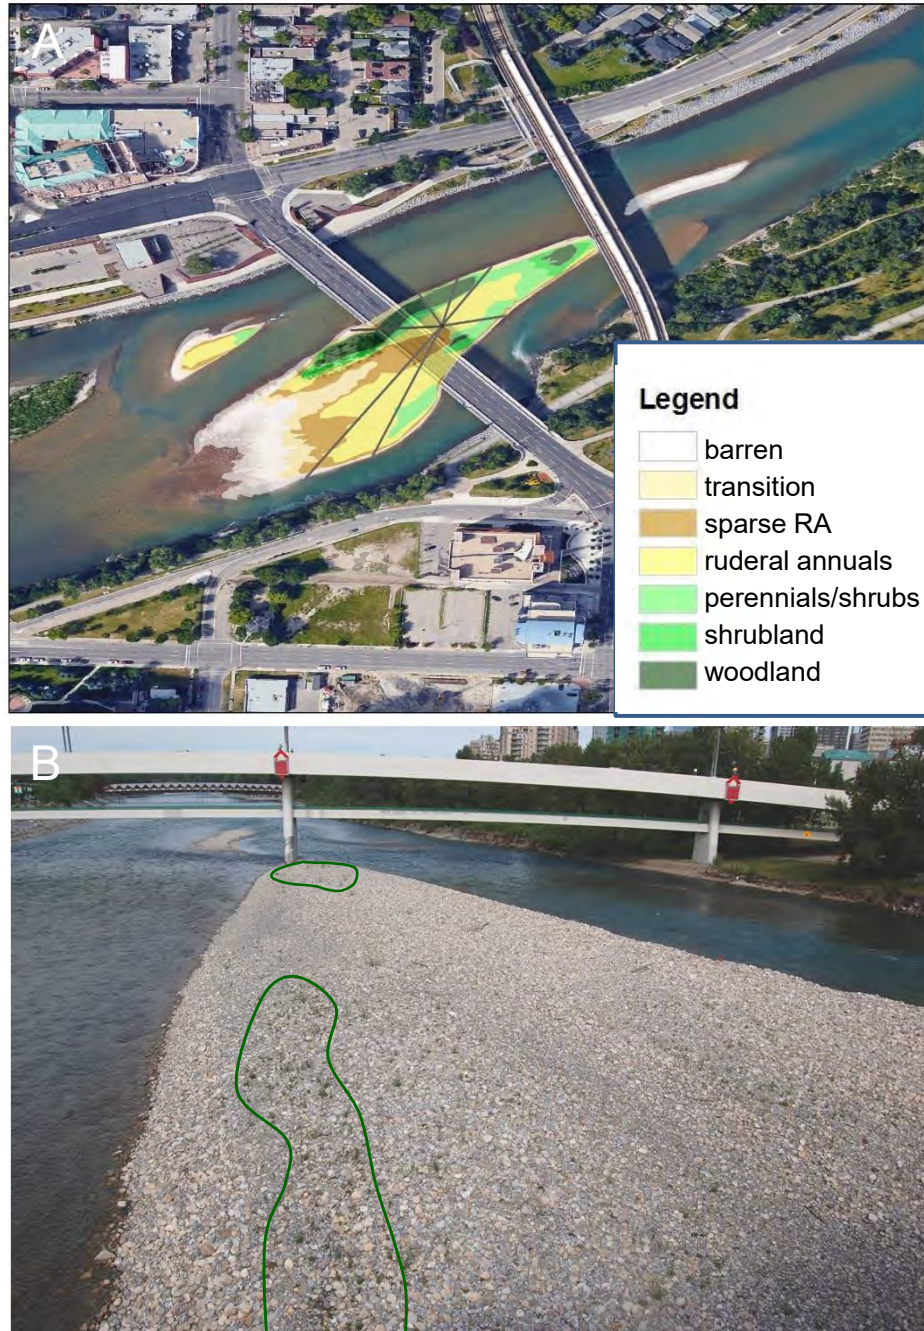
Figure 65. (A) An alternate ‘camo-map, from that of Figure 61, showing projected riparian vegetation types when 10<sup>th</sup> St. Bridge is visible. (B) Poplar seedlings are established in the woodland patch.

We anticipate at least two woodland patches, with one extending from the pre-flood patch and another small poplar grove adjacent to the LRT bridge (Figure 61). We also expect some woodland development on the river-right edge of the island downstream from another bridge pillar. Based on the elevations and inundation, there would subsequently be a large U-shaped patch of perennial vegetation, which would likely include extensive shrubs. We had also undertaken a map projection with slightly different inundation thresholds and this would also anticipate a U-shaped patch of perennial vegetation but, based on elevations alone, projected only annuals colonizing the mid-island zone within the 'U' (Figure 62). We observed the island in July, August and September and we have observed some poplar seedlings within this central zone. We consequently favor the projection in Figure 61 and anticipate that flow-exposure as well as elevation and inundation will be important. While the island zone within the U is inundated by moderate flows, as the woodland and shrubland of the U advance, this vegetation will block the flow, creating slack-water conditions within the U and avoiding the sheer stress that can limit riparian vegetation colonization and survival (Benjankar et al. 2014).

With the woodland zones along the island fringe, the whole lower portion of the island would be somewhat stabilized and there could be some further sediment trapping, which would also increase favorability for further vegetation colonization. Thus, while the camo-map provides a projection of the condition in one or two decades, it may be likely that with a longer interval the whole island would be colonized by woodland and would subsequently somewhat resemble the Elbow Park Island at the Mission of 4<sup>th</sup> St. Bridge over the Elbow River (Figure 39). There are five arched spans below the 10<sup>th</sup> St. Bridge and woodland colonization of the island could substantially impede flow conveyance through two of these. As is likely the case with the Mission Bridge, this could subsequently elevate river stages and increase the prospect for overbank flooding.

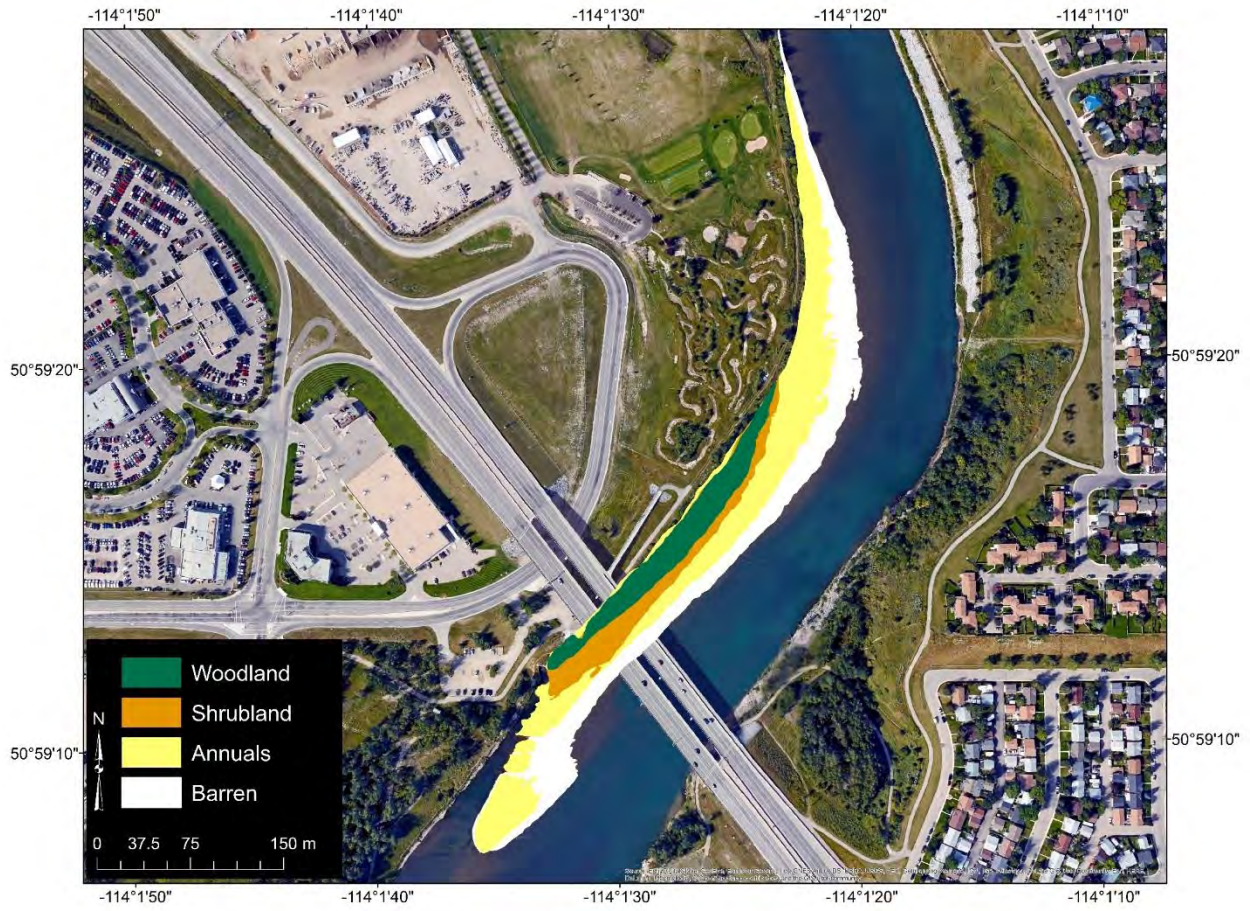
Figure 68. 'Camo-map' showing projected riparian vegetation types on the Shrub Island.

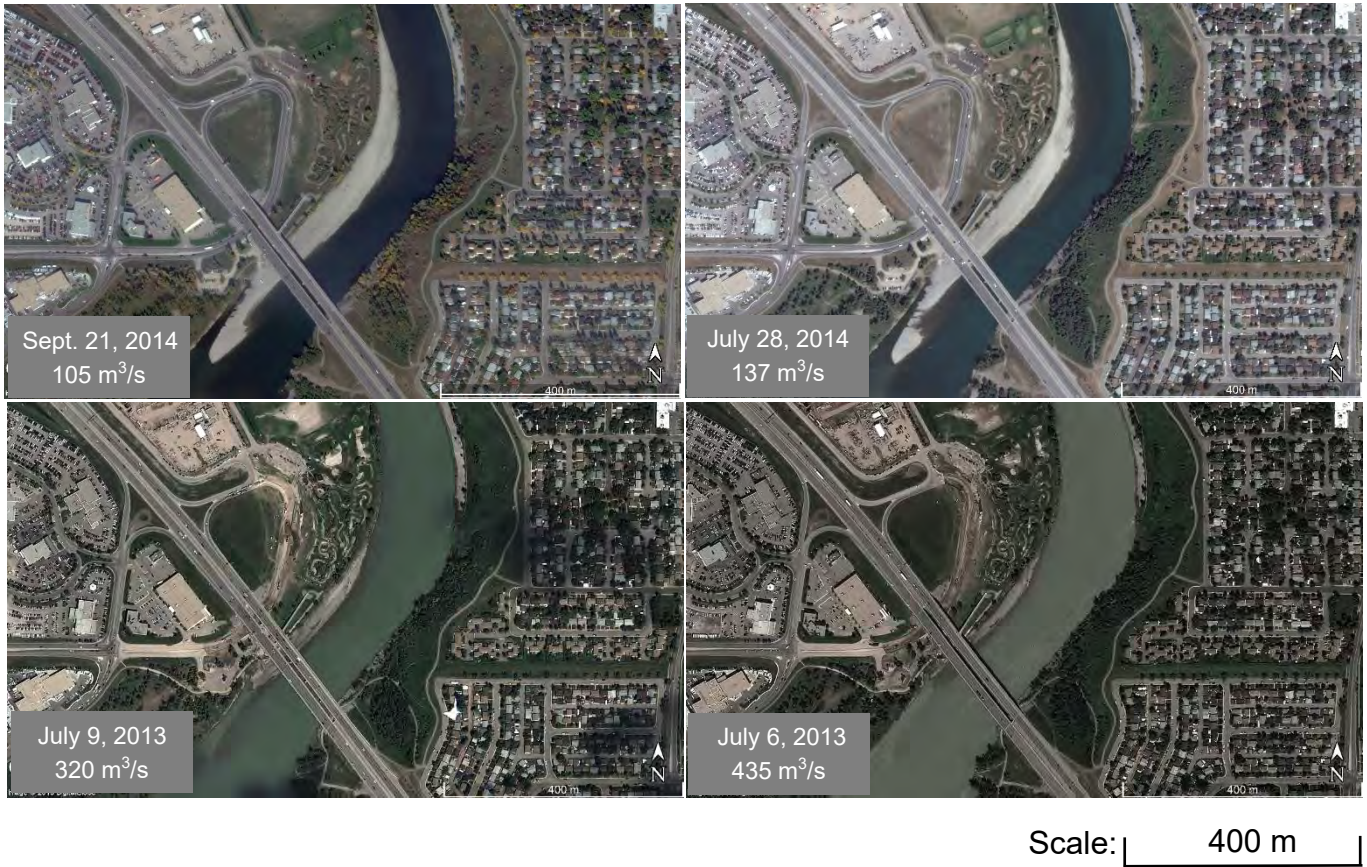
Figure 69. Post-flood aerial photographs of Glenmore Trail Bar, displaying the inundations at different river discharges that were used to project vegetation colonization patterns.

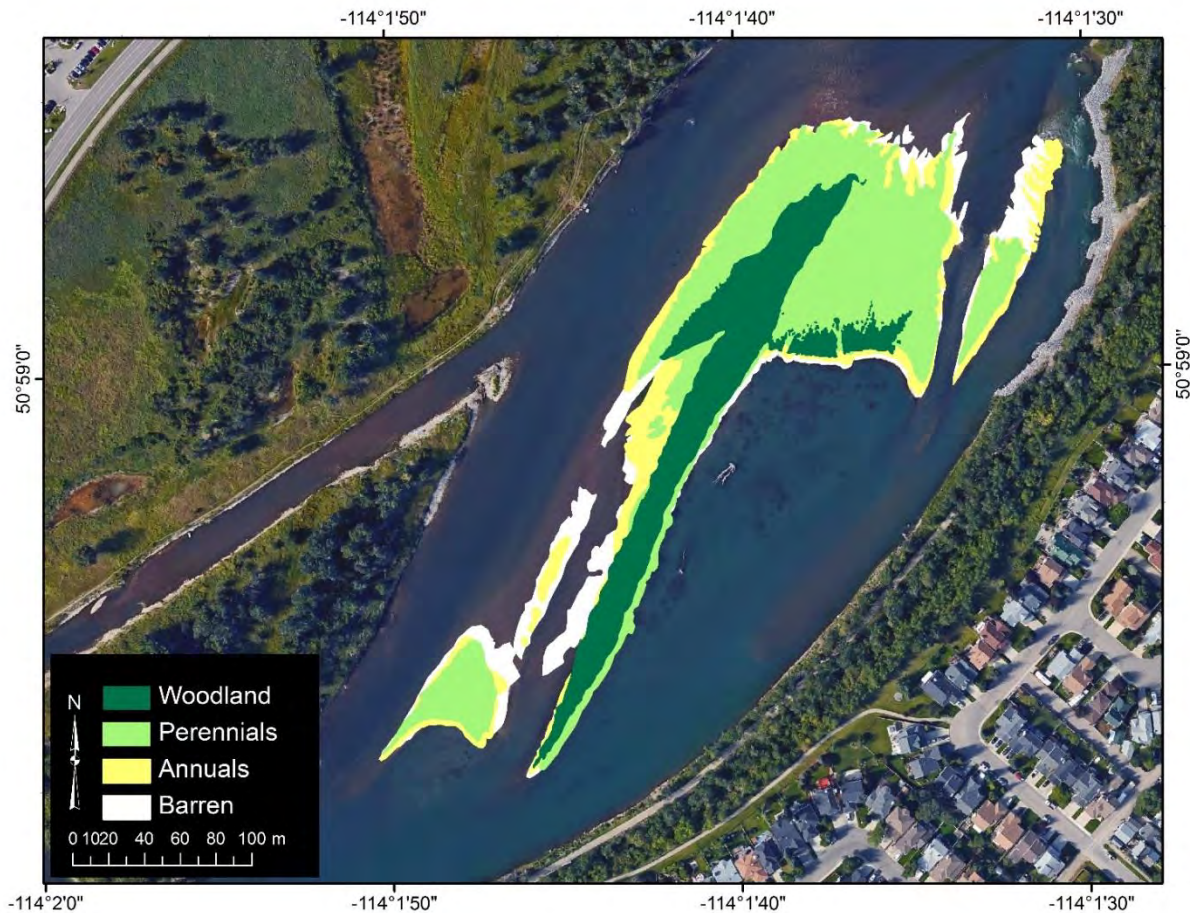
Figure 70. 'Camo-map' showing projected riparian vegetation types on the Carburn Park Island.

The Carburn Park Island provided another position of major interest, but with somewhat different considerations than those at the three upstream sites that were modeled. The Carburn Park Island is an unusual site that follows from the artificial excavations that provided the prior pools that were captured by the 2013 flood. An elongated woodland patch persists from prior to the 2013 flood and this feature involves a substantial elevational step above the other surfaces of the island; we anticipate that the woodland ridge will persist (Figure 66). As we presented, the lower, and more commonly inundated surfaces (Figure 65) are being densely colonized by reed canarygrass and other weeds (Figure 34) and this provides a zone that would provide weed propagules that would drift downstream. Following our field observations and as we discussed in the prior section, we anticipate that this may develop into a dense and extensive patch of reed canarygrass (Figure 66) and this outcome may be disfavored.

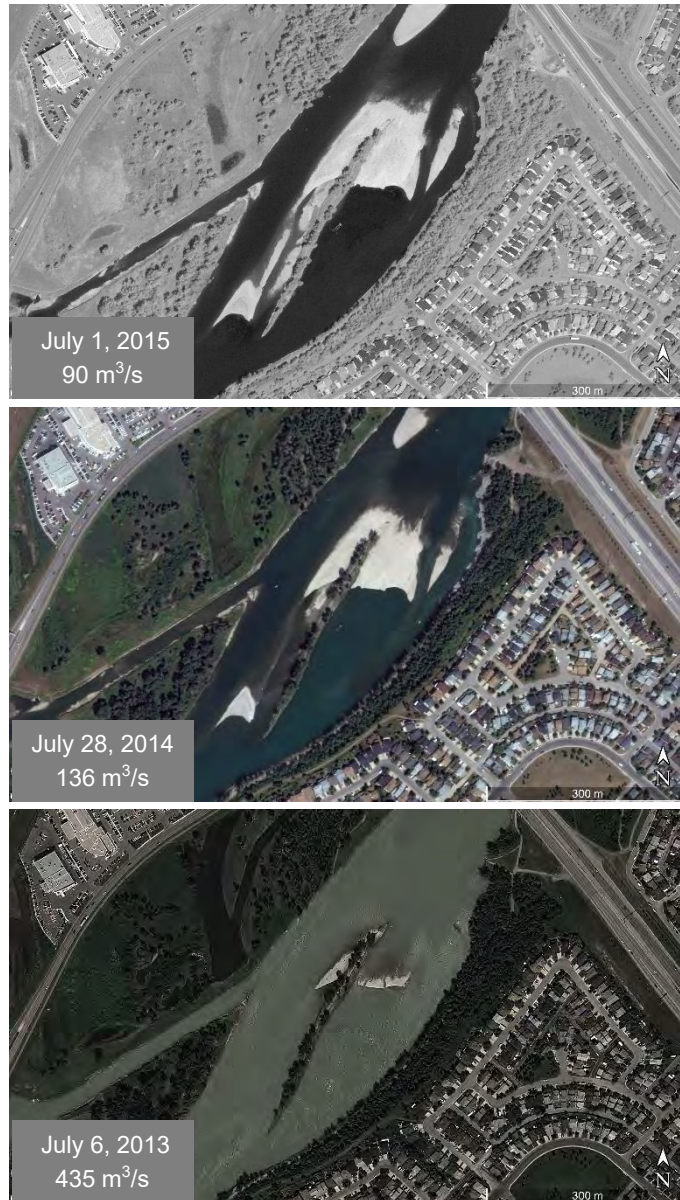
Figure 71. Post-flood aerial photographs of Carburn Park Island displaying inundations at different rivers discharges that were used to project vegetation colonization patterns.

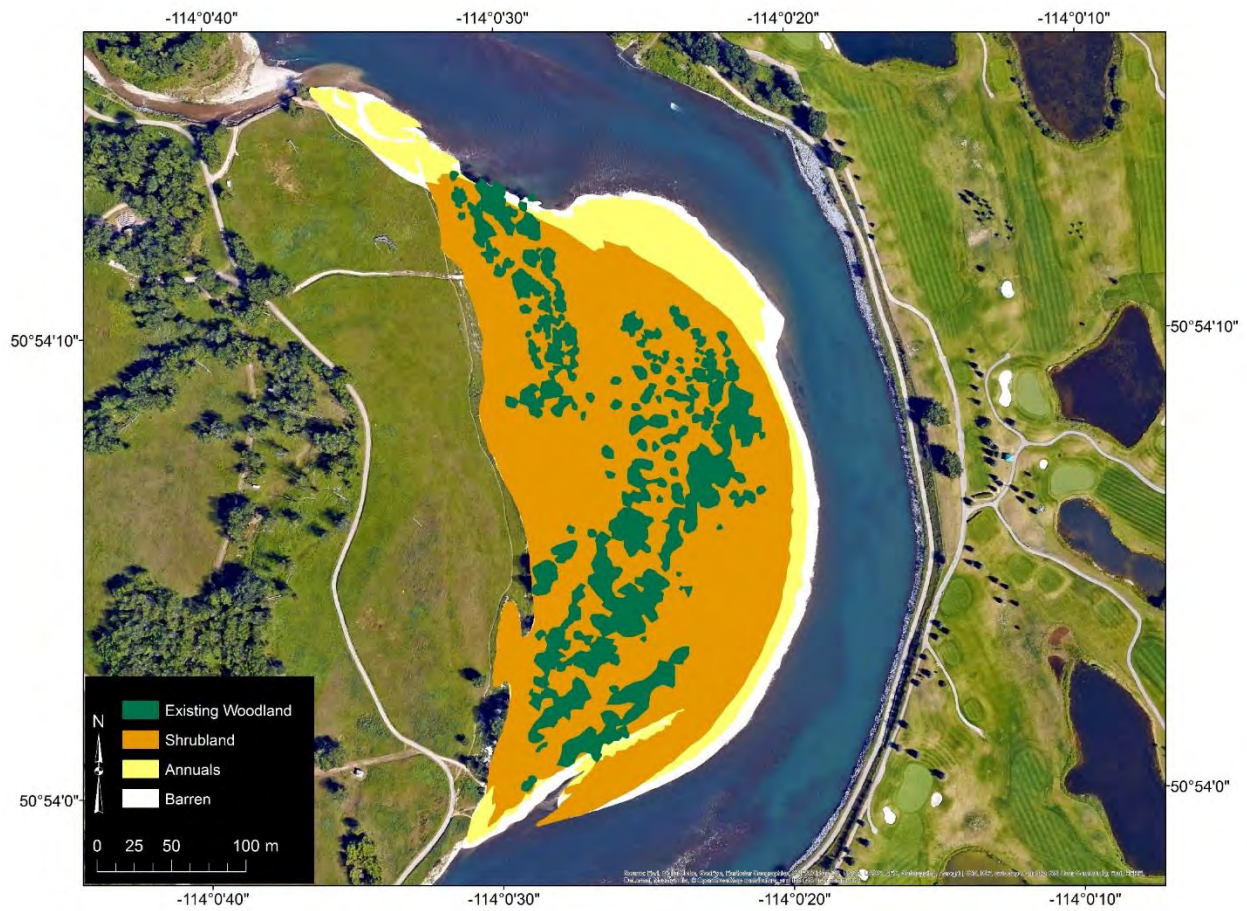
Figure 72. 'Camo-map' showing projected riparian vegetation types on the Hull's Wood Bar. (Existing woodland was mapped using the 2014 Google Earth image.)

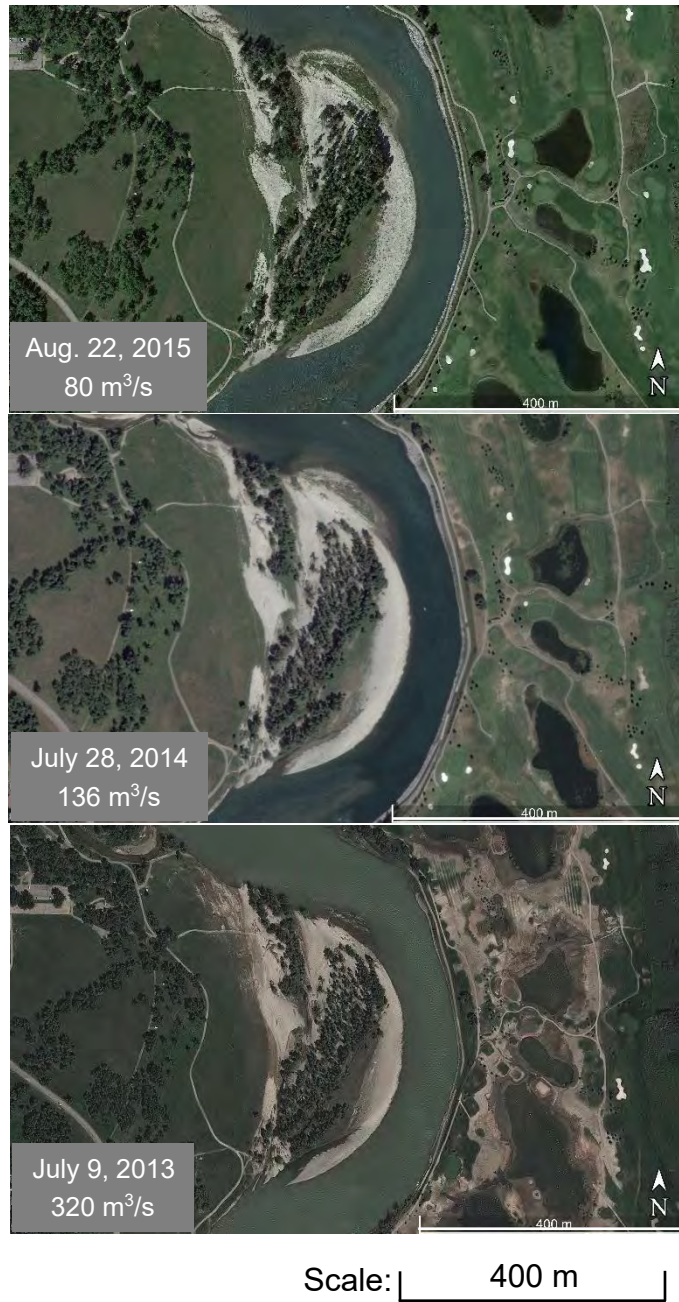
Figure 73. Post-flood aerial photographs of Hull's Wood Bar displaying inundations at different rivers discharges that were used to project vegetation colonization patterns. Google Earth aerial photographs were limited for this location.
