Landslides DOI 10.1007/s10346-008-0133-4 Received: 23 November 2007 Accepted: 24 March 2008 © Springer-Verlag 2008 Panya S. Lipovsky · Stephen G. Evans · John J. Clague · Chris Hopkinson · Réjean Couture · Peter Bobrowsky · Göran Ekström · Michael N. Demuth · Keith B. Delaney · Nicholas J. Roberts · Garry Clarke · Andrew Schaeffer

The July 2007 rock and ice avalanches at Mount Steele, St. Elias Mountains, Yukon, Canada

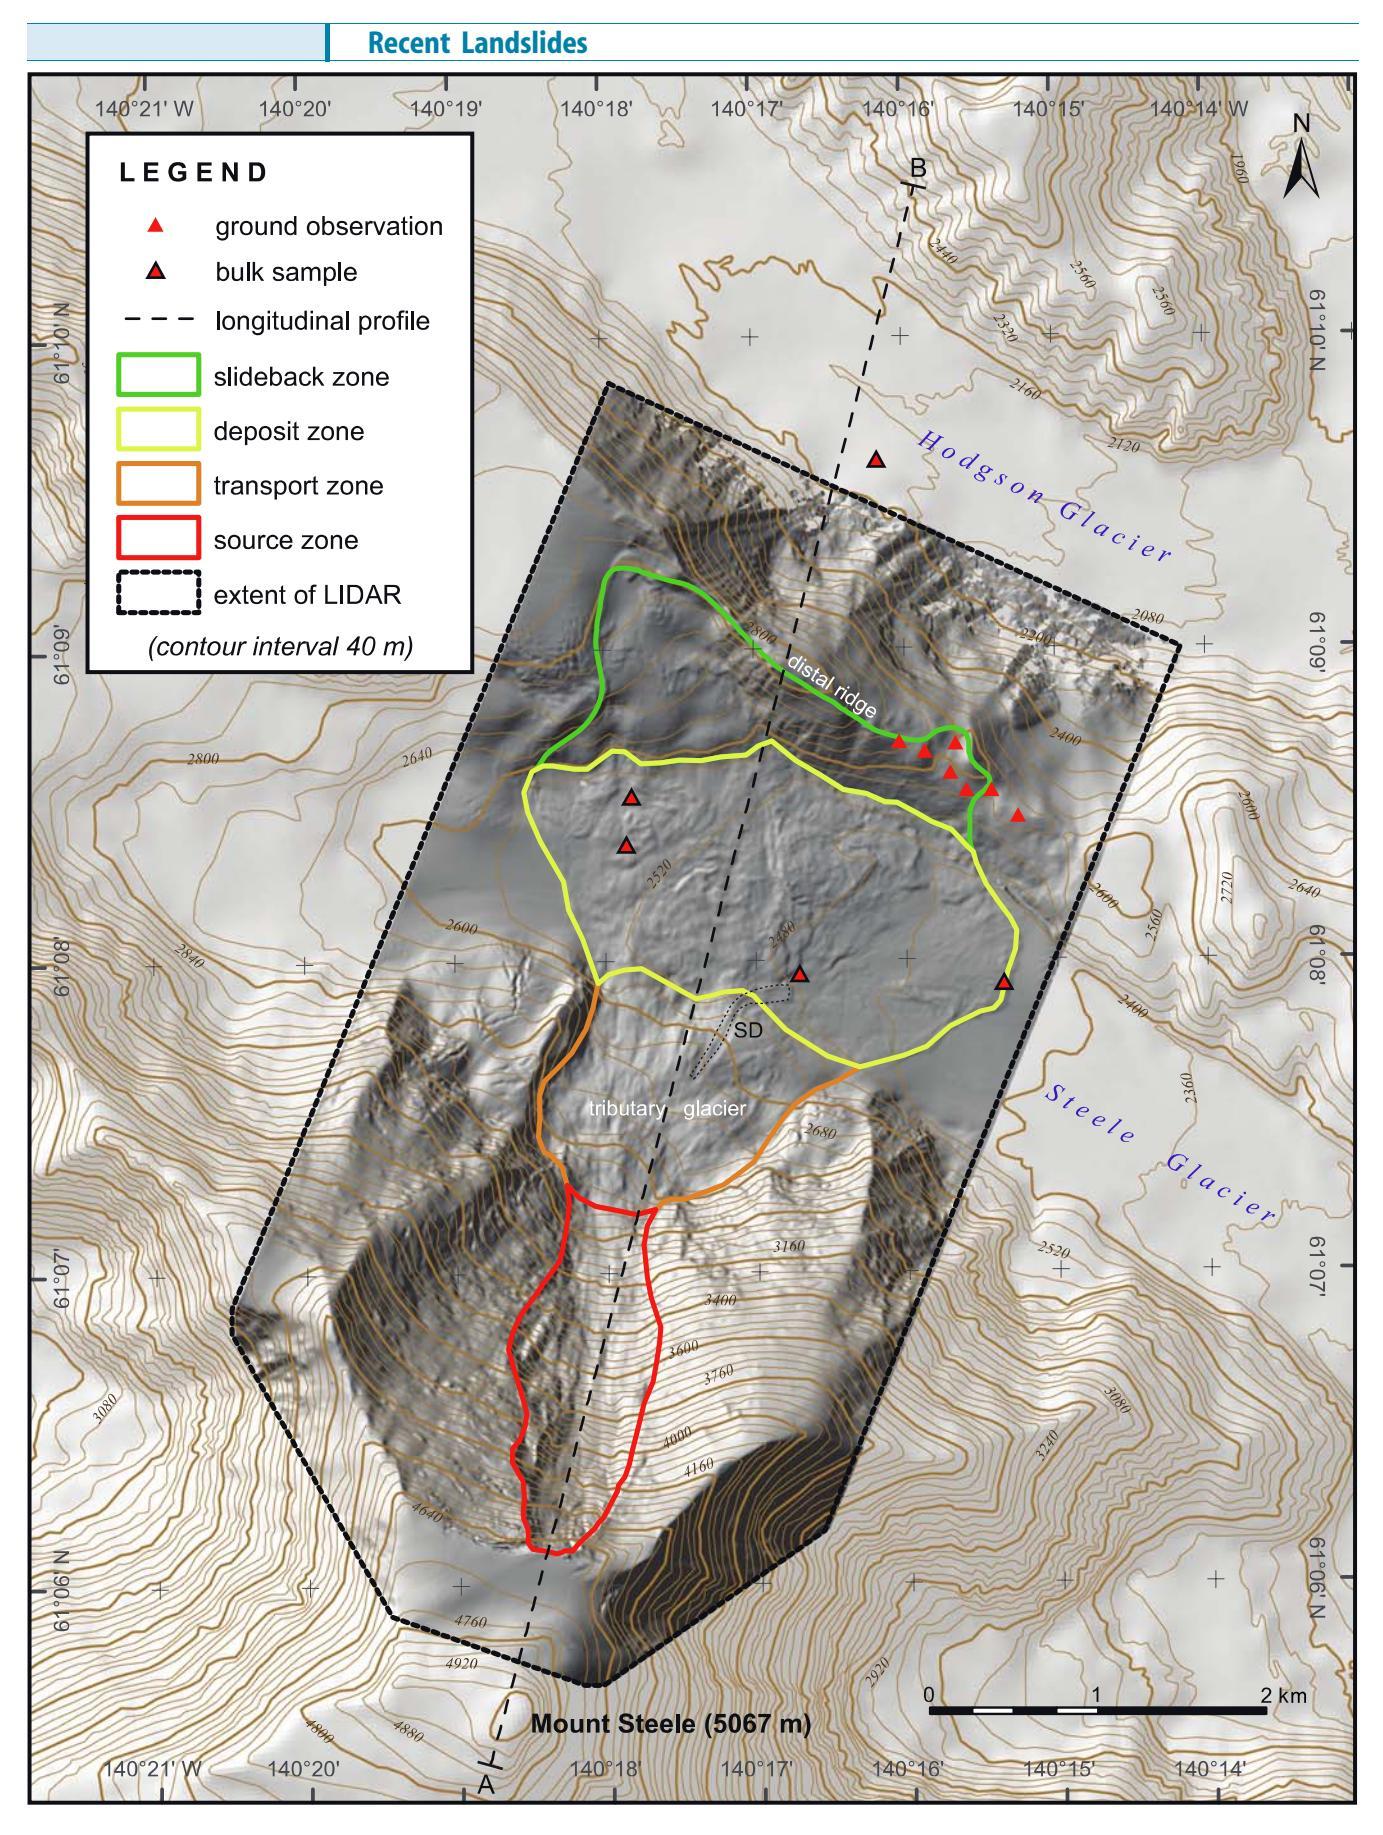
Fig. 3 Map of the July 24th rock and ice avalanche features. Hillshade image derived from the LiDAR survey described in the text. SD Secondary debris flow channel. The contours are from the pre-landslide topographic surface dating to 1951

The debris sheet of the main event covered an area of 5.28 km^2 , fanning out to a width of 3.1 km at the north margin of Steele Glacier (Fig. 3). This area includes the total area covered by debris before slideback. The area of slideback is about 1.62 km^2 , thus the total area of significant debris cover is about 3.66 km^2 .

Bulk samples (3.5–4 kg) of surface debris were collected at four locations on August 12 (Fig. 3). The solid portion of the samples consists of 58–64% coarse-grained material (>2 mm), the majority

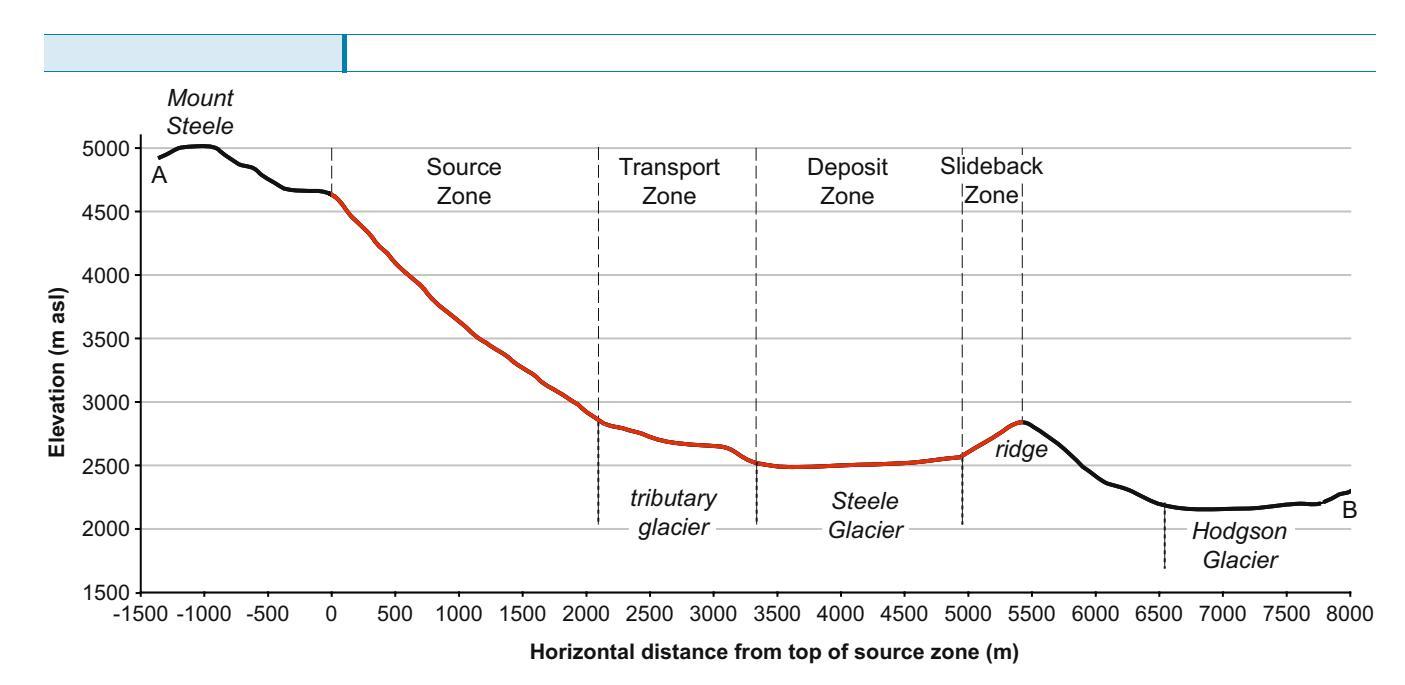
Fig. 4 Longitudinal profile along *line A–B* shown in Fig. 3. The travel path of the July 24th rock and ice avalanche is shown by the *red line*; this path is not equivalent to that used to determine maximum runout

A first-order, 2-D dynamic analysis of the main event along the path shown in Fig. 4 was carried out using the simulation software DAN (Hungr 1995; Hungr and McDougall 2008). In the DAN model, debris width (taken from Fig. 3) is input along the path length of the rock avalanche. The simulation was carried out for material which originated in the source zone as defined in Fig. 4, using an initial failure volume of 51 Mm³, in the mid-range of our volume estimates noted above. No entrainment was specified since there is no evidence of significant debris entrainment along the path of the main event. Defining the origin of the landslide as the base of the source zone, the run time and the run-out distance of the debris front were simulated very well (Fig. 8) using a Voellmy basal resistance model (Hungr 1995) with values of 0.052 and 1,525 m/s² for the friction (μ) and turbulence coefficients (ξ), respectively. These parameter values are comparable to those used to successfully simulate the 1964 Sherman Glacier rock avalanche (μ =0.03 and ξ =1,000 m/s²; Hungr and Evans 1996). The run-up to the top of the ridge is simulated almost precisely, without overtopping it, and the slideback is also predicted (Fig. 8). The simulated velocity at a horizontal distance of 5,000 m is 42 m/s, which is significantly lower than the 73 m/s estimated from the energy head formula.

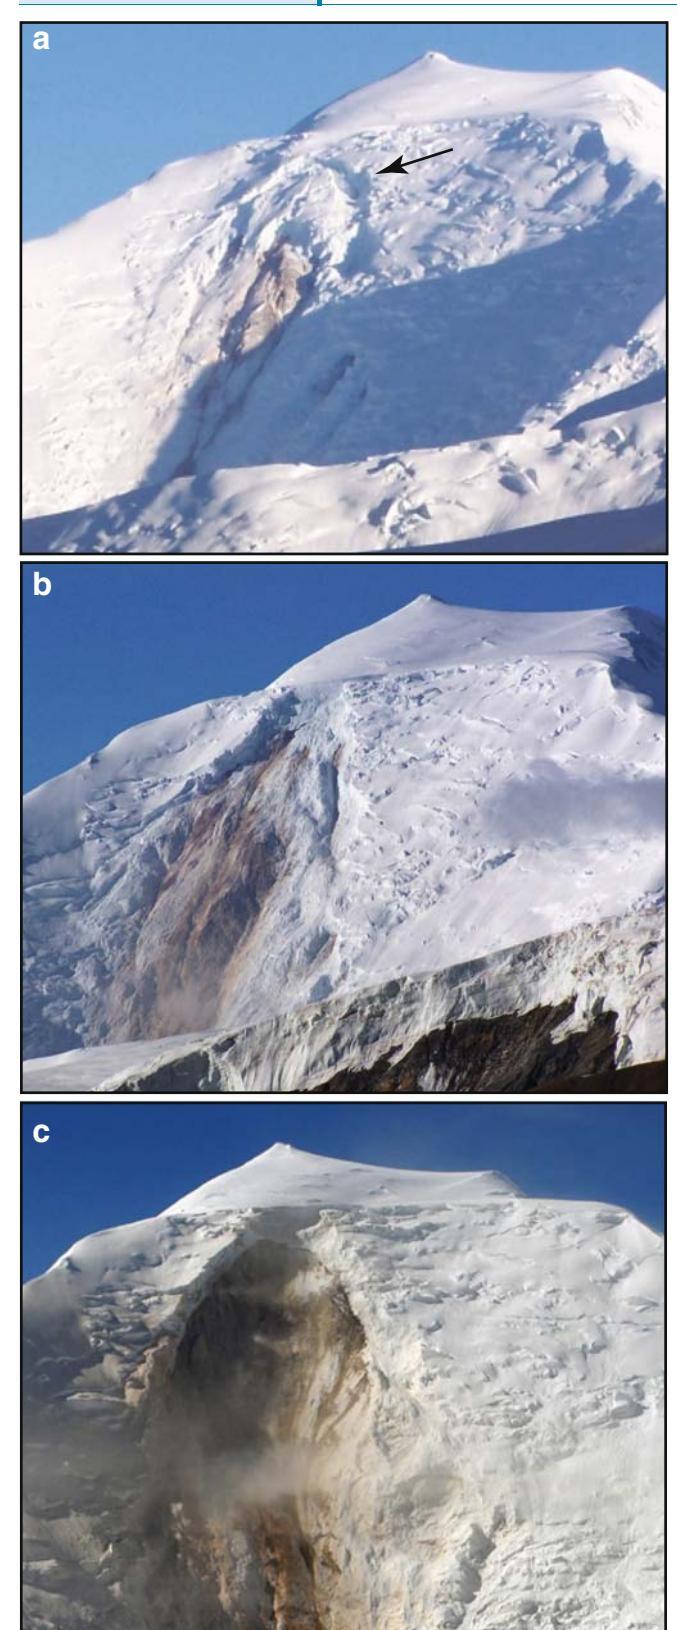
Fig. 5 Source zone of the ice and rock avalanches on the north face of Mount Steele. **a** Crevasse (*arrow*) outlining slab of ice that failed on July 22, 2007 (photo taken prior to July 22 by A. Schaeffer on July 15, 2007). **b** Bedrock exposed after the July 22 ice avalanche (photo by A. Schaeffer, July 23, 2007). **c** Source zone scar from July 24 main event; the scar is approximately 500 m wide (photo by P. von Gaza, August 2, 2007)

The events in July 2007 have been remarkably well-documented, given the remoteness of the locality and difficulty of access. Glaciologists flying to Trapridge Glacier on July 14, 2007 took photos of Mount Steele's north face showing fresh debris in the gully system. The glaciologists also observed a large crevasse that had developed in the ice above the gully system (Fig. 5a). Photos of the

A larger mass movement (the "main event") occurred at Mount Steele 2 days later, on July 24 at 1757 hours local time (Figs. 5c, 6c, d). It was not directly witnessed but was recorded on seismographs as a M_L 3.4 seismic event. The magnitude estimated from long-period surface-waves (M_s) is 5.2, and modeling of the waveforms suggests an estimated duration of 100 s (Ekström 2006; Ekström et al. 2007). Another, much smaller mass movement was detected by the Alaska Earthquake Information Centre about 1.5 h later at the same location (N. Ruppert, personal communication, 2007). A prominent light-coloured (ice-rich) debris lobe located near the east margin of the deposit (Figs. 1 and 6c) is attributed to this secondary event and suggests that it was likely an ice avalanche.

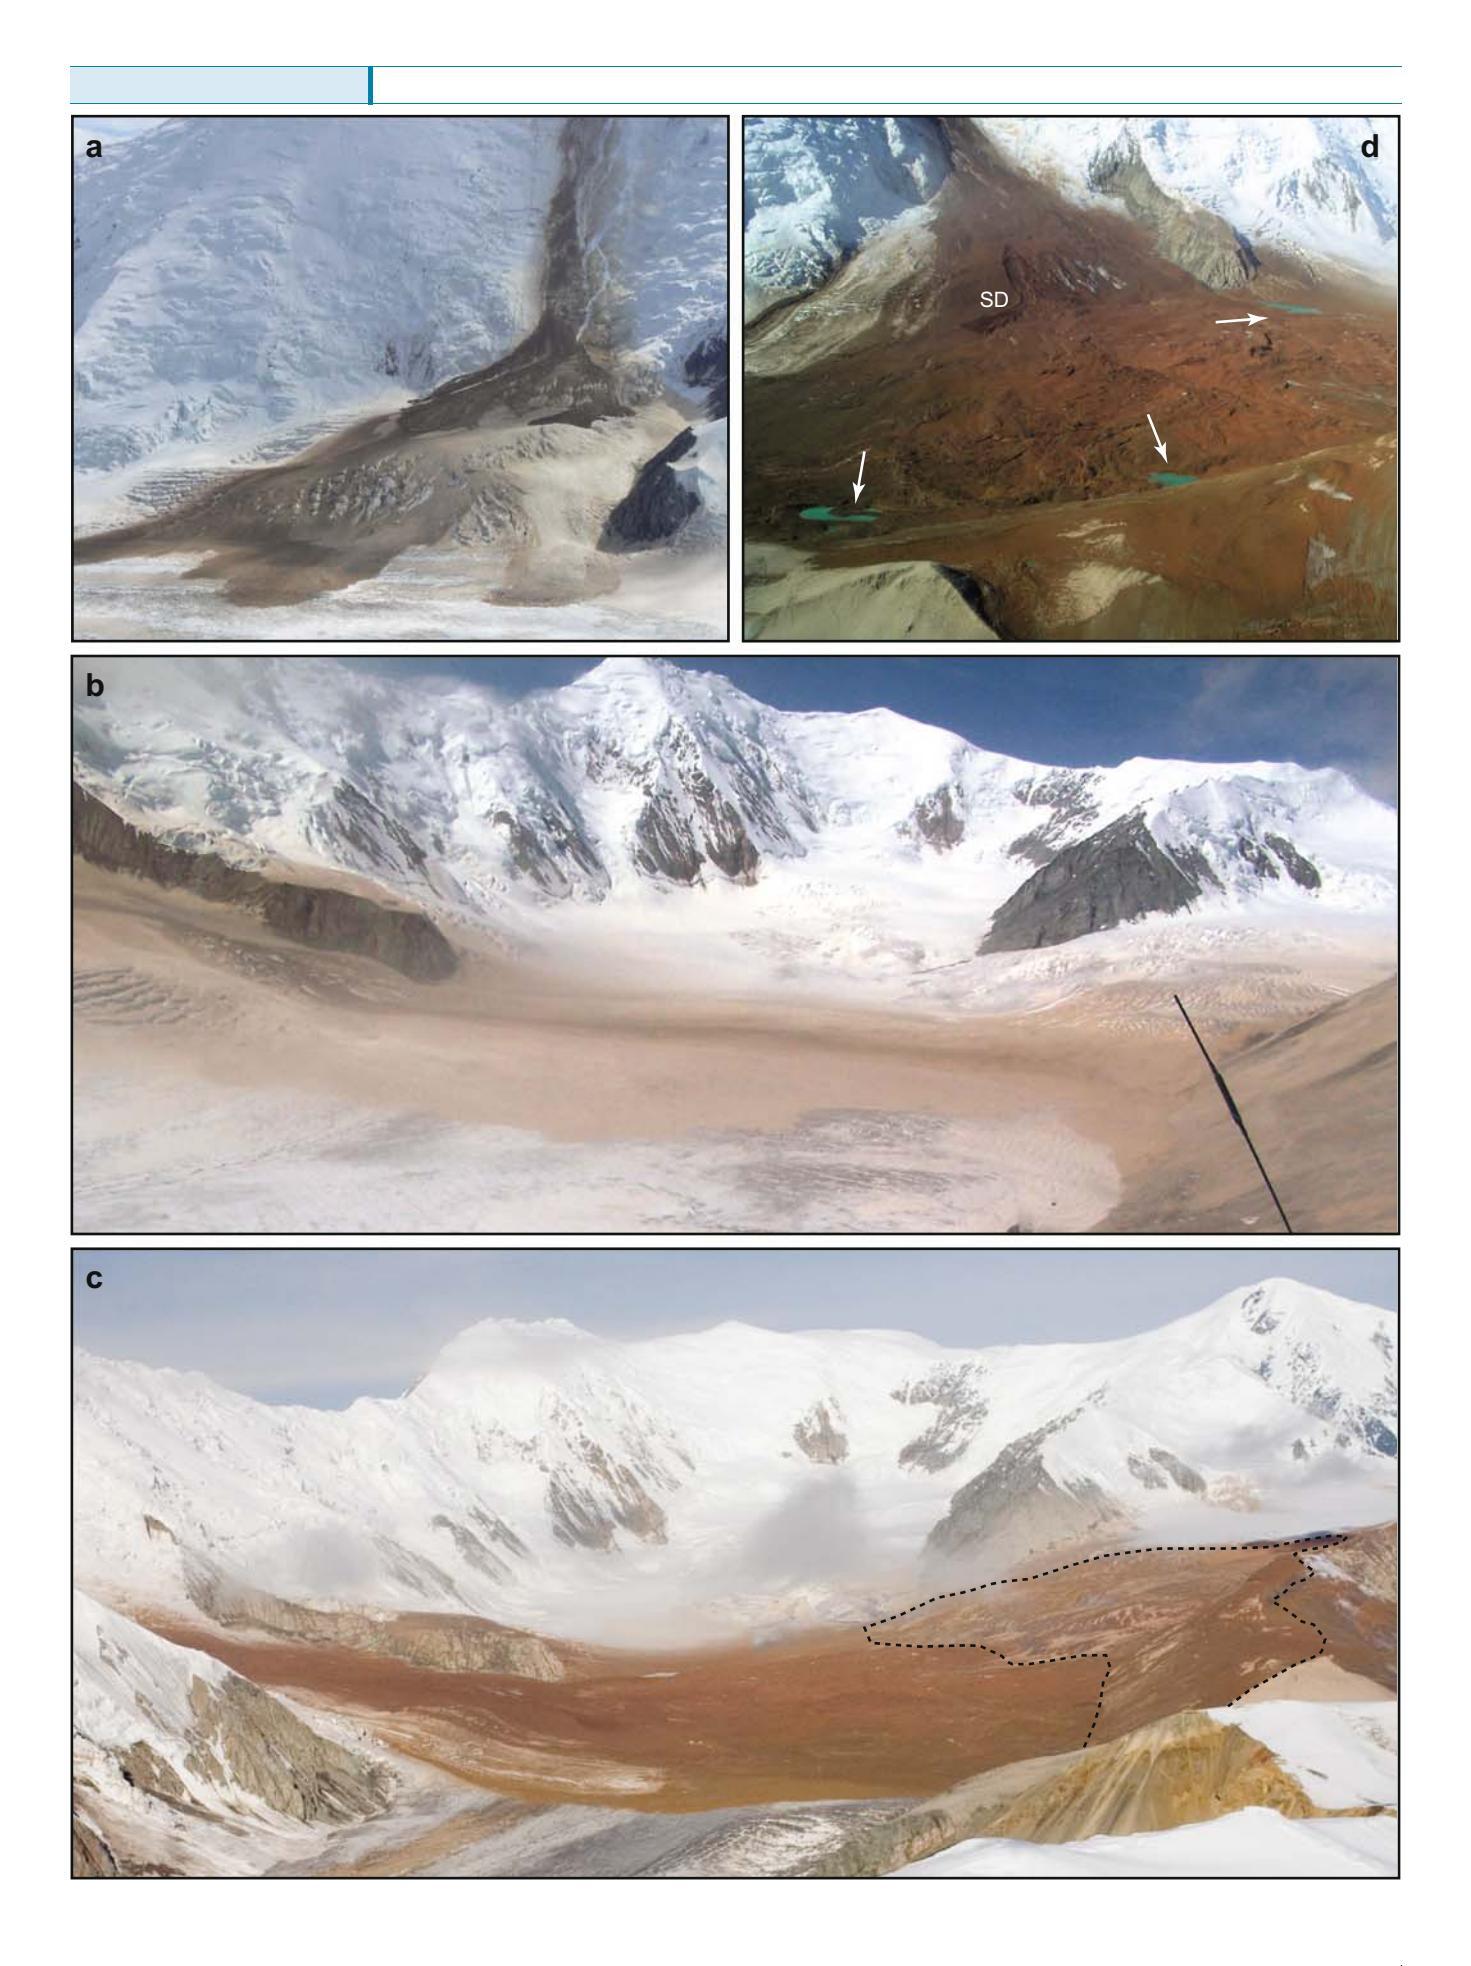
lower part of the north face taken by a park warden on July 21 show deposits of at least two fresh debris flows. One of the debris flows traveled partway down the tributary glacier, while the other traveled further and reached the southwest margin of Steele Glacier (Fig. 6a).

On July 22, at approximately 1325 hours local time (Pacific Daylight Time), the glaciologists at Trapridge Glacier witnessed a large ice avalanche on the north face of Mount Steele. A slab of ice, \sim 3 million cubic metres in volume, broke away along the crevasse noted a week earlier (Fig. 5a, b). The slab rapidly fragmented and developed into an avalanche that entrained additional snow and ice as it swept down the system of gullies onto Steele Glacier. The leading edge of the avalanche powder cloud traveled across Steele Glacier, up a 275-m-high ridge and down onto Hodgson Glacier, a total horizontal distance of at least 8 km (Figs. 3 and 4). The avalanche debris covered an area of about 2 km² on Steele Glacier (Fig. 6b), and the distal edge of

The debris was thin on the south flank of the ridge that separates Steele and Hodgson glaciers and in places on Steele Glacier itself, notably where slideback occurred (Fig. 6c). Patchy, thin debris was also present over much of the tributary glacier, but this area is not included in the deposit zone shown in Fig. 3 since debris transport dominated in this part of the path. In addition, a coating of airborne silt and sand up to 20 cm thick accumulated above snow and ice on both sides of the ridge crest, and this material was not considered part of the main debris sheet.

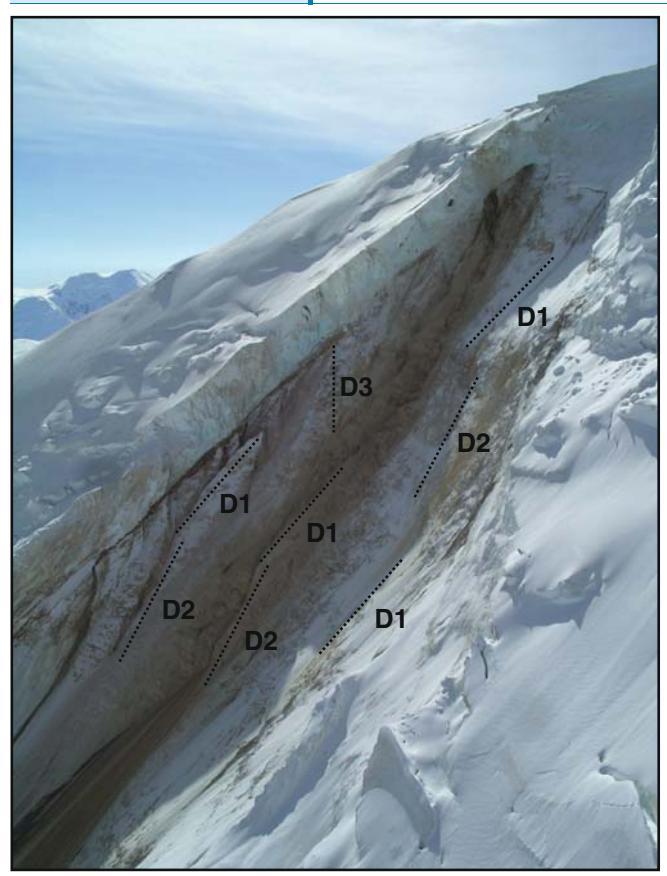
Fig. 7 Discontinuities (*D*1, *D*2 and *D*3) in the rock mass of the July 24th rock and ice avalanche source zone (photo by P. Lipovsky, August 12, 2007)

Photographs of the failure zone indicate three main sets of discontinuities in the rock mass (Fig. 7). The most conspicuous discontinuity set (D1) consists of smooth planes striking parallel to and dipping at the same angle as the slope; some D1 planes may also daylight in the slope. The second discontinuity set (D2) dips in the same direction as D1, but at a steeper angle, and therefore does not daylight. The third discontinuity set (D3) is sub-vertical, strikes southwest to northeast, and probably controls the east lateral margin of the main scarp.

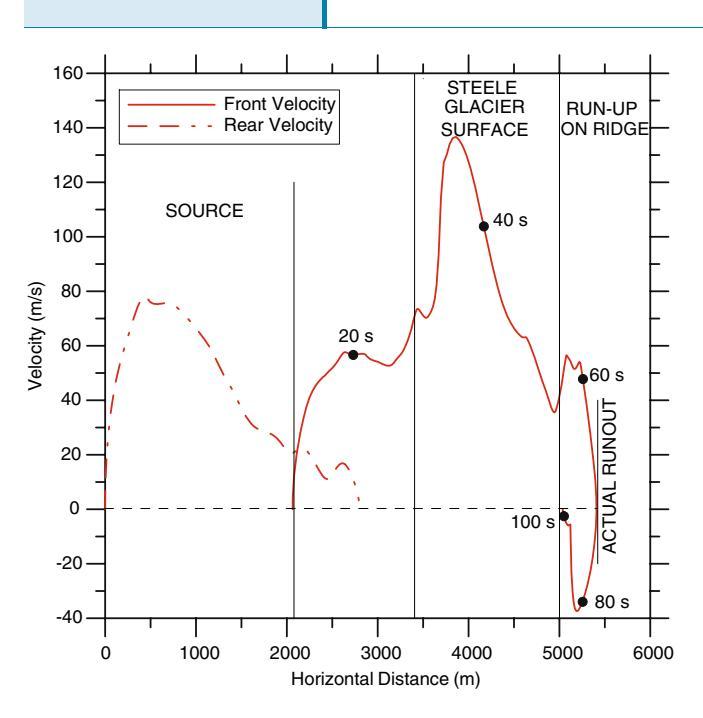
Fig. 8 Simulated velocity profile of the main event rock and ice avalanche on July 24th, 2007. The velocity of the front and rear of the debris sheet are shown. Note the rapid acceleration of the debris when the front of the sheet encounters the surface of Steele Glacier, followed by rapid deceleration as the debris thins and spreads out on the glacier surface. The *black dots* represent position and velocity of the debris front at 20 s intervals during movement. Maximum runout was achieved at 69 s, suggesting a simulated mean velocity of 78 m/s. By 100 s, the slideback of debris had reached the base of the ridge. Simulation was carried out using the Voellmy model in DAN (Hungr 1995) with values of 0.052 and 1,525 m/s² for the friction and turbulence coefficients, respectively

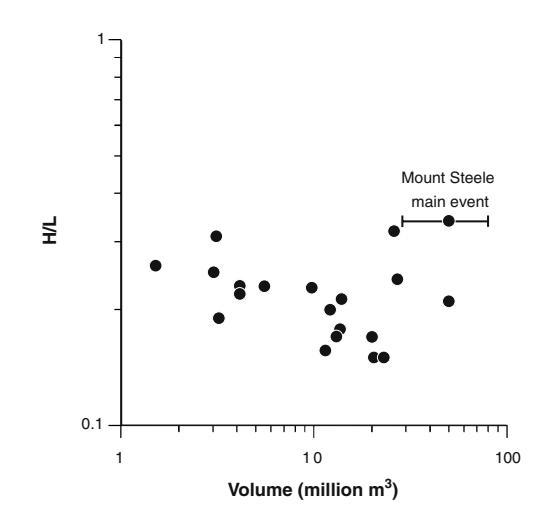
Fig. 9 Comparison of Mount Steele main event mobility with 20 rock avalanches (volume $>1 \text{ Mm}^3$) onto glaciers documented in northwest North America (Alaska, Yukon and British Columbia) between 1956 and 2007. *H/L* is defined in the text, and the volume of the main event is plotted as the mid-point between the minimum and maximum volume estimates described in the text. Data are from Evans and Clague (1988 and 1999), Jibson et al. (2006) and Molnia et al. (2006)

The runout of rock avalanches on glaciers is commonly enhanced compared to that of non-glacial rock avalanches of the same volume (Evans and Clague 1988, 1999). However, the runout of the main event at Mount Steele was significantly less than other rock avalanches of similar volume that have occurred on glaciers (Fig. 9; Evans and Clague 1988, 1999; Jibson et al. 2006; Molnia et al. 2006). In the Mount Steele case, runout was impeded when the landslide encountered a significant topographic barrier-the 275m-high ridge separating Steele and Hodgson glaciers (Figs. 2 and 3). In addition, the Mount Steele landslide, although initially guided by ravines on the north flank of the mountain, subsequently spread over the nearly flat surface of Steele Glacier, dissipating much of its energy. The combination of a topographic barrier and rapid unconfined spreading of the debris on the glacier surface explains the relatively short travel distance of the landslide in relation to its volume.
